March 8, 2019

Version 2

Safety Recall: Driver's Airbag Replacement Inflator Can Be Over-Pressurized

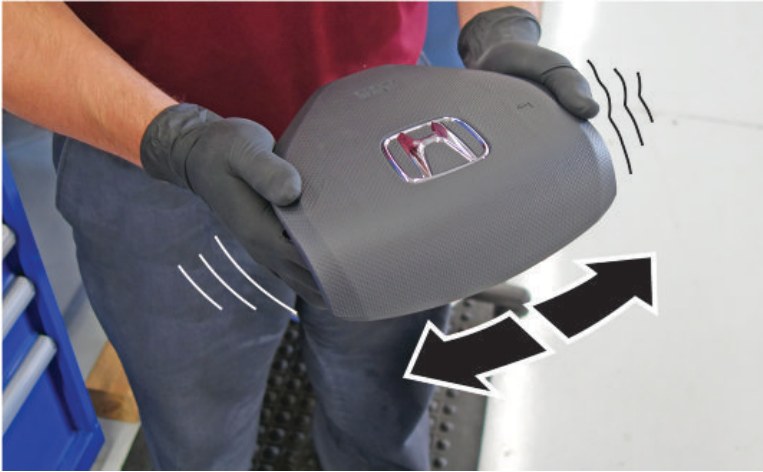
8. Use shop air to clean any debris that may be on the inflator, then remove the inflator from the airbag.

- Do not allow any debris to enter the inflator opening in the airbag.
- Do not deploy the inflator. The inflator must be returned to its supplier in the box the new inflator came in. Follow the shipping instructions supplied with the inflator kit. If you have any questions about shipping, call Warranty Parts Inspection (WPI) at **937-642-2737**.

9. Turn over the airbag (inflator side down), and shake it to remove any debris from the inflator opening.

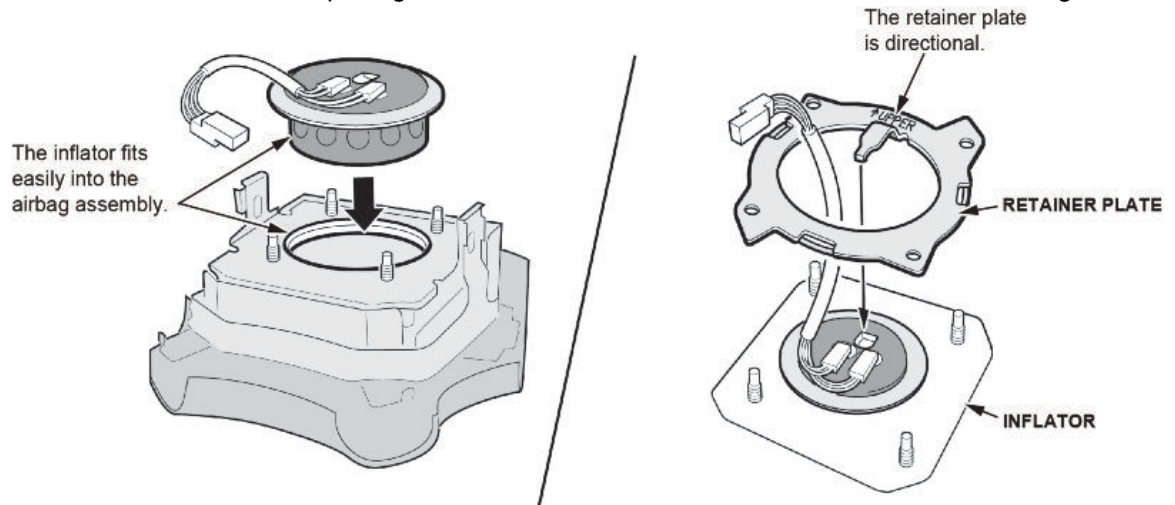
10.2.1. Place the inflator into the opening with the inflator harness toward the bottom of the airbag.

10.2.2. Install the bracket onto the studs. Make sure the locator tab fits into the locator hole as shown.

Make sure the harness comes out through the center opening. Do not install the bracket over the harness wires.

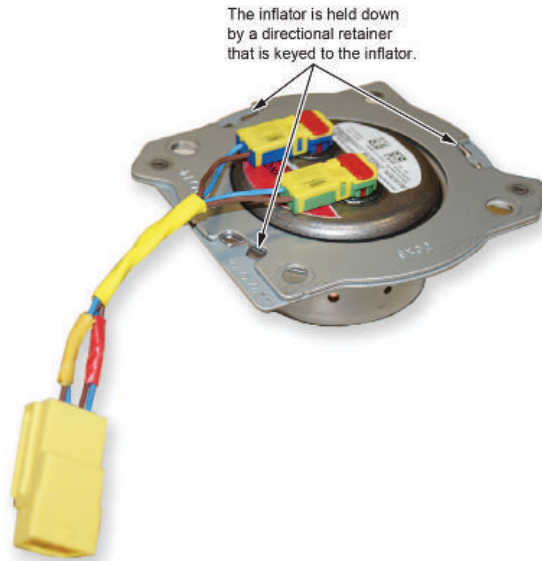
10.3.1. Place the inflator into the opening with the inflator harness toward the bottom of the airbag.
