Keystone RV Company

SAFETY ADVISORY # 19-348

Capital Two-Burner Cooktop

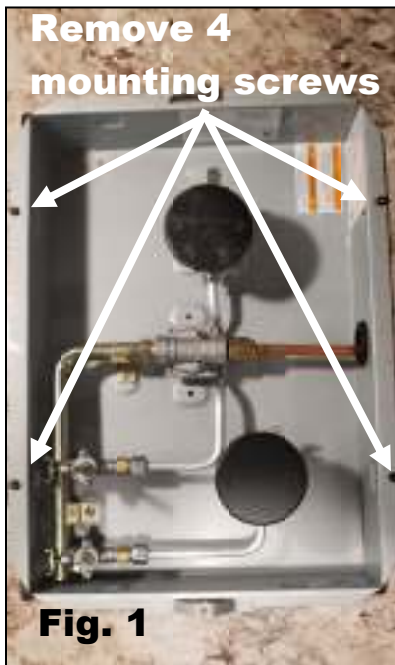
Remove the four screws mounting the box to the counter top (Figure 1), remove the propane gas supply line. Remove the remove the Capital burner box (discard).

Install KRV # 252380 - Range - Drop In - Outside Burner Box - Box Only, attaching the propane gas supply and installing 4 mounting screws. For more details see the installation instructions that come with the part.

Perform leak test and install the burner top and grills.
