April 12, 2019

Safety Recall: 3.5L V6 Timing Belt

During production, a supplier produced some timing belts that do not meet specification. These timing belts may shred or slip, causing the cam shafts to fall out of timing. Camshafts that are out of timing will set *DTC P0341: CMP Sensor and CKP Sensor Incorrect Phase Detected* and/or *DTC P0369: CMP Sensor Circuit Intermittent Interruption* and the engine will run rough. Additionally, shredded timing belts may cause the vehicle to stall and not be able to restart, which increases the risk of a crash.

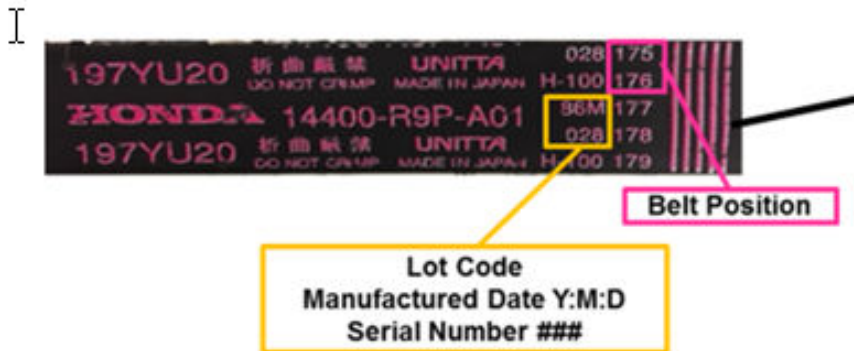
6. Check the Lot Code.

- If the Lot Code is listed in the table, go to step 7.

- If the Lot Code is not listed in the table, the timing belt is okay, and the inspection is complete. Reassemble the vehicle in the reverse order of removal.

85B001	85B013	85E013	85E021	85E029	85E033	85E037	85E041	85F006	85F017
85F021	85F037	85F045	85F053	85G012	85G024	85G032	85G036	85G043	85G054
85H004	85H012	85H024	85H052	85I017	85I032	85I037	85I040	85I044	85L013
85L017	85L021	85L025	85L029	85L037	85L045	85M005	85M009	85M013	85M021
85N029	85N045	868039	868052	86B003	86B007	86B026	86B034	86C018	86C044
86C048	86I004	86I010	86I014	86J001	86J045	86J049	86J053	86K005	86K009
86K013	86K025	86K029	86K033	86K039	86L016	86L028	86L032	86L040	86L044
86L056	86M028	86M044	86M048	86M052	86M056	86P028	86P044	86R003	86R019
86R043	86R051	86S054	86T064	876006	876039	87A038	87B007	87B015

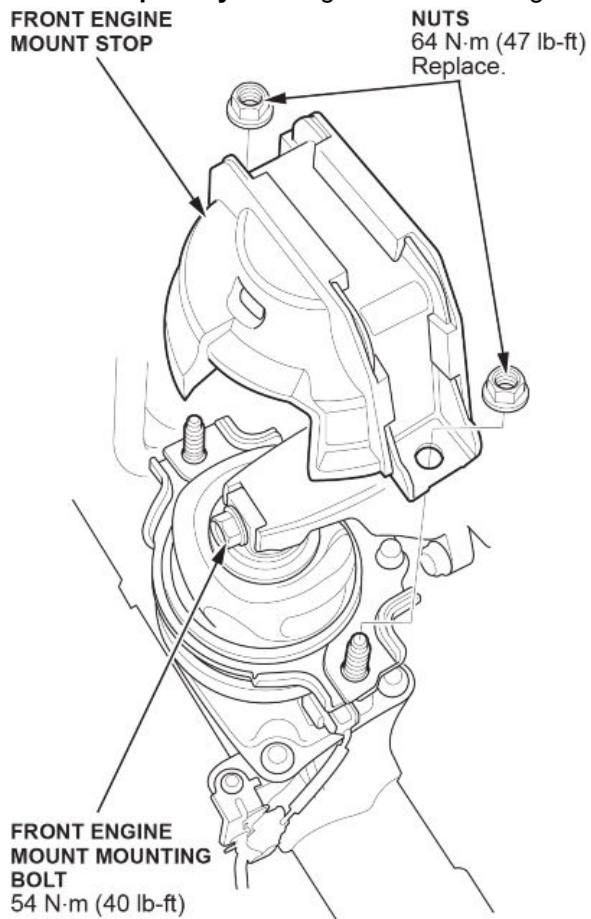
38. **For RLX Sport Hybrid:** Tighten the front engine mount stop and front engine mount mounting bolt.

38.1. Tighten the front engine mounting bolt.

38.2. Install the front engine mount stop using new nuts.
