Product Safety Recall

A182202370 Lower Control Arm Weld

Release Date: June 2019

Revision: 03

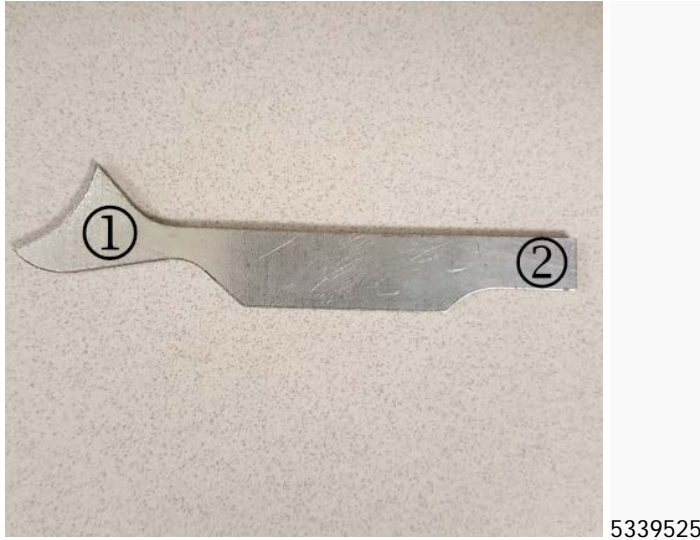
Photograph of the Inspection Gauge. Use the gauge to measure two weld gaps on the lower control arm. Use the number one (1) side of the gauge to measure the weld gap in step 4 and the number two (2) side of the gauge to measure the weld gap in step 5.

1. Lift the vehicle. Refer to *Lifting and Jacking the Vehicle* in SI.
2. Locate your inspection gauge and identify sides 1 and 2 as shown below.

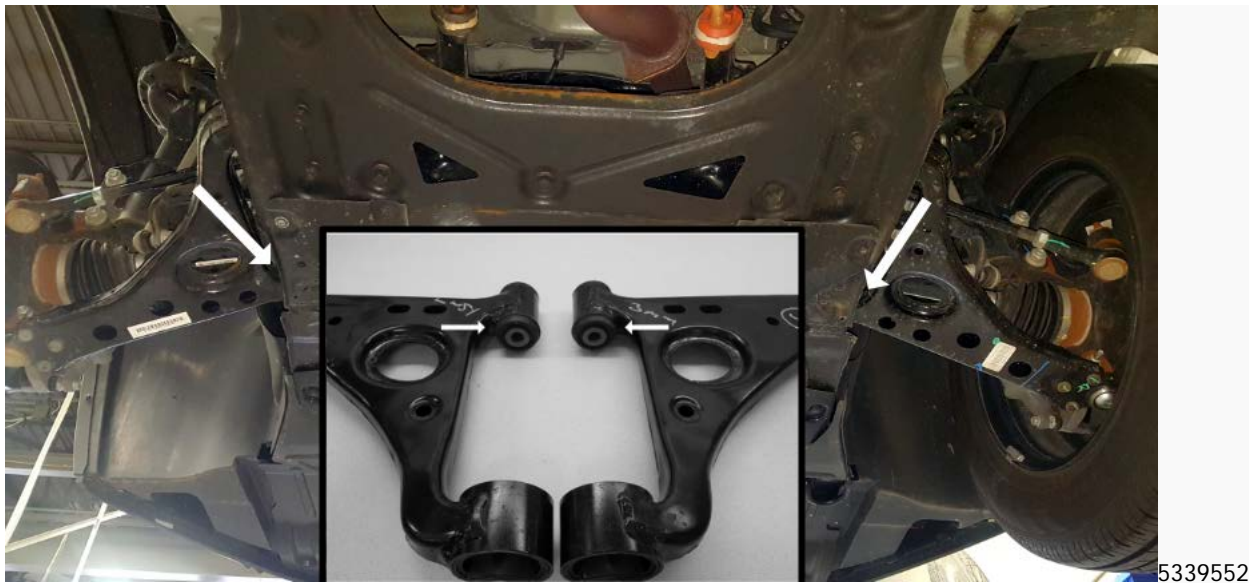
Photograph of Gap 1 (between the welds, red) and Gap 2 (between the control arm body and bushing barrel, purple).

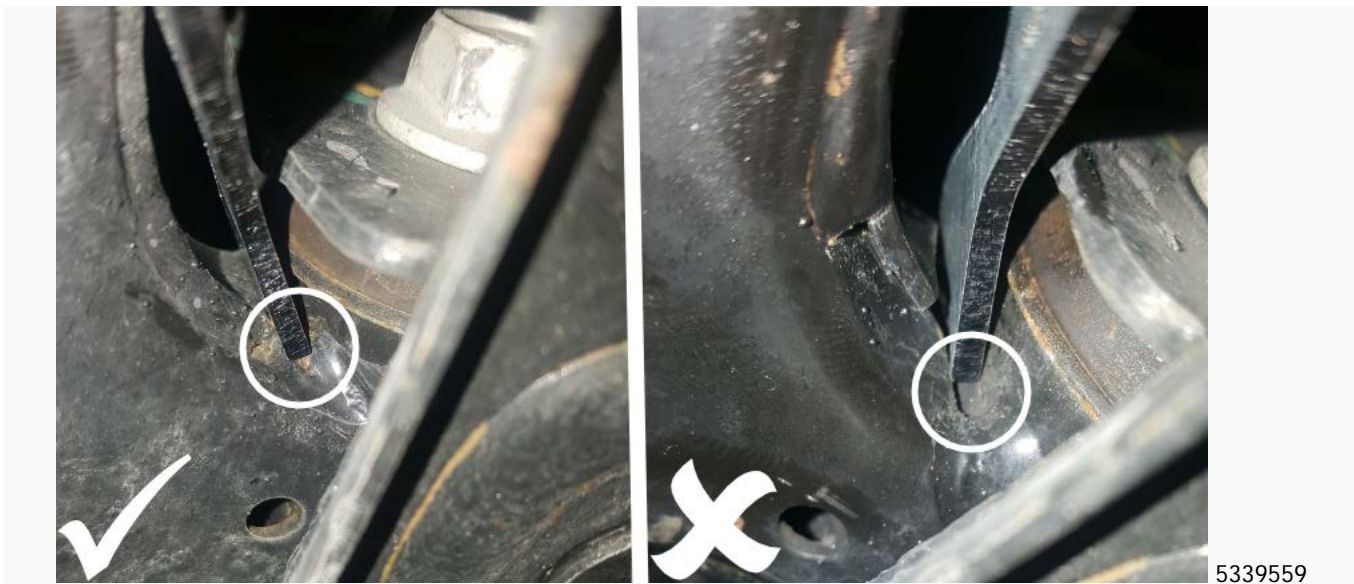
4. Inspect the Gap (1) in the weld using the number one (1) side of the gauge. With the gauge oriented as shown, slide the top of the tool along the barrel of the bushing until it contacts the upper weld. Then, pivot the bottom of the gauge in while holding the top against the upper weld until the bottom of the tool is also contacting the bushing barrel or weld.

- If the inspection gauge does **not** fit in the gap between the welds (check mark), the control arm is good.
- If the inspection gauge **does** fit in the gap between the welds (X), the control arm is bad and must be replaced.

3. Inspect the welds on the rearward side of the driver's side front control arm bushing barrel using the provided gauge.

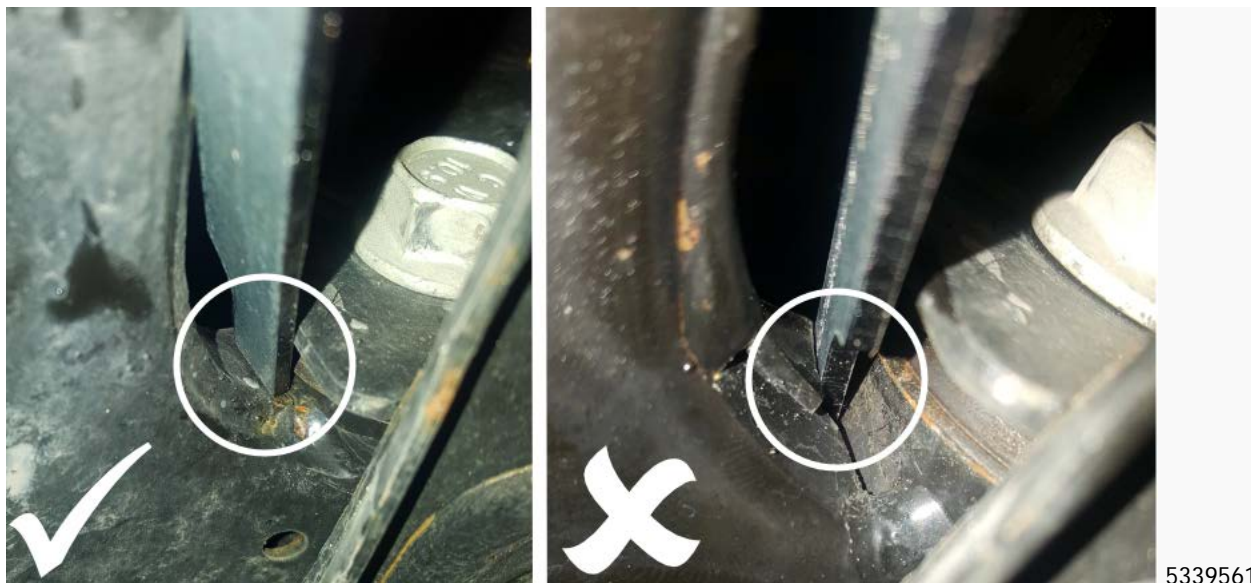
5. Inspect the gap (2) between the control arm bushing barrel and the control arm using the rear number two (2) of the inspection gauge.

- If the 2nd side of the gauge does **NOT** fit between the bushing barrel and the control arm (check mark), the control arm is good.
- If the 2nd side of the gauge **does** fit in the gap between the bushing barrel and control arm (X), the control arm is bad and must be replaced.
- Repeat the process again starting at step 3 on the passenger's side control arm.

- If all control arms passed the gauge inspection, no further action is required on that vehicle. Proceed to step 7.
6. Replace any front control arms that failed inspection. Refer to *Lower Control Arm Replacement* in SI.
 7. Lower the vehicle. Refer to *Lifting and Jacking the Vehicle* in SI.
