Product Safety Recall

N182206312 Diesel Engine Block Heater Cord

Release Date: January 2020

Revision: 02

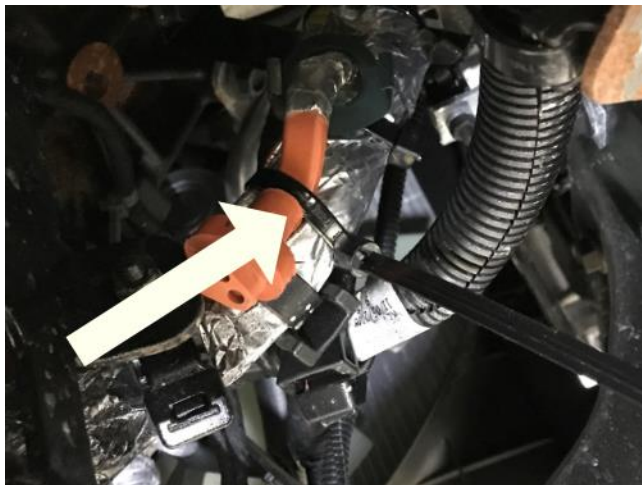
5340516

1. From underneath the vehicle, locate the engine coolant heater power cord. It is on the front passenger side of the engine block. Cut the wire tie securing the engine block heater power cable. Remove and discard the wire tie. (shown without the shrink tube installed).

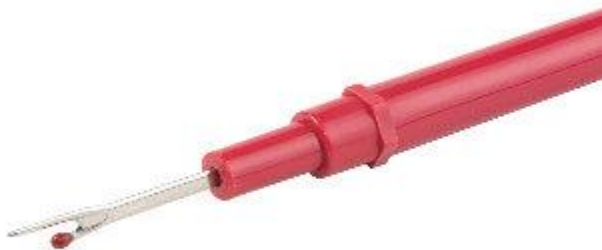
5495374

TIP: A seam ripper is a good example of the type of tool used in the following step.

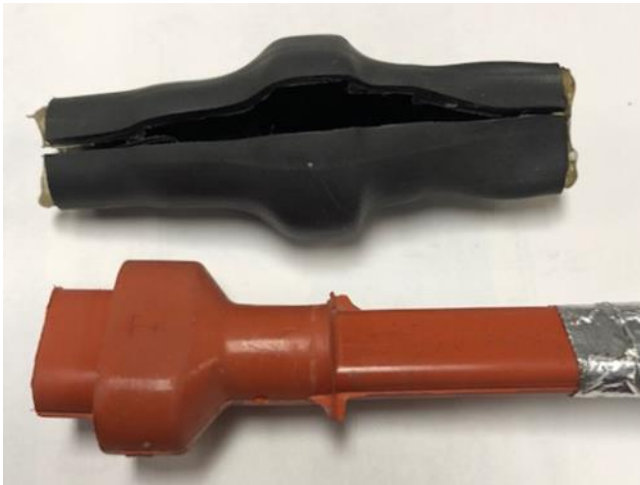
5415696

- Using an appropriate cutting tool, carefully slice the shrink tube from the power cord. Use care to cut away from the harness itself to ensure that you do not cut into the harness or body of the connector.
- Inspect the connector cavities and mating surface for any heat shrink tube adhesive. Carefully remove the adhesive if required.

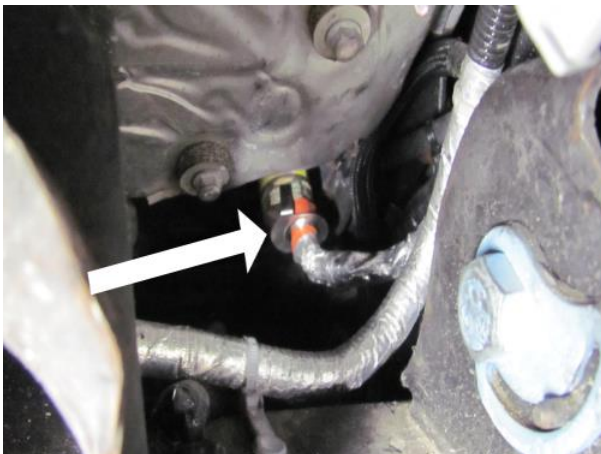
5420813

- Plug the engine coolant heater cord assembly into the heater and secure it with the metal clip. Be certain the metal retaining clip is secured onto to the deeper of the two grooves.
- Fill the cooling system. Refer to *Cooling System Draining and Filling (Vac N Fill)* in SI.
