Product Safety Recall

N182206310 Diesel Engine Block Heater Cord

Release Date: April 2019

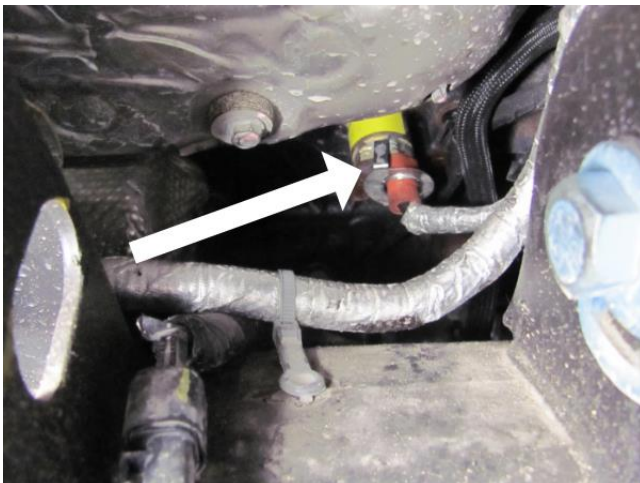
2. Looking through the area between the wheel house liner and the suspension, locate the engine block heater.

1. Raise the vehicle and remove the right front wheel. Refer to *Tire and Wheel Removal and Installation (8-Lug Wheel)* in SI.

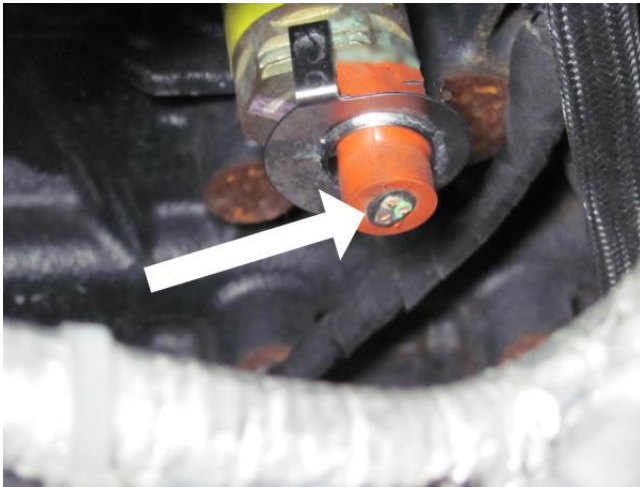
5326659

3. Using a pair of wire cutters, cut the engine block heater power cord from the connector. Cut the cord as close as possible to the connector. Leave the connector in place on the block heater to eliminate road debris from getting on the block heater terminals.

4. With the vehicle still raised, locate and remove any power cord attachments accessible from the underside of the vehicle.
5. Reinstall the right front wheel. Refer to *Tire and Wheel Removal and Installation (8-Lug Wheel)* in SI.

6. With the vehicle lowered, raise the hood and locate the remainder of the engine heater power cord (it should be bundled at the right-side front of dash area).

7. Locate and remove all of the attachment points. Remove the complete engine heater power cord assembly.
8. Discard the power cord assembly.
9. Remove the existing Monroney label (window sticker) and Install the new Monroney label. (for U.S. Dealers Only)
