N333NAS1

TECHNICAL BULLETIN

501-20A

Non-Compliance Recall - Front Left Seatbelt Emergency Locking Retractor

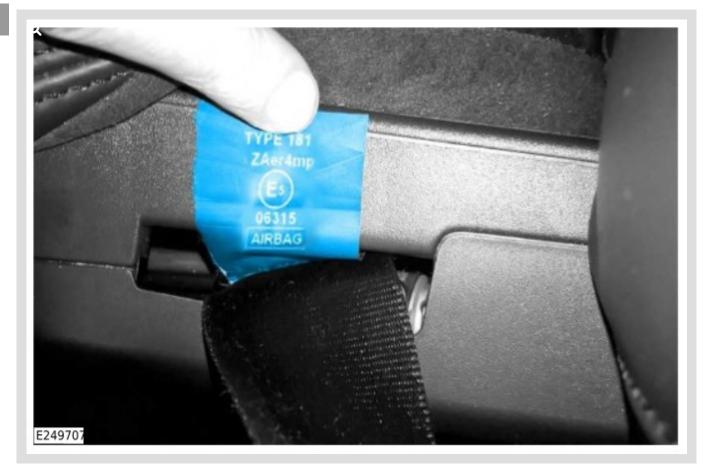
Locate the label on the **front left** seatbelt.

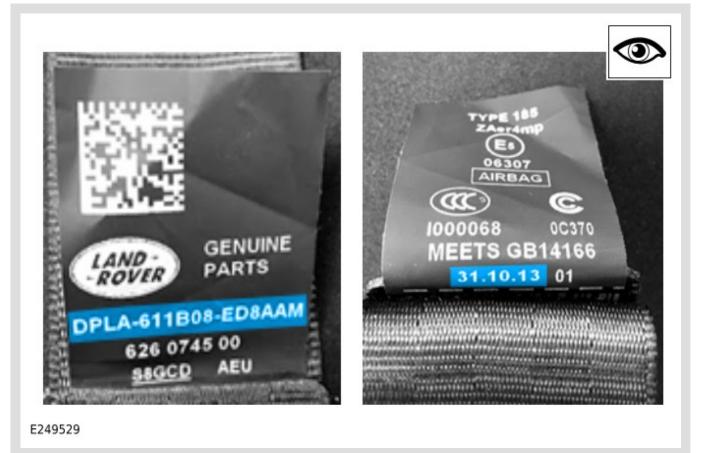
- The date codes and part numbers shown are for illustrative purposes only.
- Only inspect the front left seatbelt label.
- The label may need to be folded back on itself to view the printed production date.
- Take note of the printed date and part number.

Vehicles with ebony seatbelts only: inspect both sides of the front left seatbelt label for the production date and part number.

- If the front left seatbelt part number is 'CPLA 611B09ED8PVJ' and the production date is from 07/05/2016 up to and including 15/09/2016, go to step 5.
- If the front left seatbelt part number is 'CPLA 611B09ED8PVJ' but the production date is not from 07/05/2016 up to and including 15/09/2016, release the vehicle.

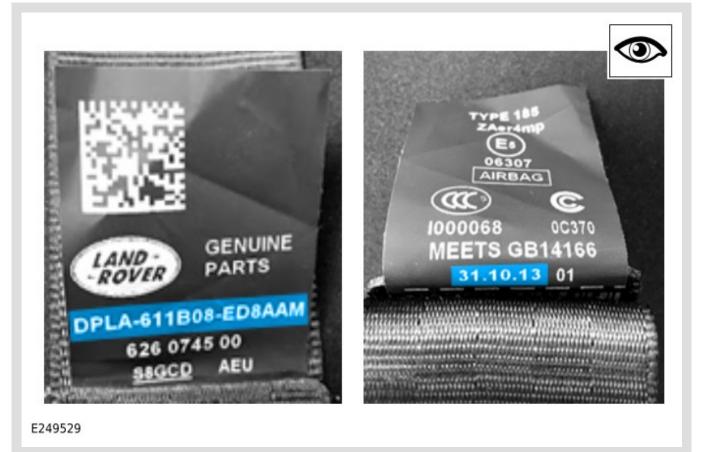
- The date codes and part numbers shown are for illustrative purposes only.
- Only inspect the front left seatbelt label.
- The label may need to be folded back on itself to view the printed production date.
- Take note of the printed date and part number.

Vehicles with espresso seatbelts only: visually inspect both sides of the **front left** seatbelt label for the production date and part number.

- If the front left seatbelt part number is 'CPLA 611B09ED8AAM' and the production date is from 07/05/2016 up to and including 13/09/2016, go to step 5.
- If the front left seatbelt part number is 'CPLA 611B09ED8AAM' but the production date is not from 07/05/2016 up to and including 13/09/2016, release the vehicle.
- Renew the front left seatbelt retractor (see TOPIx Workshop Manual section 501-20A: Seatbelt
 System Removal and Installation).
