May 17, 2019

Safety Recall: Incorrect Installation of the Takata Front Passenger's Airbag Inflator

AFFECTED VEHICLES

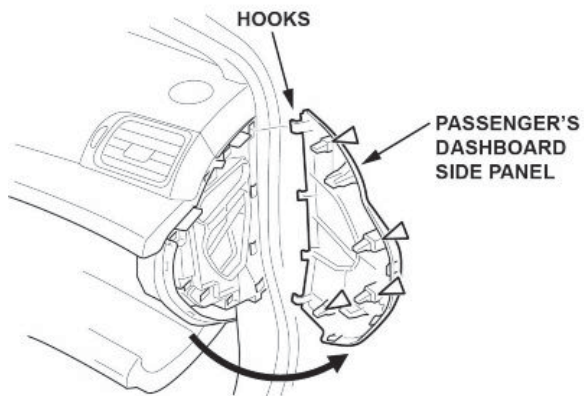
1. Using a plastic trim tool, remove the passenger's dashboard side panel.

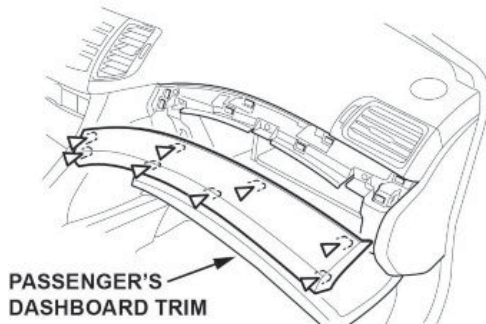
2. Open the glove box, and remove the passenger's dashboard trim.

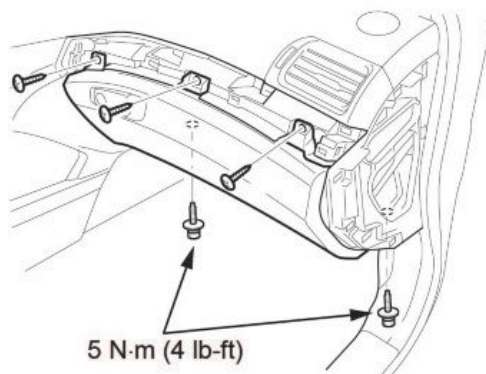
3. Close the glove box, and remove the bolts and screws.

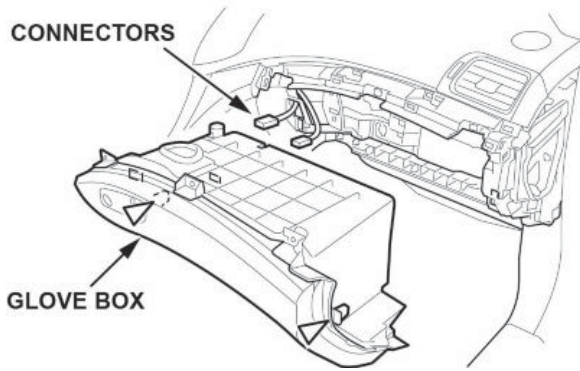
4. Pull the glove box out to detach the clips.

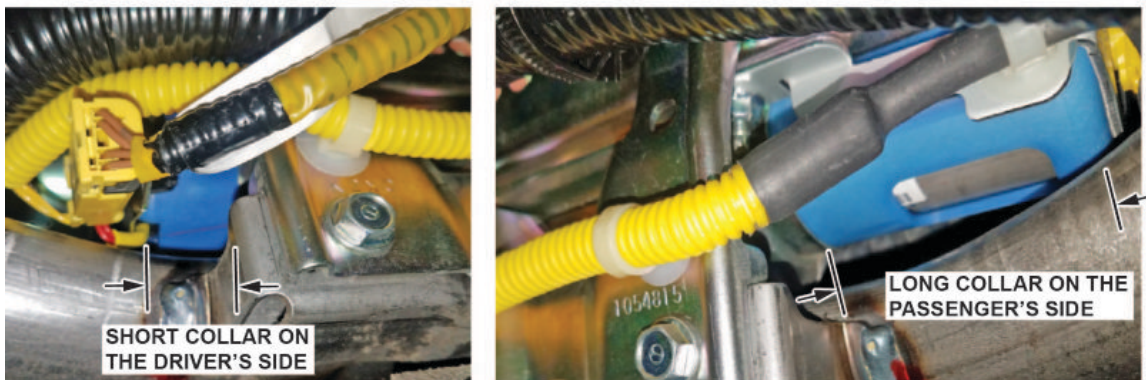
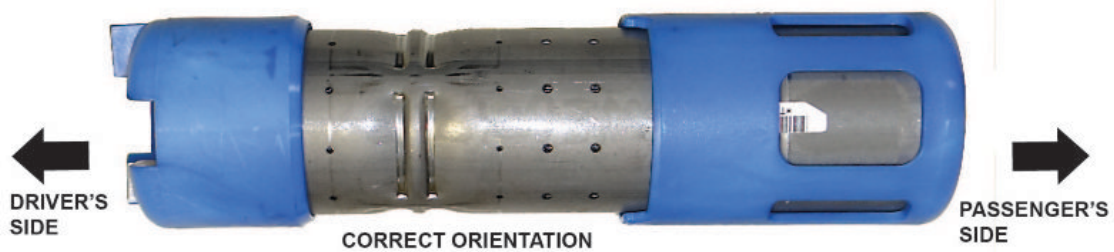
5. Disconnect the glove box light connector and the trunk lid opener main switch connector.
6. Inspect the plastic collars on the passenger's airbag inflator.
 - If the long collar is closer to the front passenger's door, the inflator installation is **GOOD**. Reassemble the glove box in the reverse order of removal.
 - If the long collar is closer to the driver's side, the inflator installation is **NO GOOD**. Go to AIRBAG MODULE INSTALLATION.

Inspect the front passenger airbag inflator and, **if the inflator is not installed correctly, replace the airbag module assembly.**

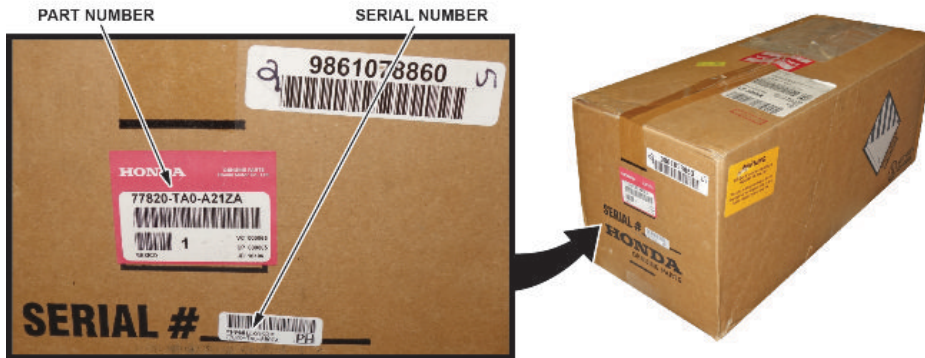
1. **For airbag module replacement only** - Write the serial number and part number from the side of the new front replacement passenger's airbag module box on the RO. For the warranty claim to be paid, **the new front passenger's airbag module part number and serial number** must be included in the warranty claim.

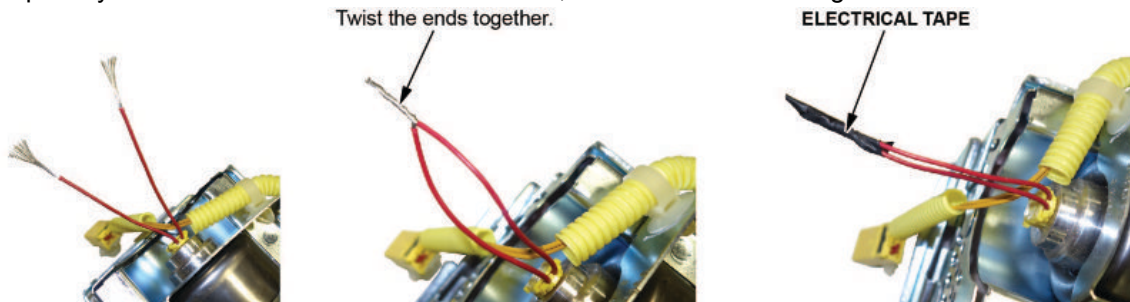
- 3.2. Strip away about 1 inch of the red wire insulation, then twist the wires together.

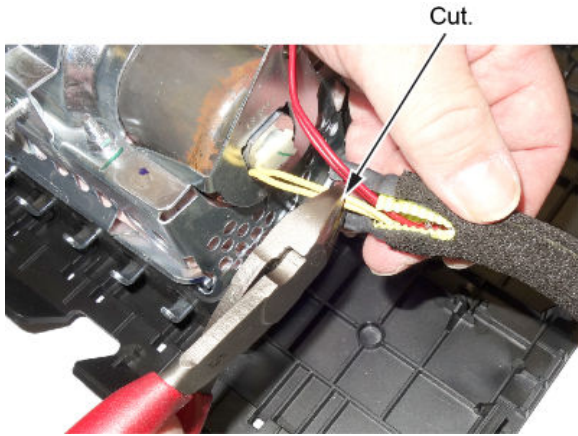
3.4. Cut the yellow wires about 2 inches from the inflator.

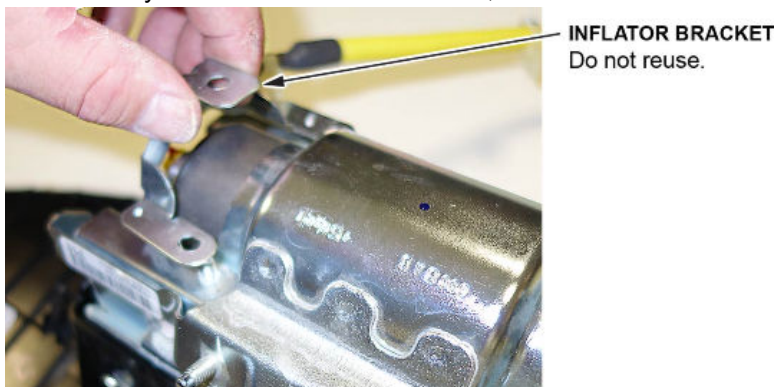
4. Remove the inflator bracket.

You can only remove one of the brackets, as the other is welded to the airbag housing.
