May 17, 2019

Safety Recall: Incorrect Installation of the Takata Front Passenger's Airbag Inflator

CORRECTIVE ACTION

Inspect the front passenger airbag inflator and, **if the inflator is not installed correctly, replace the airbag module assembly.**

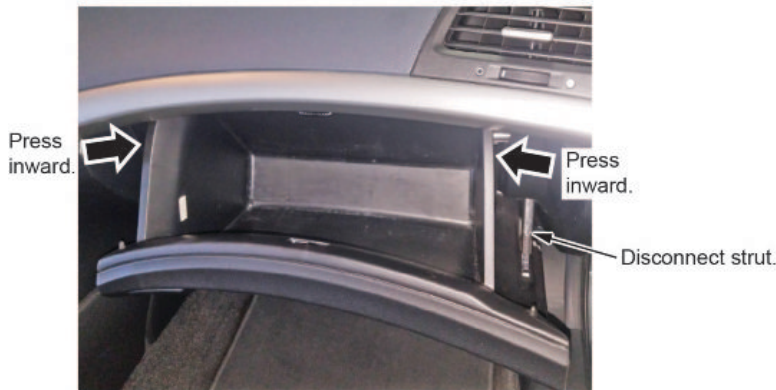
1. Open the glove box.
2. **Accord/Crosstour** - Disconnect the strut.

Accord shown - others similar.

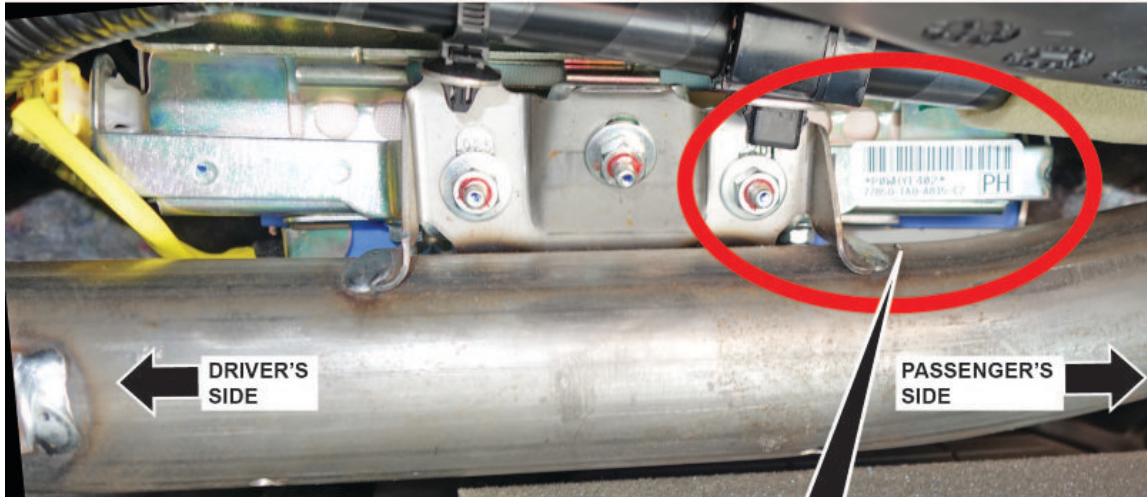
3. Push the glove box tabs in as shown, and lower the glove box.
4. Inspect the plastic collars on the passenger's airbag inflator. **Refer to the following pages for model specific images.**
 - If the long collar is closer to the front passenger's door, the inflator installation is **GOOD**. Reassemble the glove box in the reverse order of removal.
 - If the long collar is closer to the driver's side, the inflator installation is **NO GOOD**. Go to AIRBAG MODULE REPLACEMENT PROCEDURE.

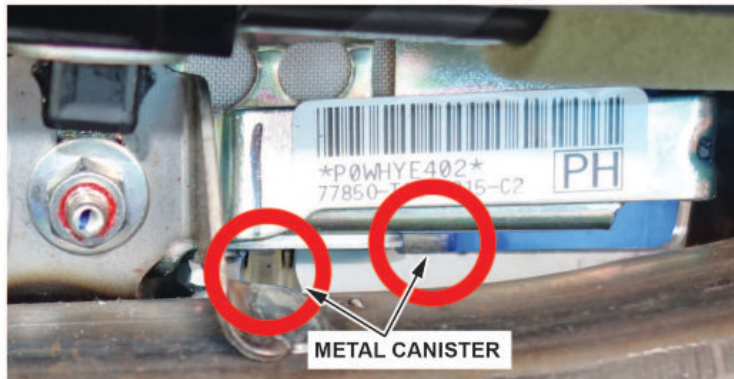
**NO GOOD**

If the inflator has been installed incorrectly, the metal canister will be visible.

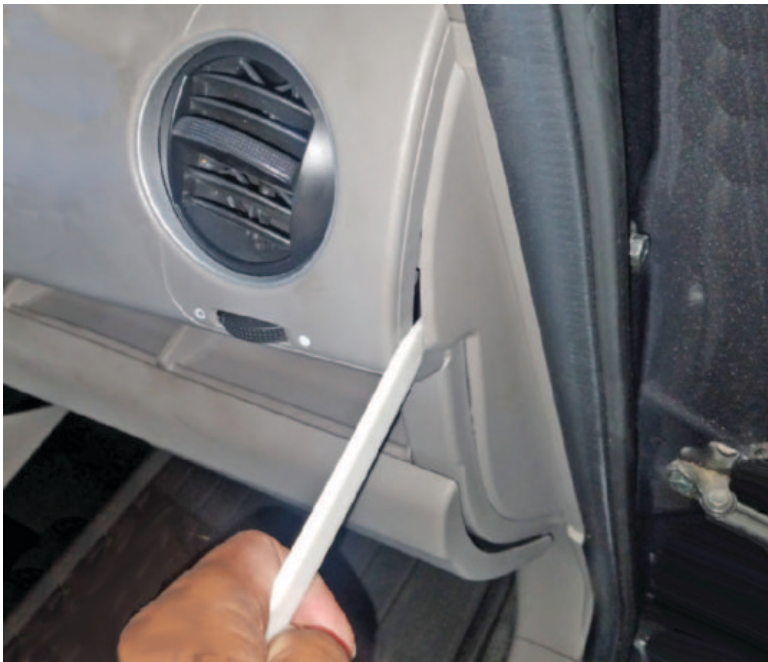
1. Remove the side trim panel using a plastic pry tool.

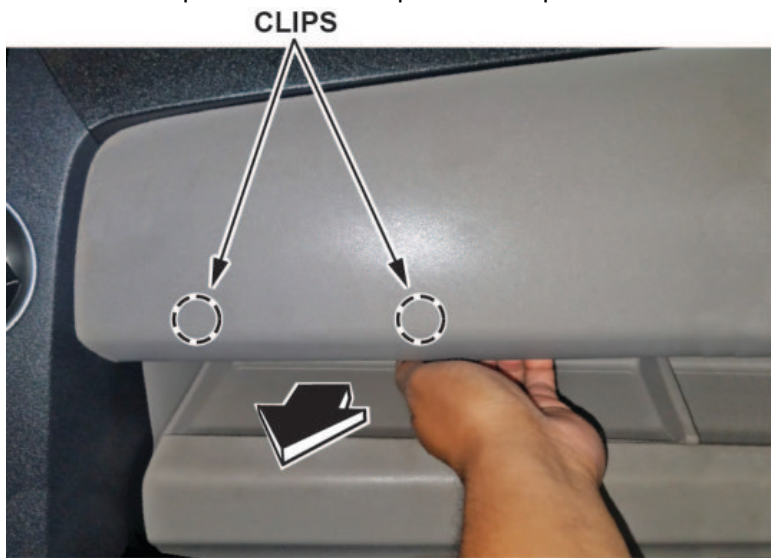
2. Pull on the left portion of the trim piece at the places shown to disengage the retaining clips.

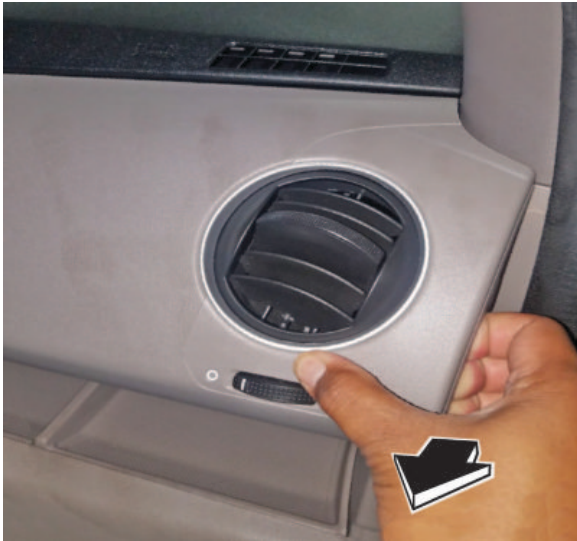
3. Pull on the right portion of the trim to disengage the remaining clips and remove the trim piece.

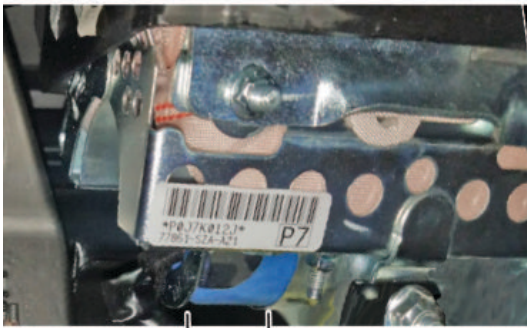
4. Inspect the plastic collars on the passenger's airbag inflator.

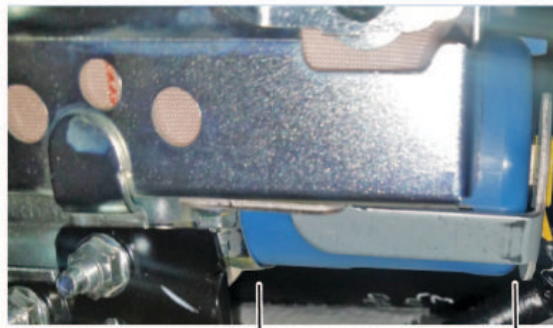
SHORT COLLAR ON THE DRIVER'S SIDE

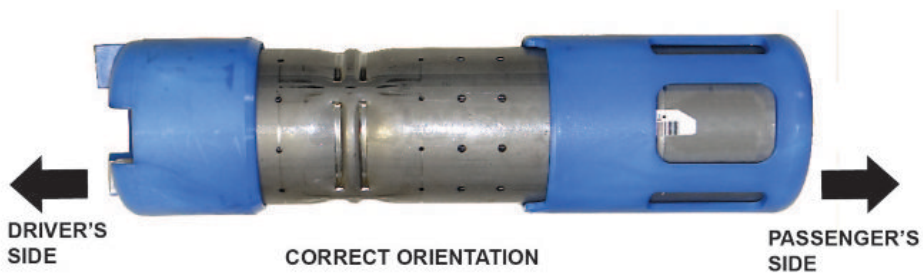
LONG COLLAR ON THE PASSENGER'S SIDE

- If the long collar is closer to the front passenger's door, the inflator installation is **GOOD**. Reassemble the dashboard panel trim in the reverse order of removal.
- If the long collar is closer to the driver's side, the inflator installation is **NO GOOD**. Go to AIRBAG MODULE REPLACEMENT PROCEDURE.

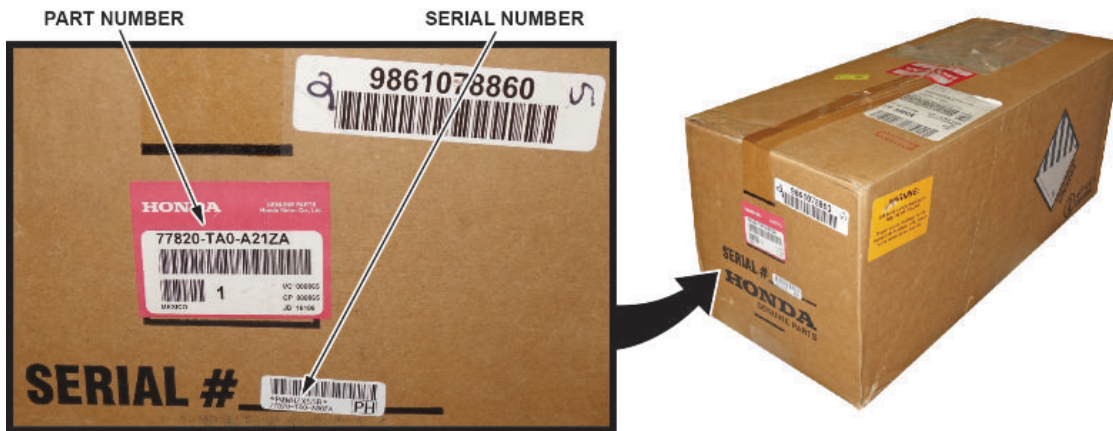
4. Write the serial number and part number from the side of the new front replacement passenger's airbag module box on the RO. For the warranty claim to be paid, the **new front replacement passenger's airbag module part number and serial number** must be included in the warranty claim.

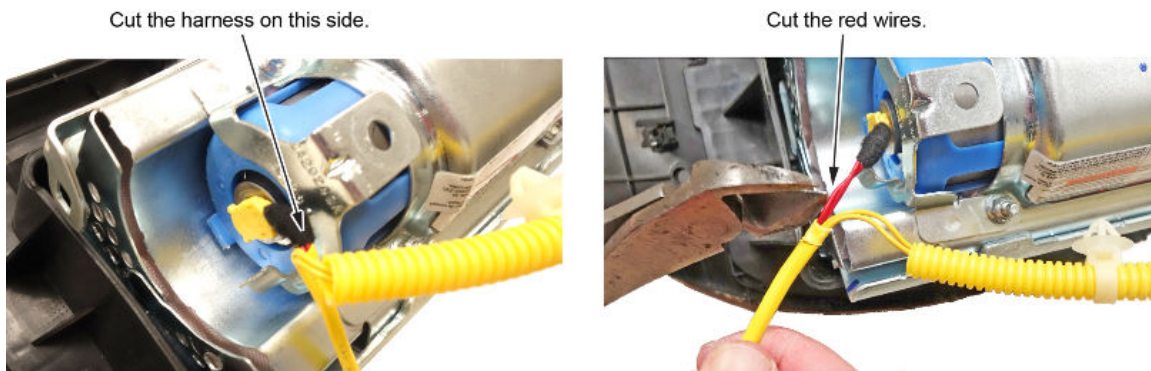
- 3.1. Cut the red wires about 2 inches from the inflator.

There may be some protective tube covering the wires that needs to be cut away to access the wires.

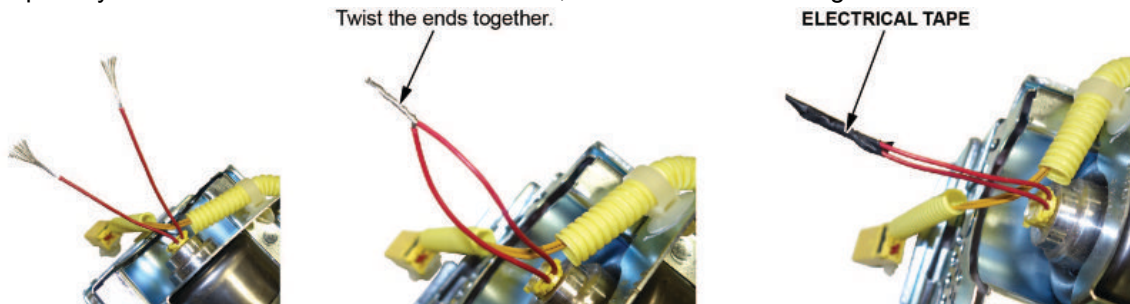
- 3.2. Strip away about 1 inch of the red wire insulation, then twist the wires together.

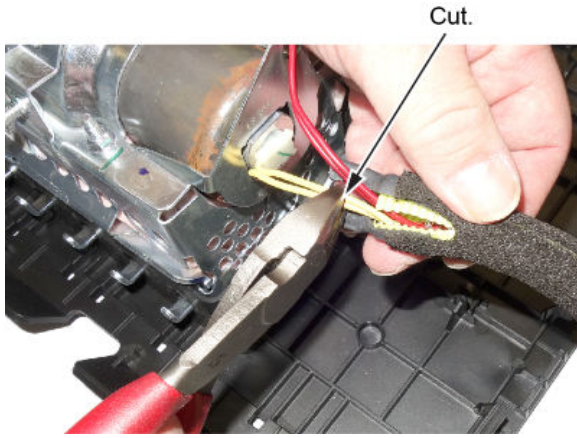
3.4. Cut the yellow wires about 2 inches from the inflator.

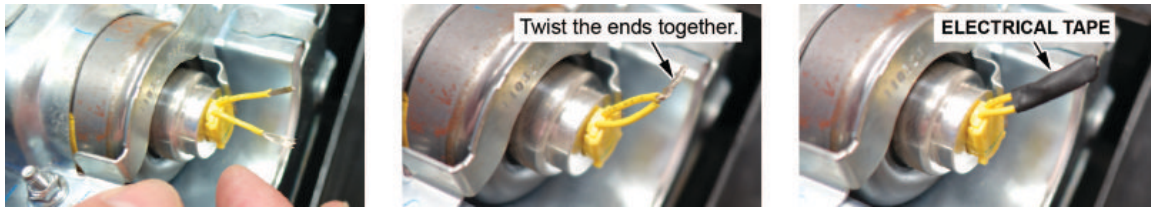
3.5. Strip away about 1 inch of the yellow wire insulation, then twist the wires together.

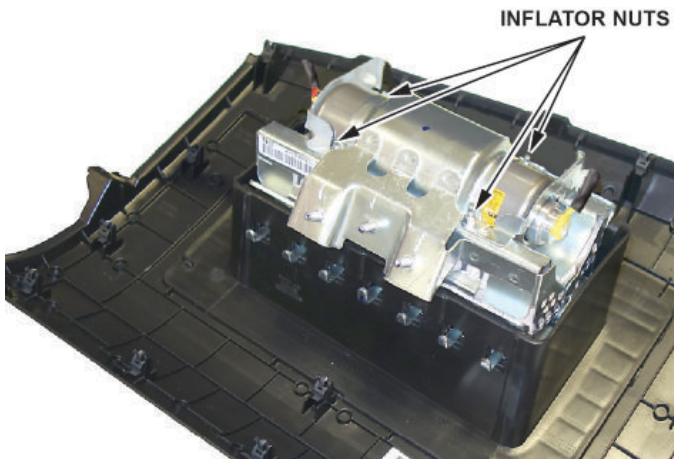
3.7. Remove the four inflator nuts.

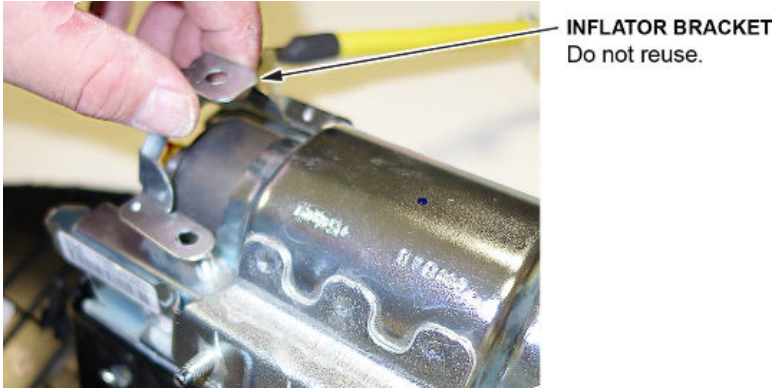
4. Remove the inflator bracket.

You can only remove one of the brackets, as the other is welded to the airbag housing.

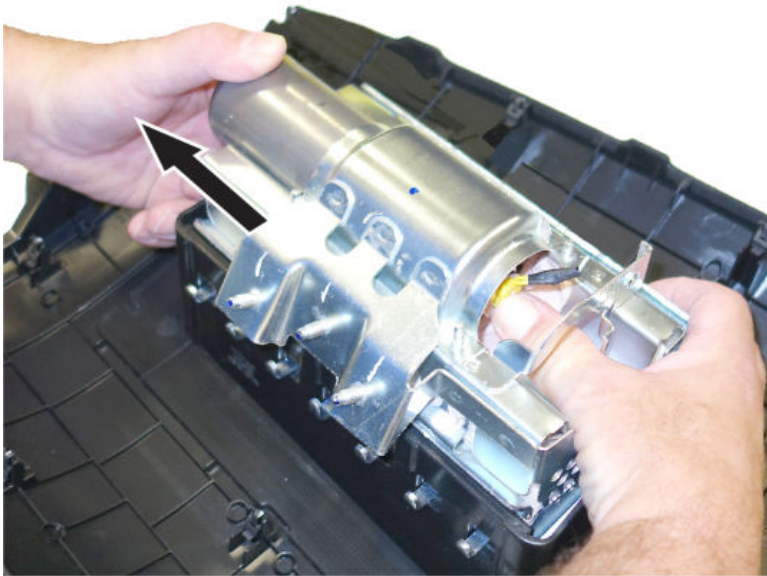
5. Remove the inflator by pulling it out.
