May 29, 2019

Safety Recall: 2019 CR-V Cable Reel and Sub-Wire Harness

The steering wheel sub-wire harness may be damaged by a burr on the steering wheel frame. A damaged sub-wire harness may cause a short in the wiring, resulting in damage to the cable reel, and malfunctions in the SRS, horn, and steering wheel controls.

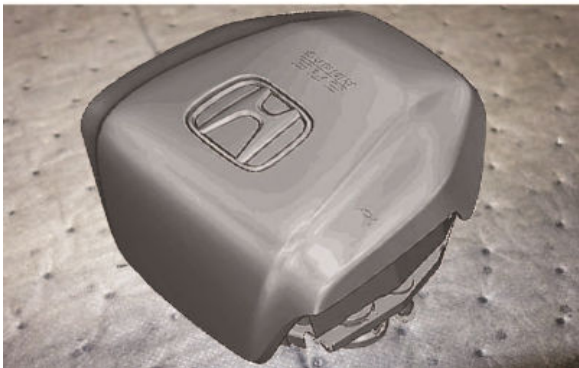
9. Disconnect the horn connector, and remove the airbag module. Set it facing up on a shop towel to avoid damaging the surface.

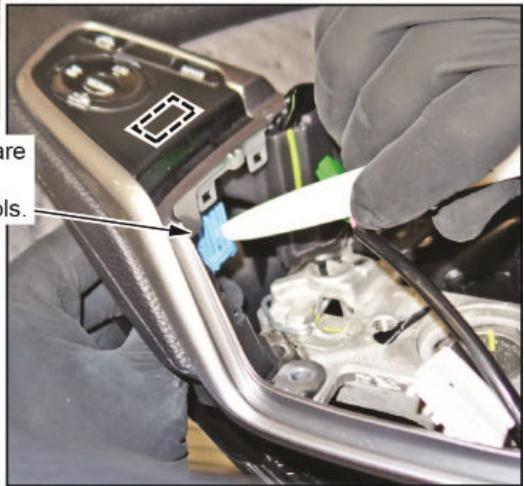
18. Disconnect the sub-wire harness from the audio remote switch assembly and the cruise control switch assembly. Remove the four screws, and remove the back cover from the steering wheel.

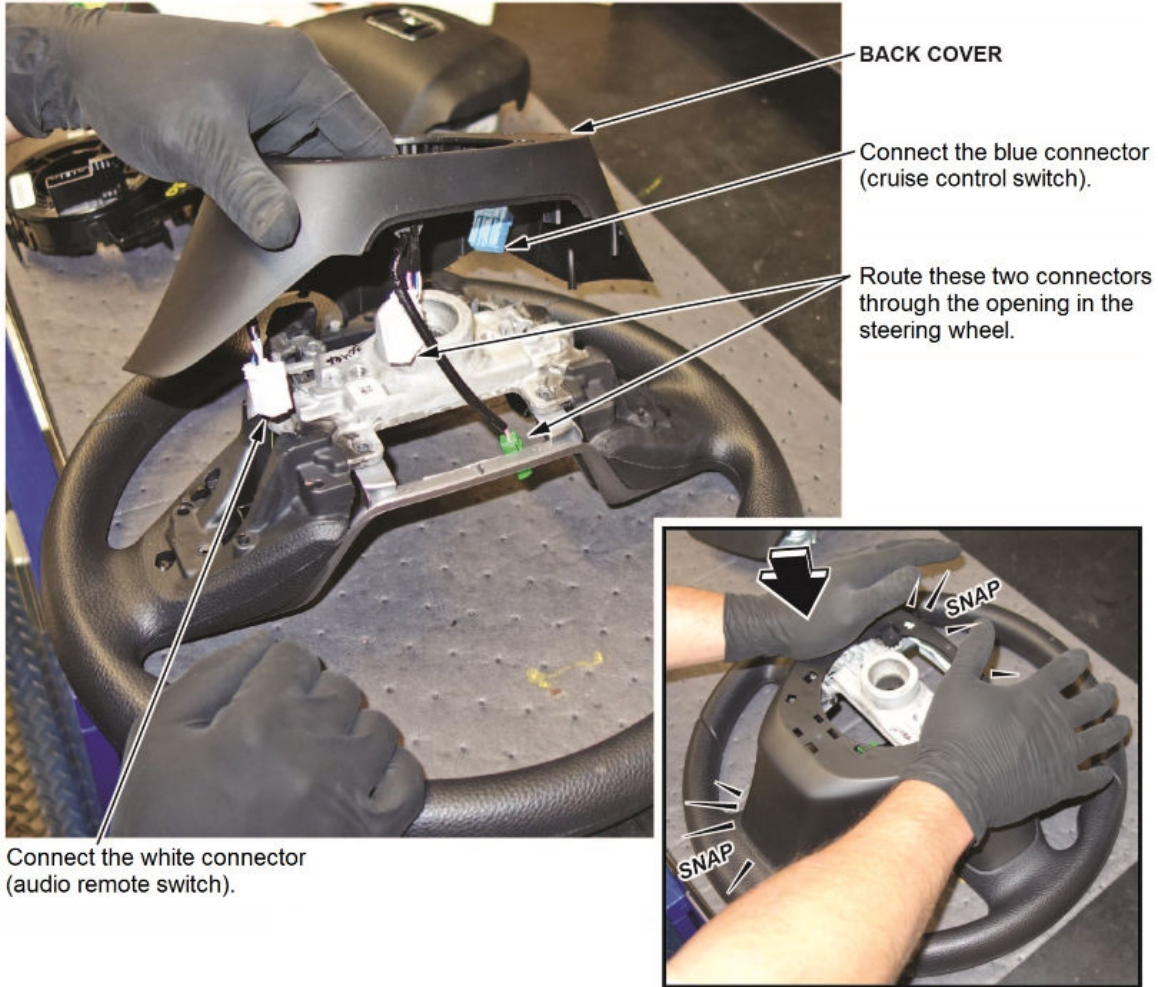
22. Install the back cover to the steering wheel. Make sure the blue and white connectors are routed through their openings in the steering wheel.

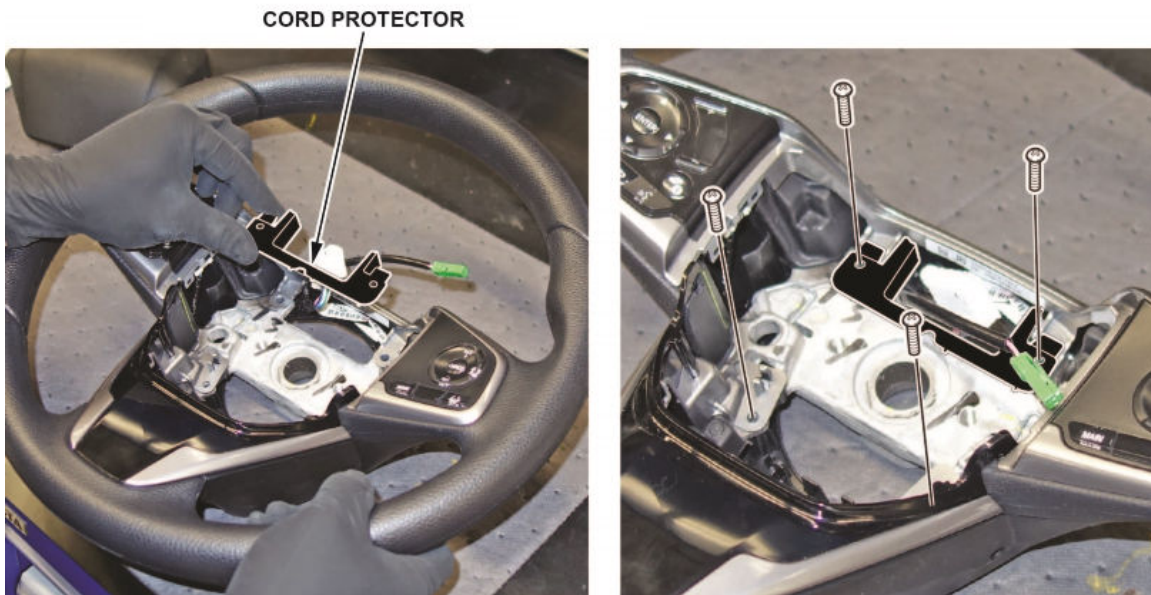
24. Install the cord protector and the four screws that secure the steering wheel back cover.

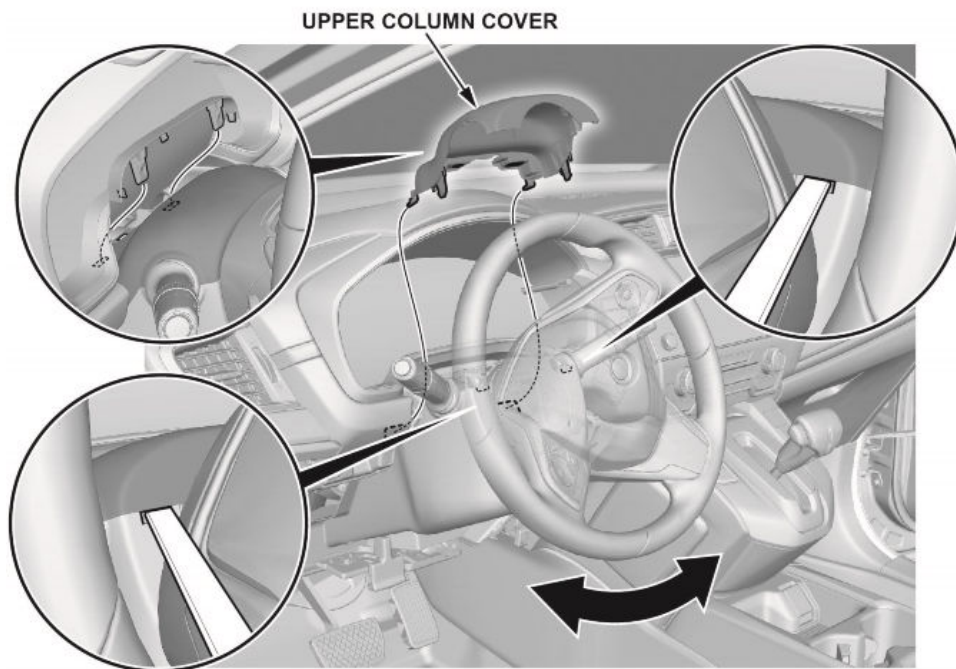
25. Remove the upper column cover. Use a plastic trim tool (commercially available) to unclip it.

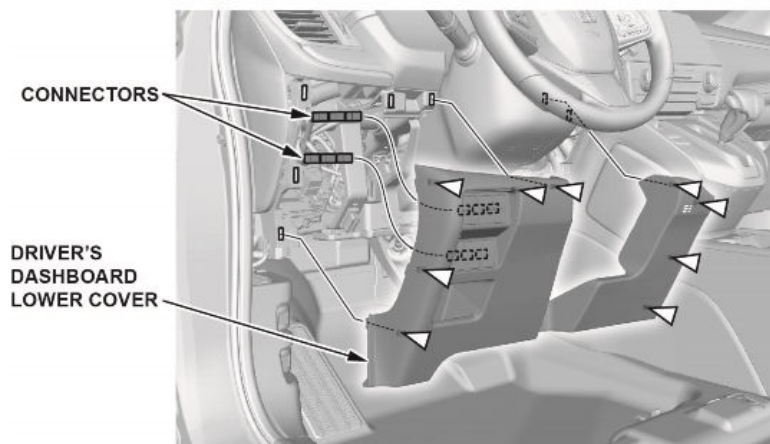
27. Remove the driver's dashboard lower cover. Disconnect the connectors.

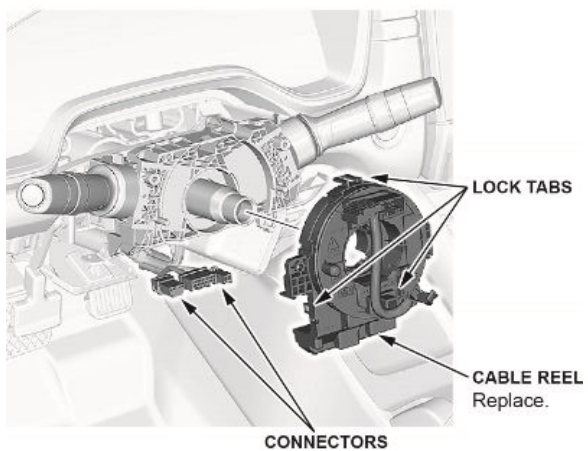
29. Disconnect the connectors from the back of the cable reel.

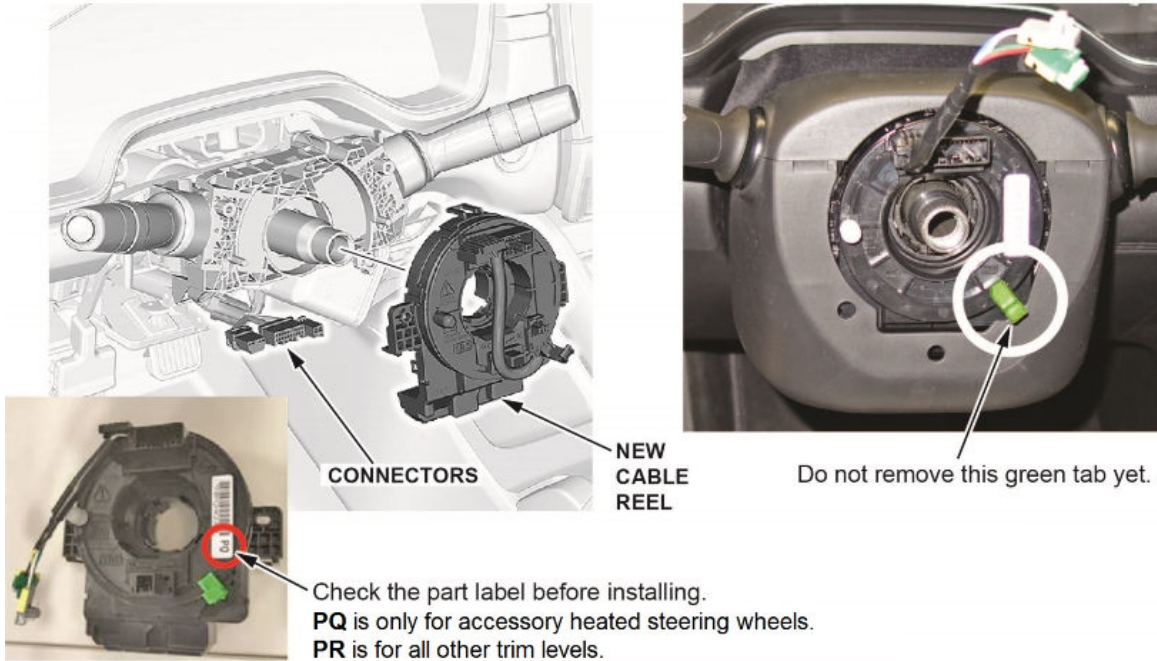
31. Check the part label on the new cable reel to make sure you are installing the correct part. Cable reels labeled **PQ** are only for accessory heated steering wheels. Cable reels labeled **PR** are for all other trim levels.

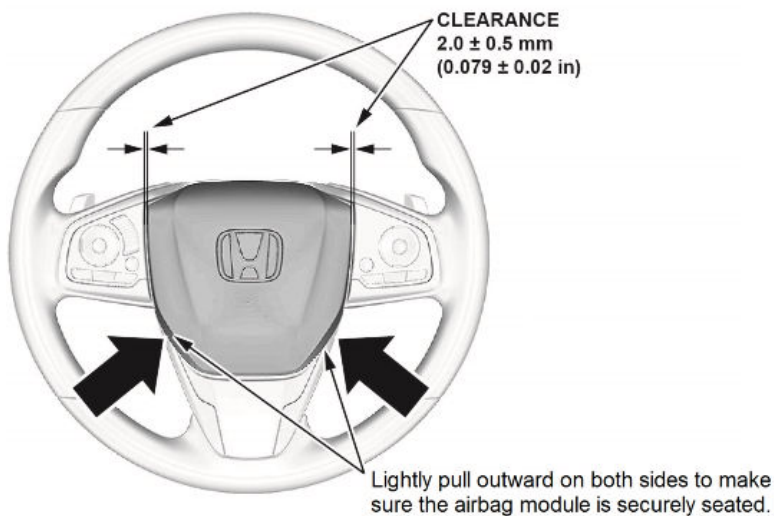
44. Make sure the driver's airbag module is centered in the steering wheel.
