N336NAS2

TECHNICAL BULLETIN

501-14

SAFETY RECALL: Door Will Not Latch

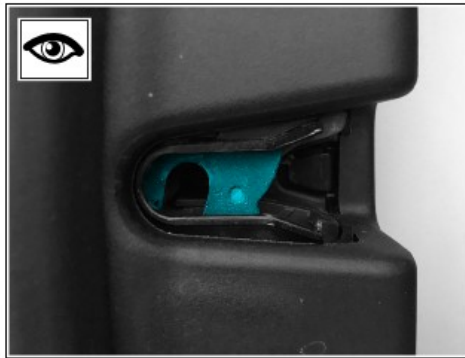
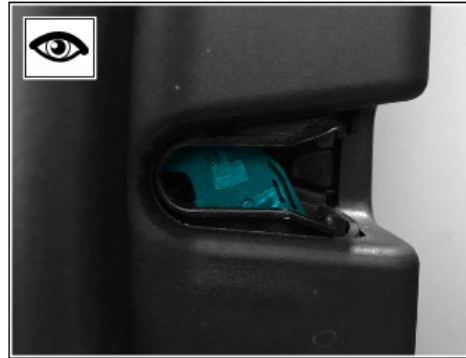
E258158

Use a quick and smooth motion to grasp and pull the exterior door handle, hold the handle in the open/extended position, and observe the position of the door latch lever.

- If the door latch is still in the latched position, as shown by the **GREEN '✓'** in the illustration, **go to step 5.**

- If the door latch is in the unlatched position, as shown by the **RED 'X'** in the illustration, **return to step 2.**

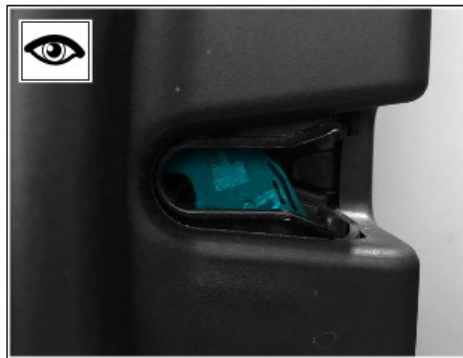
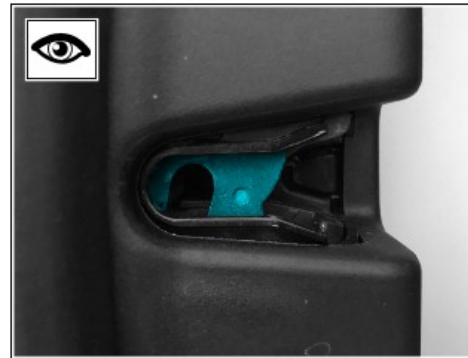
E258160

Observe the position of the door latch lever.

- If the door latch lever is in the unlatched position, as shown by the **GREEN '✓'** in the illustration, the front left door latch has passed the functionality test; **go to Service Instruction 'B'.**
- If the door latch lever is still in the latched position, as shown by the **RED 'X'** in the illustration, **go to step 8.**

-
8. ■ Renew the front left door latch (see TOPIx Workshop Manual section 501-14: Handles, Locks, Latches and Entry Systems - Removal and Installation - Front Door Latch).
 - When all tasks are complete, **go to Service Instruction 'B'**.

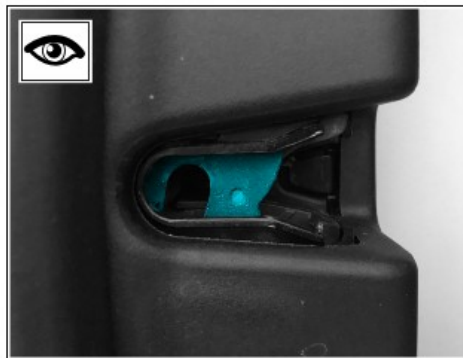
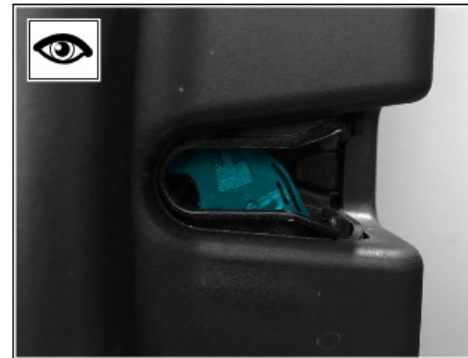
E258158

Use a quick and smooth motion to grasp and pull the exterior door handle, hold the handle in the open/extended position, and observe the position of the door latch lever.

- If the door latch is still in the latched position, as shown by the **GREEN '✓'** in the illustration, **go to step 5.**

- If the door latch is in the unlatched position, as shown by the **RED 'X'** in the illustration, **return to step 2.**

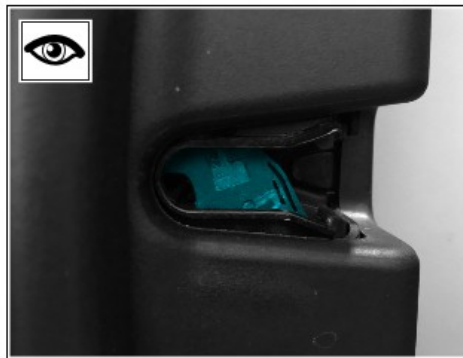
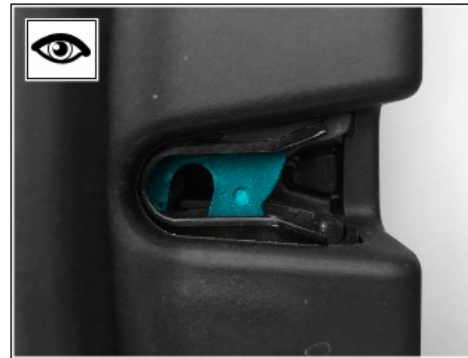
E258160

Observe the position of the door latch lever.

- If the door latch lever is in the unlatched position, as shown by the **GREEN '✓'** in the illustration, the rear left door latch has passed the functionality test; **return the vehicle to the customer.**
- If the door latch lever is still in the latched position, as shown by the **RED 'X'** in the illustration, **go to step 8.**

-
8. ■ Renew the rear left door latch:
- **Range Rover Sport** - (see TOPIx Workshop Manual section 501-14: Handles, Locks, Latches and Entry Systems - Removal and Installation - Rear Door Latch).
 - **Range Rover - Standard wheelbase** - (see TOPIx Workshop Manual section 501-14: Handles, Locks, Latches and Entry Systems - Removal and Installation - Rear Door Latch - Standard Wheelbase).
 - **Range Rover - Long wheelbase** - (see TOPIx Workshop Manual section 501-14: Handles, Locks, Latches and Entry Systems - Removal and Installation - Rear Door Latch - Long Wheelbase).
 - When all tasks are complete, **return the vehicle to the customer.**
