June 28, 2019

Version 1

Safety Recall: Front Passenger's Airbag Inflator Can Be Over-Pressurized (Phase 5)

AFFECTED VEHICLES

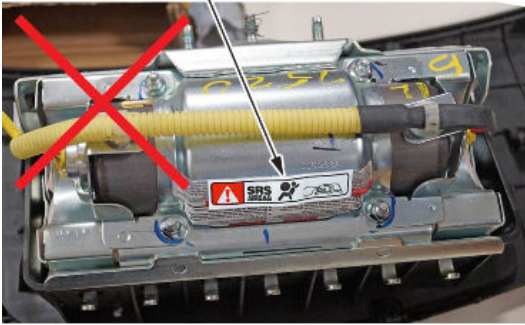
NON-STANDARD SAFETY LABEL

- If there is nothing unusual about the airbag or the inflator, continue with the inflator replacement procedure.
- If there are any unusual markings, like an incorrect label or a model year written in marker, the airbag and inflator may not be the correct airbag and/or inflator for the vehicle or it may be a counterfeit part. For more information about counterfeit airbags, you can refer to safercar.gov, enter keywords **MANAGING COUNTERFEIT**, and select **Recommended Dealer Guidance for Managing Counterfeit Air Bags** from the list. **If you suspect that the airbag or inflator is counterfeit, do not continue this procedure.** Contact your DPSM for assistance.

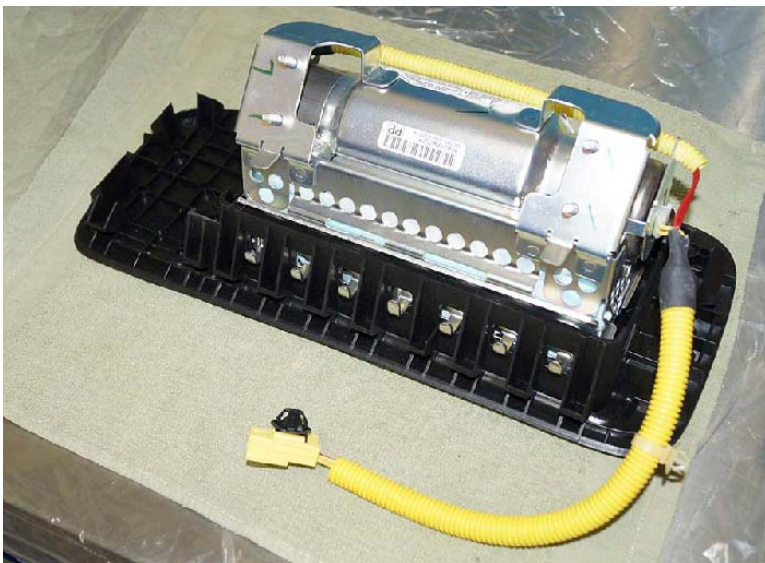
4. Place the airbag, face-down, on a clean shop towel.

- The orientation of the airbag is critical because if the inflator is installed incorrectly, the harness will be too short when you reinstall the airbag.
- The brackets between the various models are similar but may differ from the example shown.

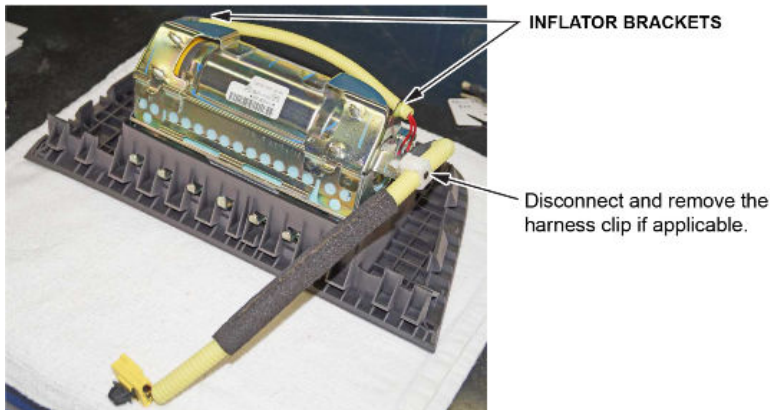
7. Remove the harness from both ends of the inflator bracket.

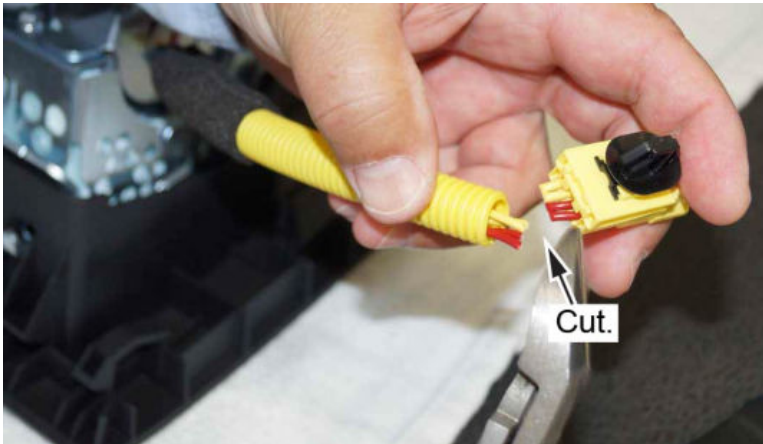
- 9.1. Cut all four wires to remove the connector.

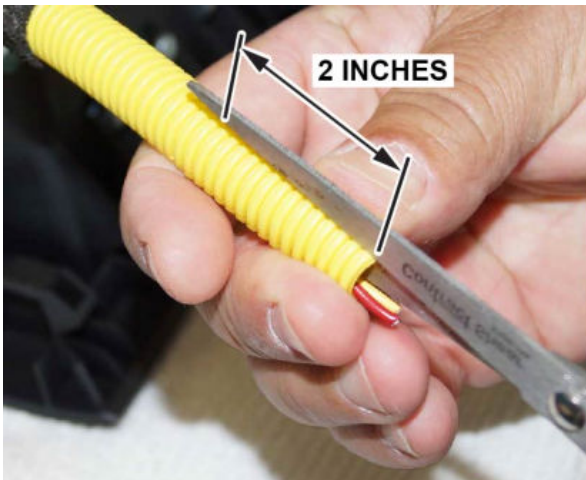
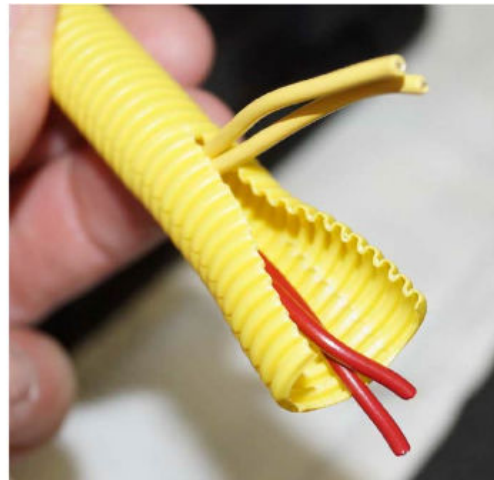
- 9.2. Cut about 2 inches of the corrugated tube, then pull out the yellow wires.

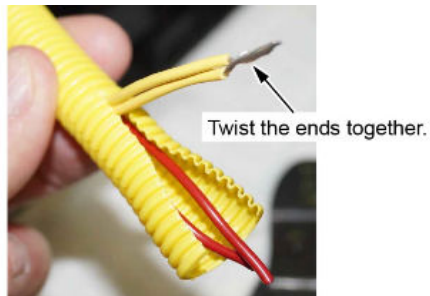
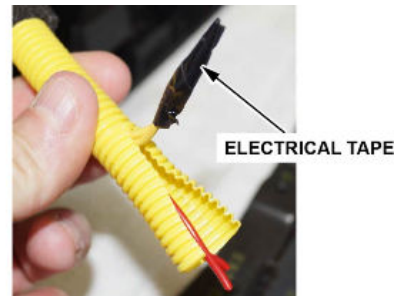
- 9.3. Strip away about an inch of the wire insulation, then twist the wires together.

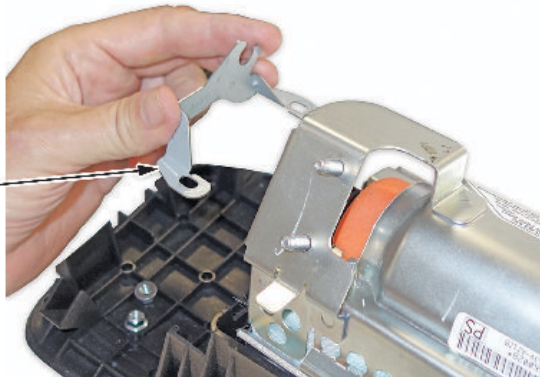
INFLATOR BRACKET

11. Remove the inflator bracket.

You can only remove one of the brackets, as the other is welded to the airbag housing.

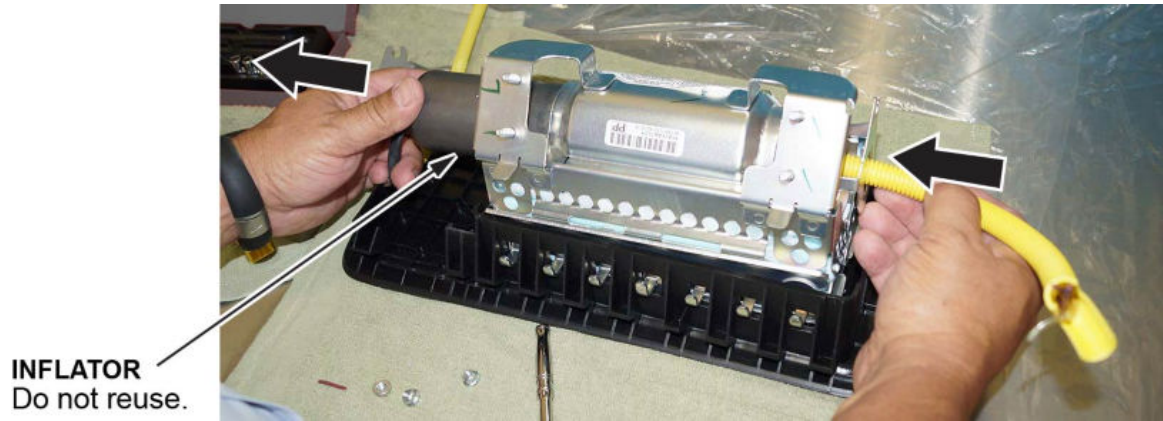
12. Remove the inflator by pushing it out.

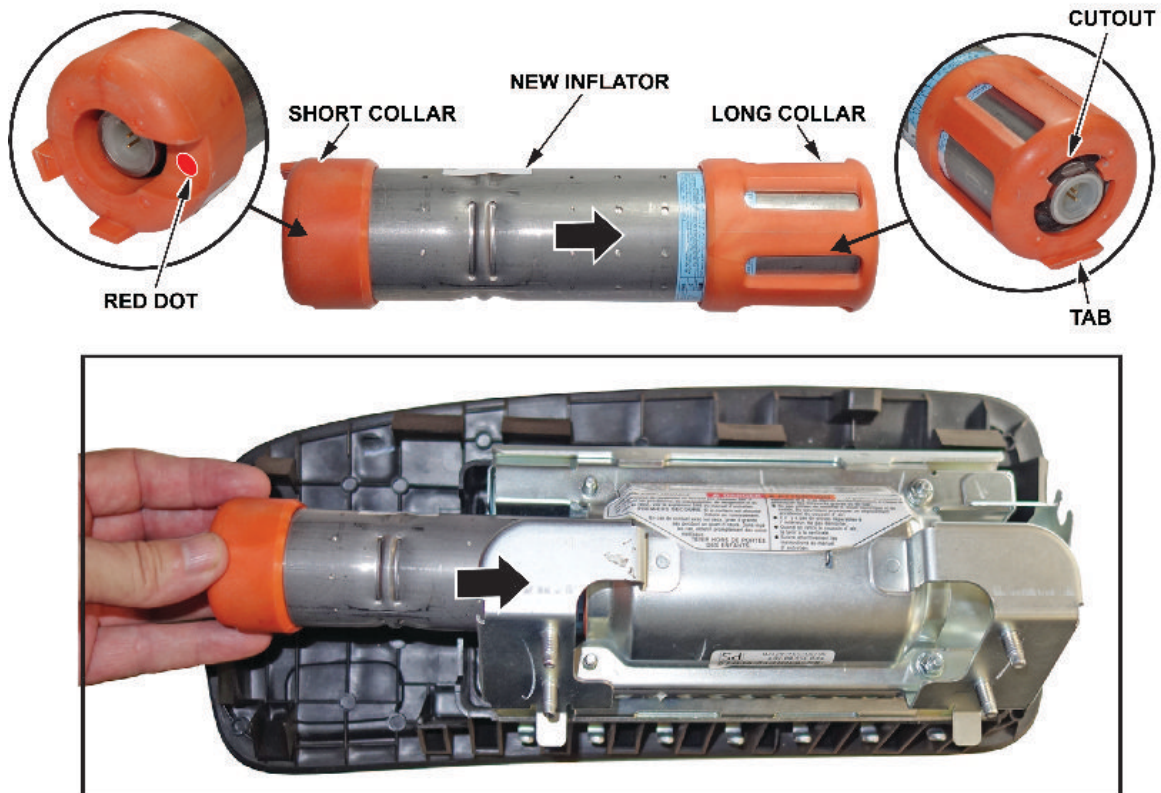
- 13.2. Collars on this inflator are orange. One side of the inflator has a longer collar, a tab, a plastic cutout, and a small flat spot on the connector. The other side of the inflator has a shorter collar, two tabs, and a notch with a red dot. Make sure you insert the end with the longer collar into the airbag first.

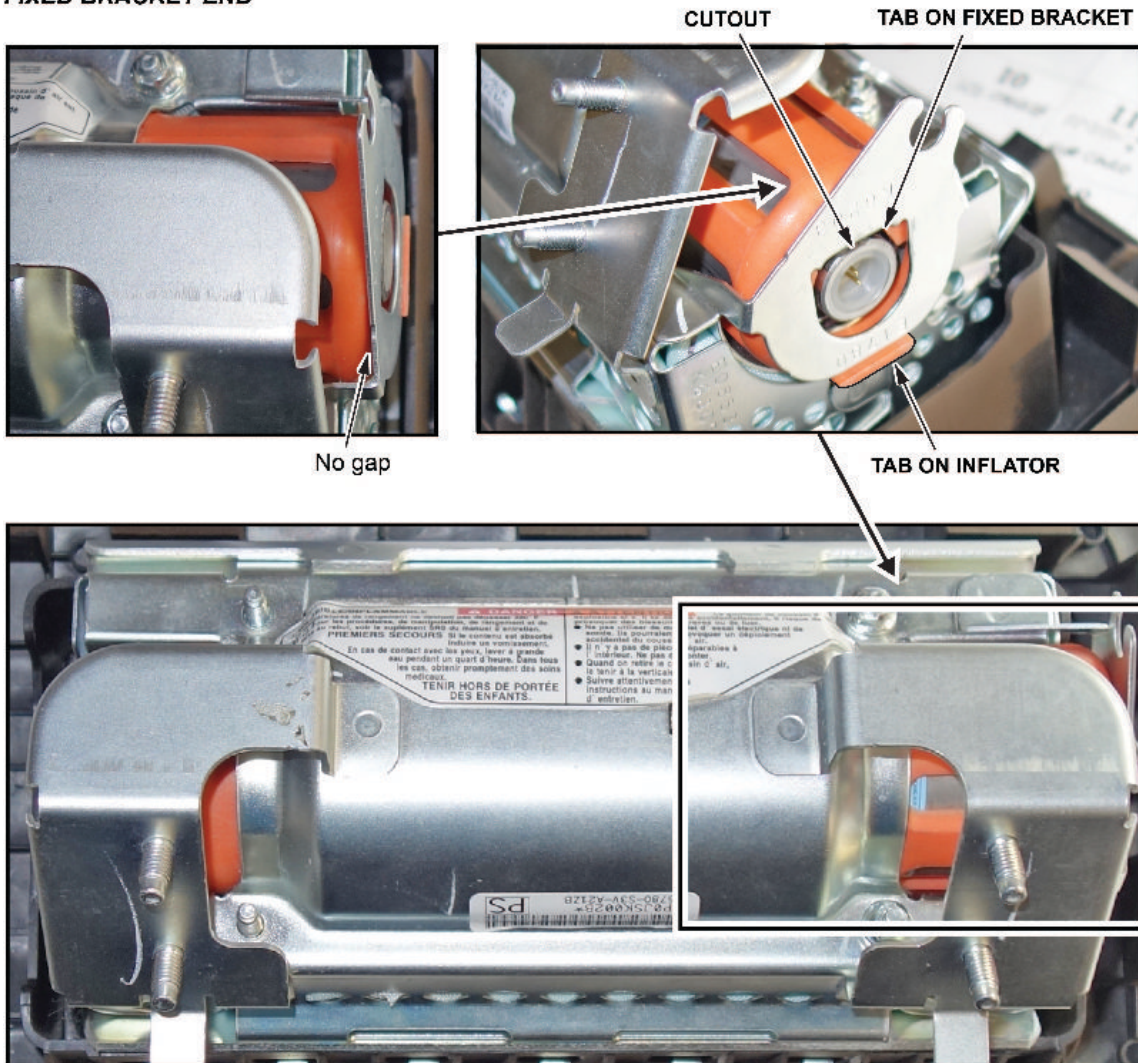
FIXED BRACKET END

- 13.3. Slide the inflator in until the plastic cutout and the small flat spot align with the tab on the bracket. There should be no space or gap between the inflator and bracket.

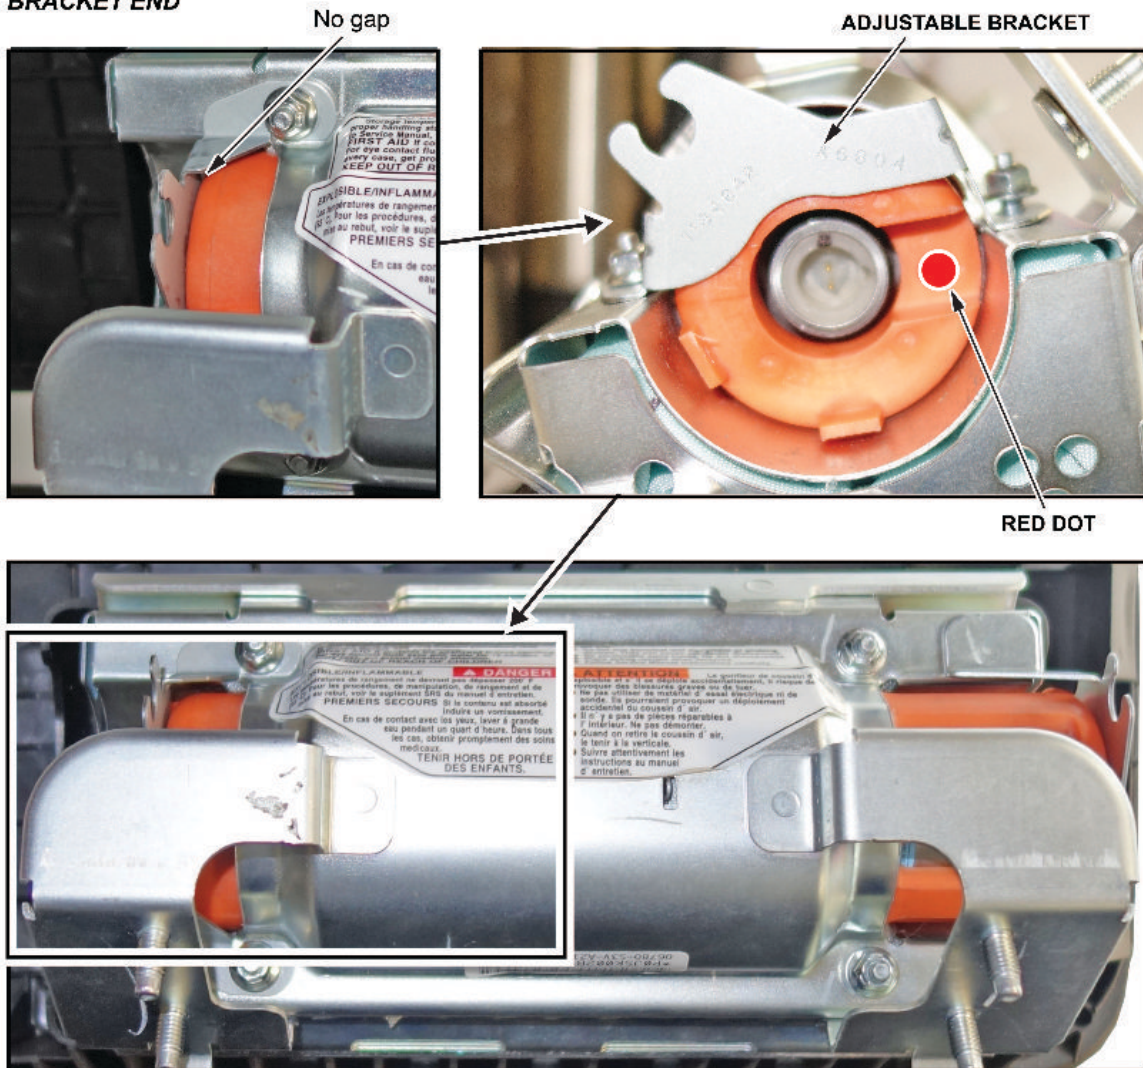
**ADJUSTABLE
BRACKET END**

- 13.4. Install the bracket included in the kit onto the airbag module. There should be a red dot visible on the end of the plastic collar. There should be no space or gap between the inflator and bracket.

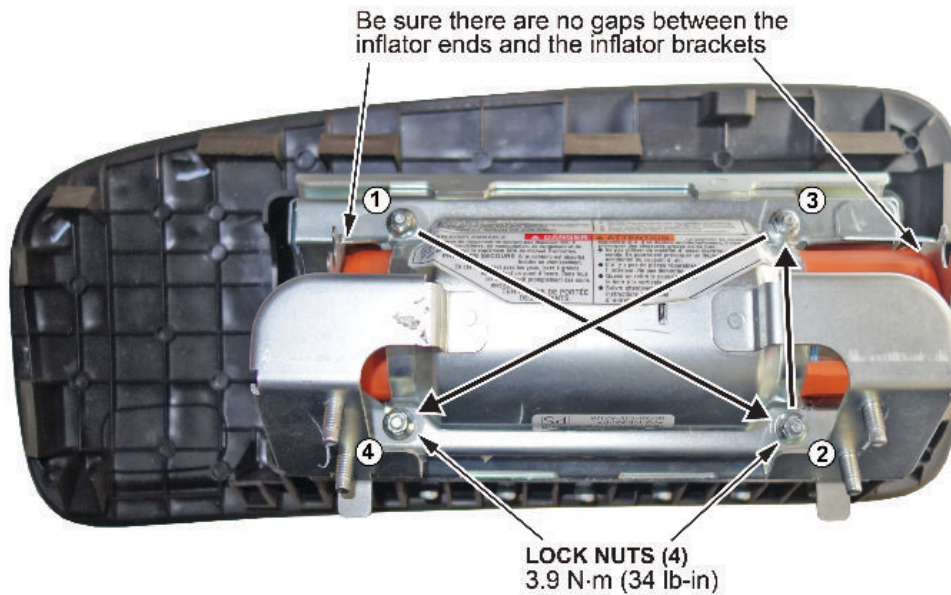
14. Install the new 5 mm locknuts and torque them in sequence to **3.9 N•m (34 lb-in)** .

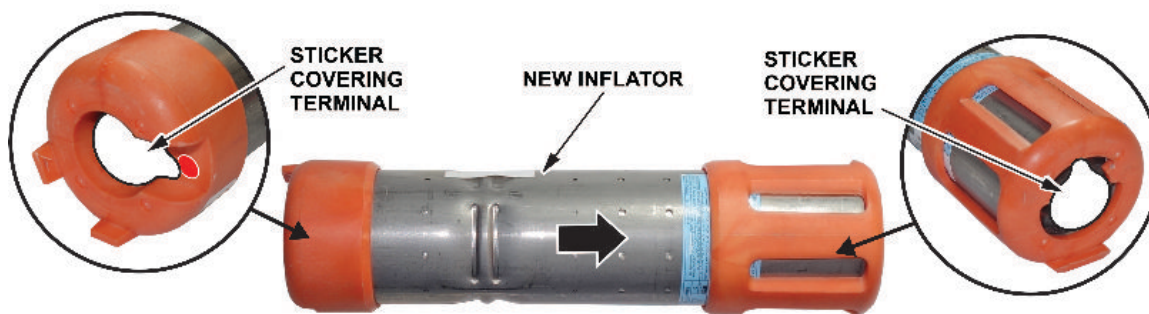
15. Remove the stickers covering the terminals on both sides of the new inflator.

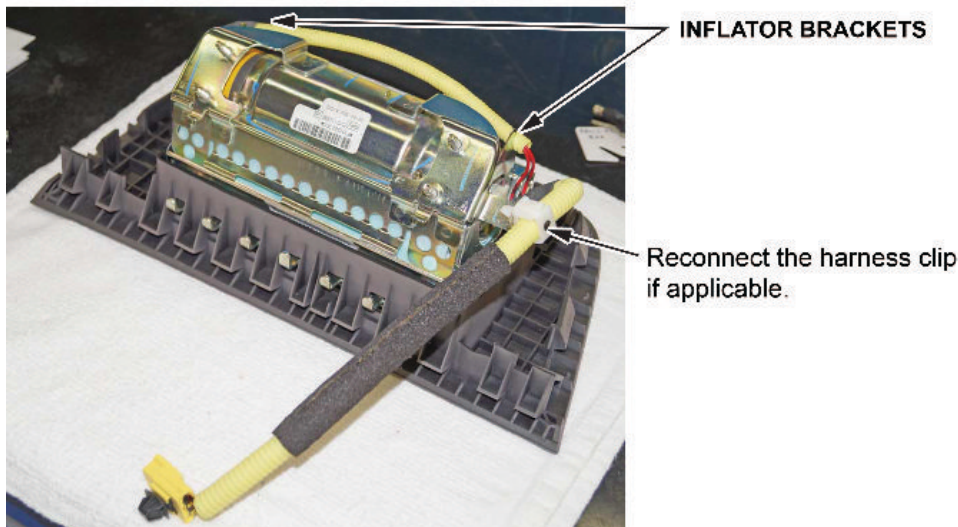
16.1. Make sure the airbag and harness are aligned as shown.

- **Make sure you have the orientation correct as shown below.** If you connect the harness incorrectly, the harness cannot be removed, and you will not be able to reinstall the airbag because the harness will be too short.
- Connect the red wire connector to the short collar side of the inflator with the red dot.

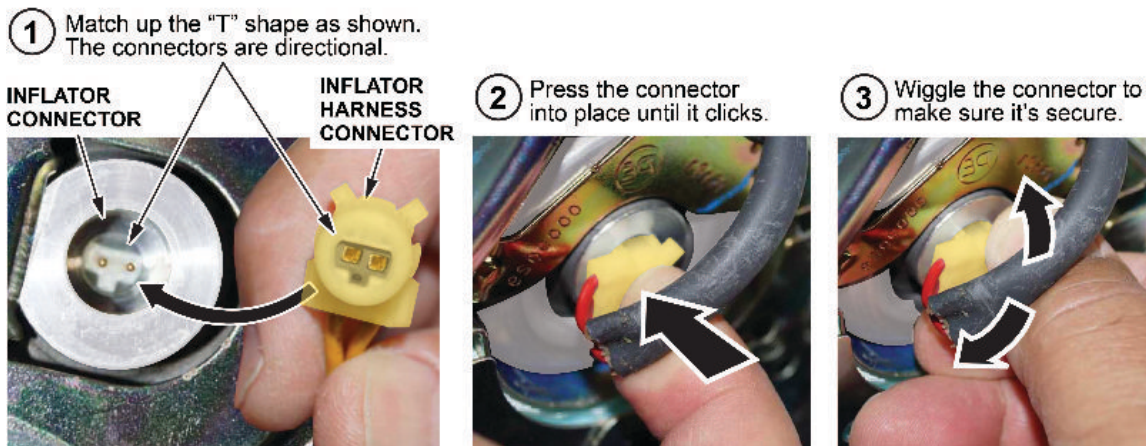
16.2. Connect the two connectors. Align the "T" shape in the inflator harness connector with the T-shaped inflator connector, then press the connector into place.

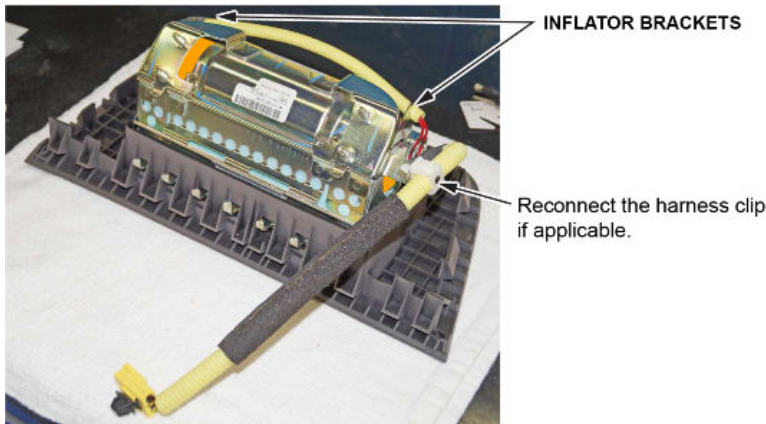
17.1. Insert the side without the shrink wrap tubing into the bracket first.

17.2. Insert the side of the harness with the shrink wrap tubing into the inflator bracket. Make sure the harness is securely inserted and that it does not sag.

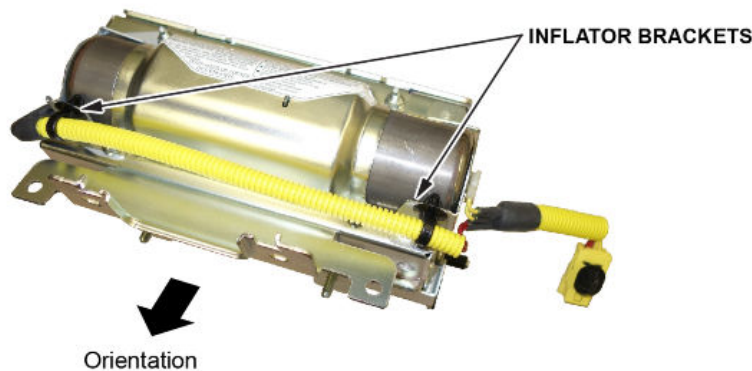
4. Place the airbag, face-down, on a clean shop towel.

The orientation of the airbag is critical because if the inflator is installed incorrectly, the harness will be too short when you reinstall the airbag.

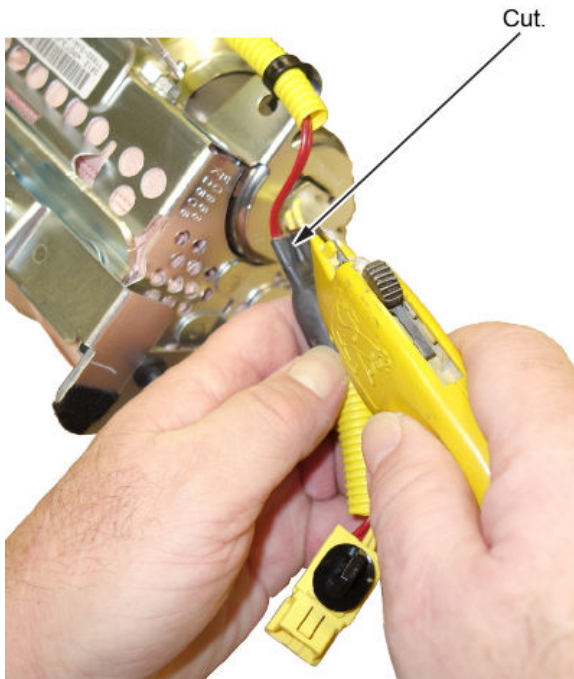
- 8.1. Cut the black rubber tubing to separate the red and yellow wires.

Make sure you don't cut the wires at this stage.

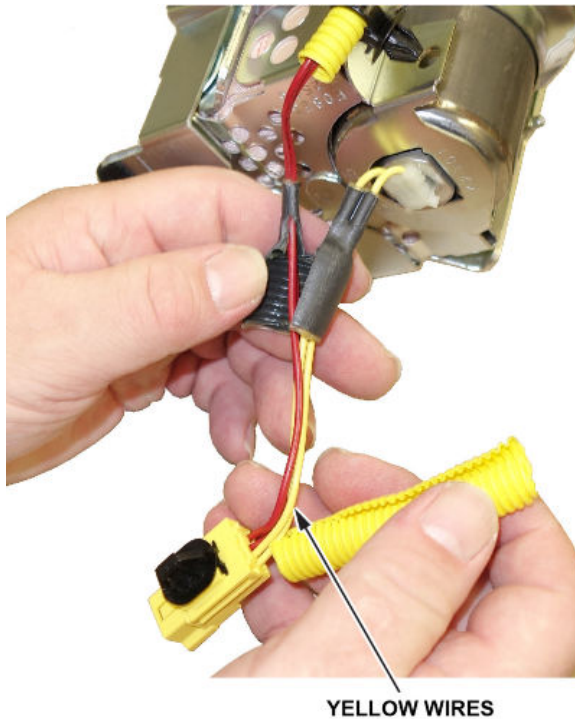
8.2. Cut and remove the yellow corrugated tubing.

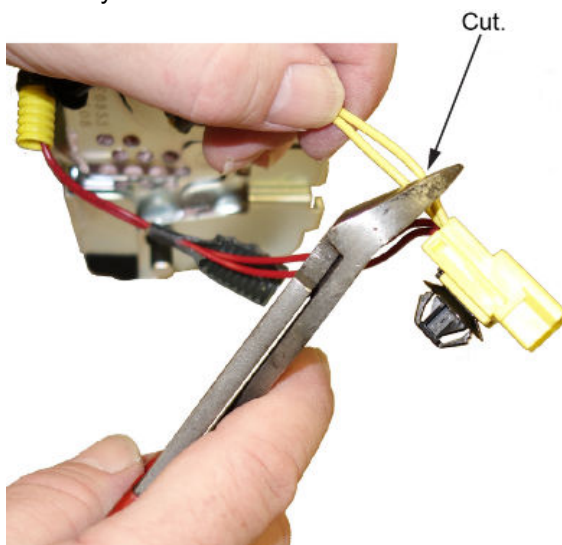
8.3. Cut the yellow wires as shown.

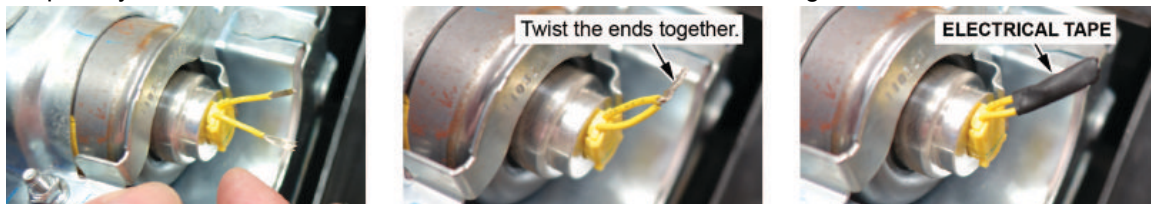
8.4. Strip away about 1 inch of the wire insulation, then twist the wires together.

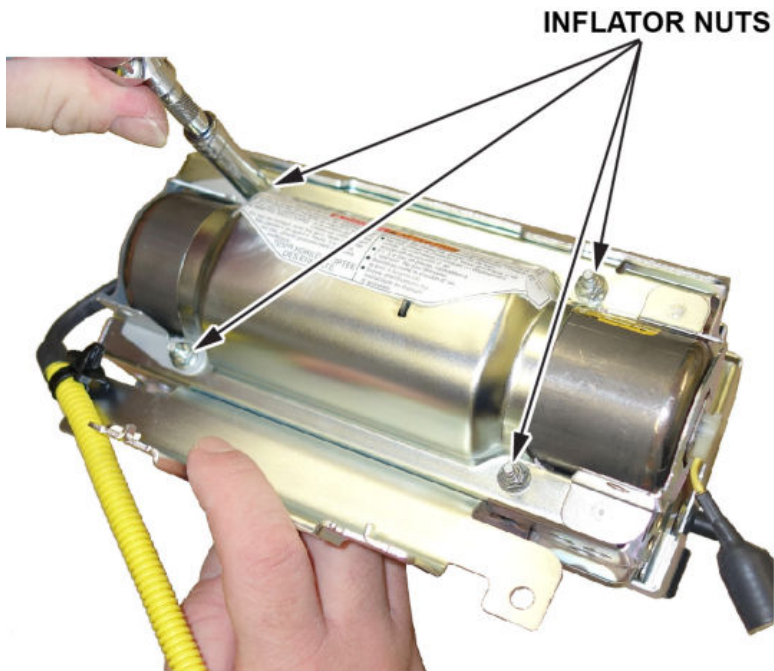
9. Remove the four inflator nuts.

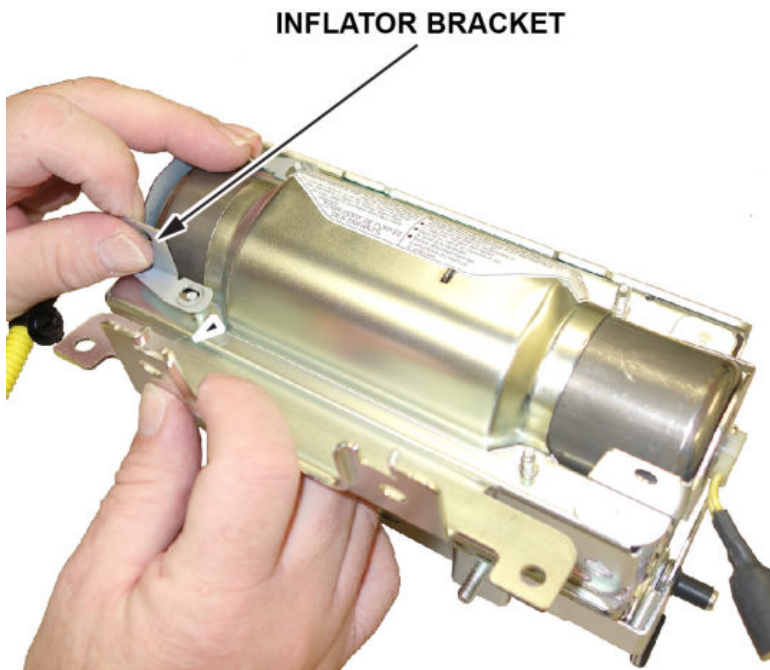
10. Remove the inflator bracket.

You can only remove one of the brackets, as the other is welded to the airbag housing.

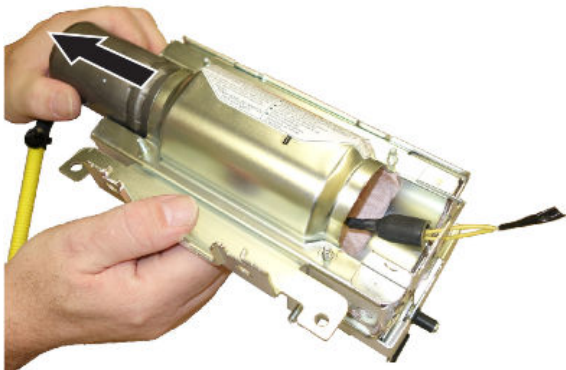
11. Remove the inflator by pushing/pulling it out.

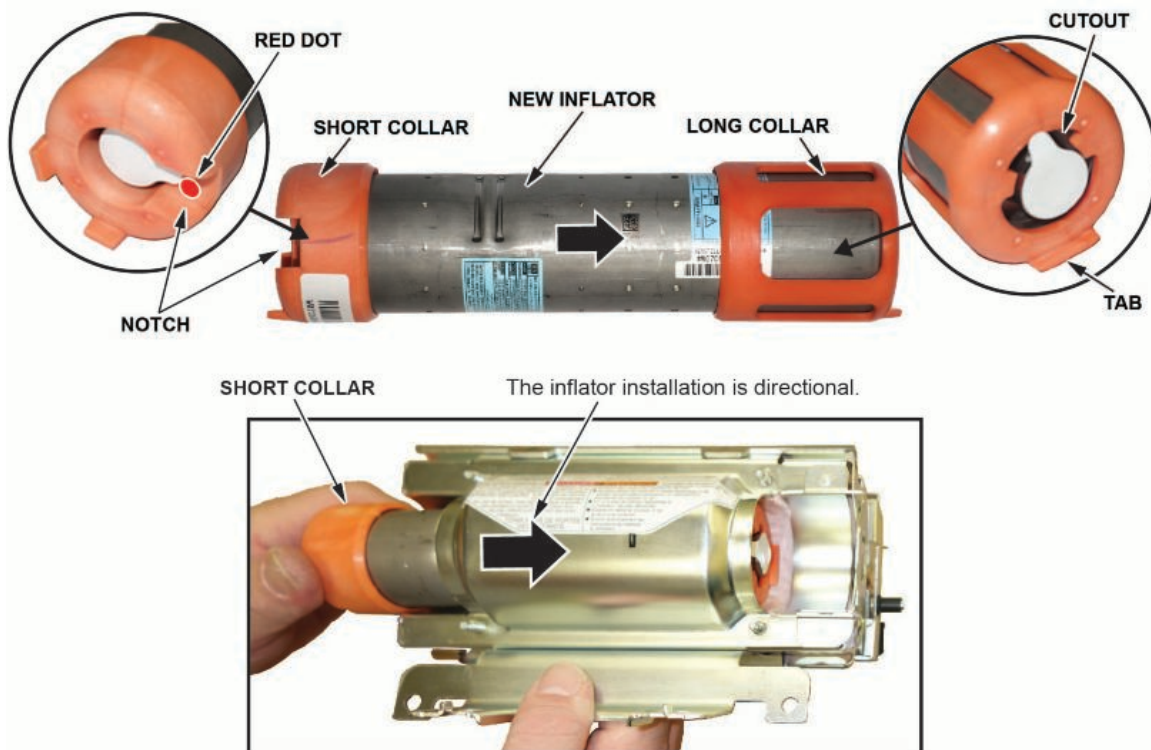
- 12.2. Collars on this inflator are orange. One side of the inflator has a longer collar, a tab, a plastic cutout, and a small flat spot on the connector. The other side of the inflator has a shorter collar, two tabs, and a notch with a red dot. **Make sure you insert the end with the longer collar into the airbag first.**

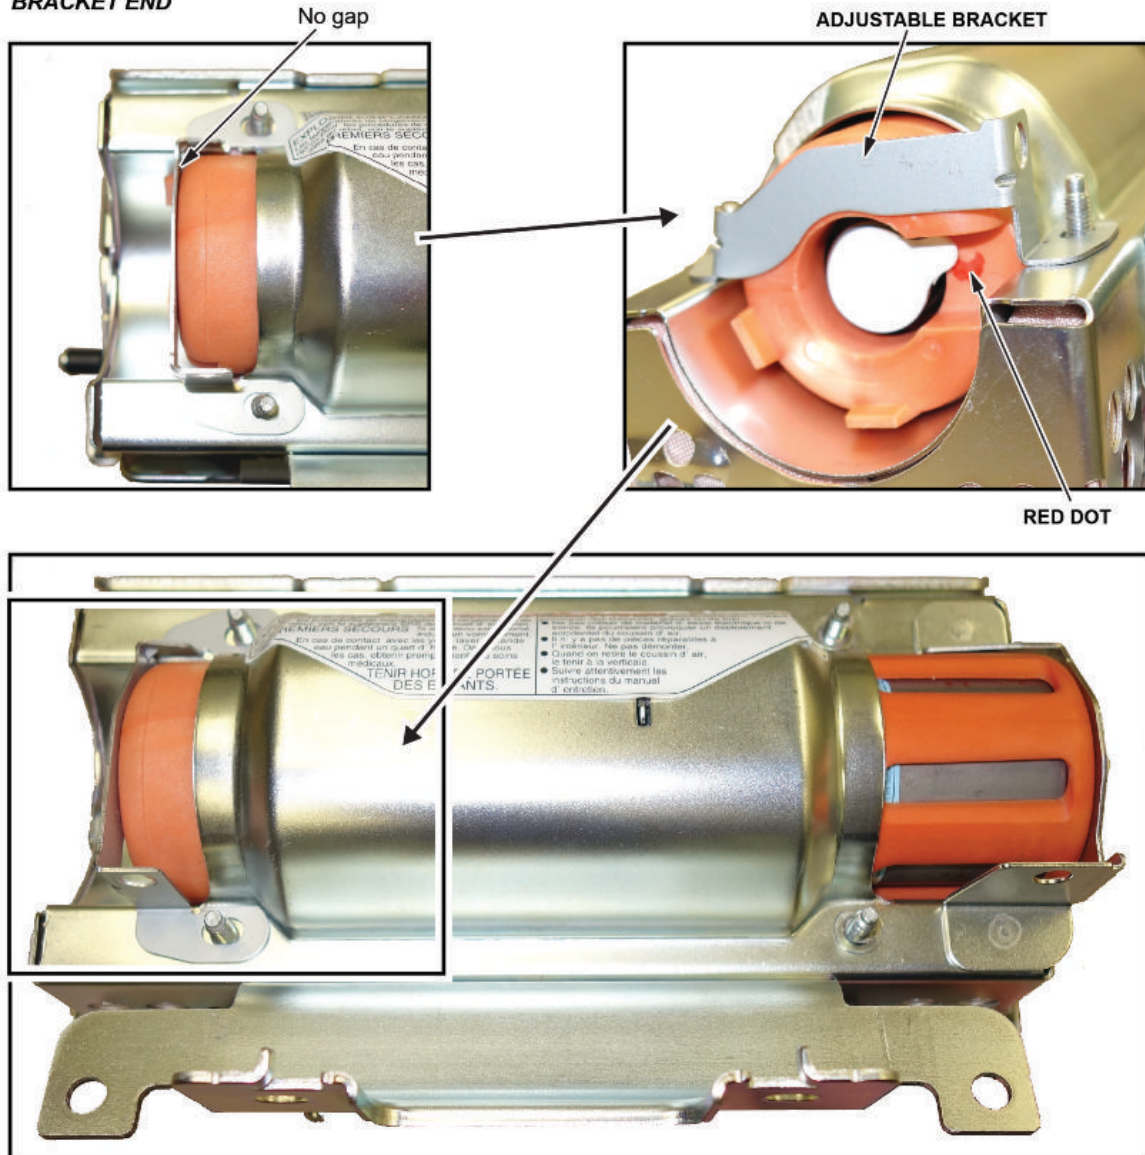
**ADJUSTABLE
BRACKET END**

- 12.4. Install the bracket included in the kit onto the airbag module. There should be a red dot visible on the end of the plastic collar. There should be no space or gap between the inflator and bracket.

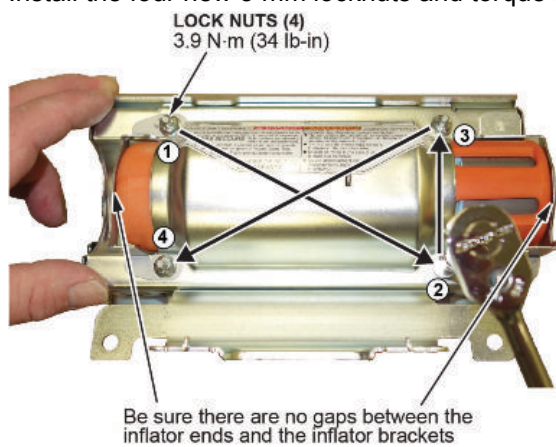
13. Install the four new 5 mm locknuts and torque them in sequence to **3.9 N•m (34 lb-in)** .

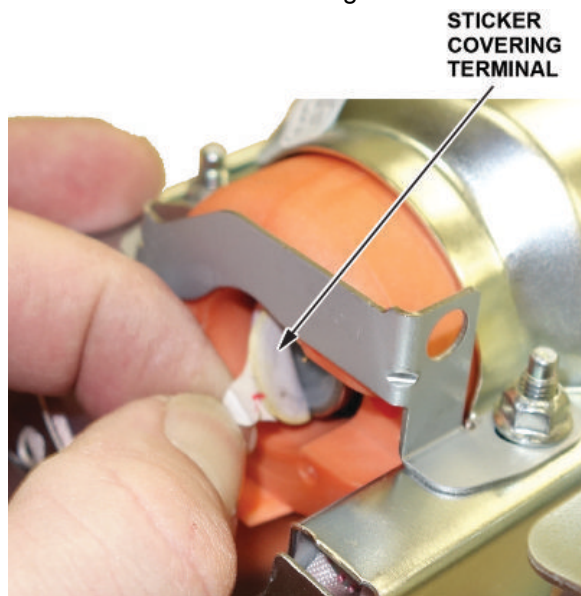
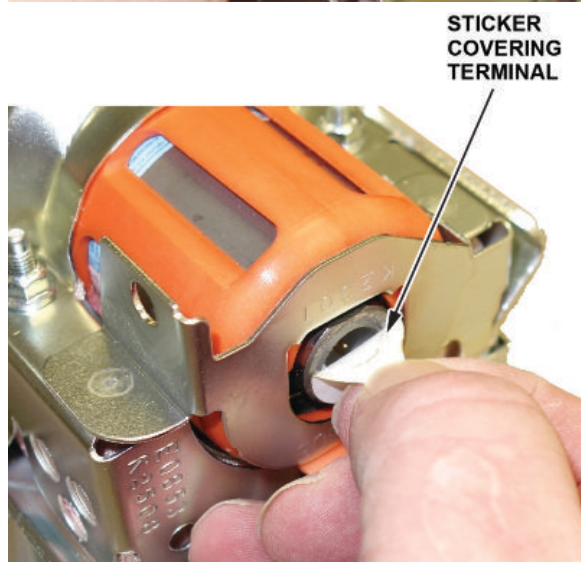
14. Remove the stickers covering the terminals on both sides of the new inflator.

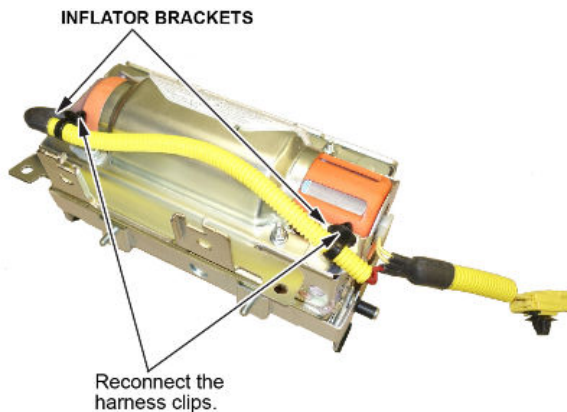
15.1. Make sure the airbag and harness are aligned as shown.

- **Make sure you have the orientation correct as shown below.** If you connect the harness incorrectly, the harness cannot be removed, and you will not be able to reinstall the airbag because the harness will be too short.
- Connect the red wire connector to the short collar side of the inflator with the red dot.

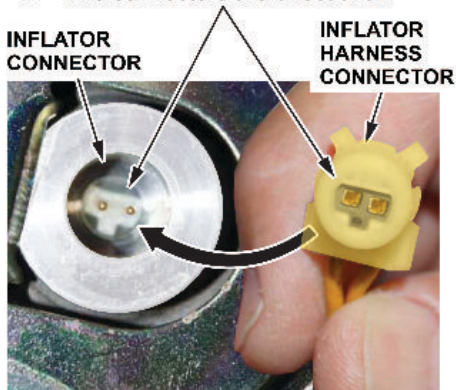
- ① Match up the "T" shape as shown. The connectors are directional.

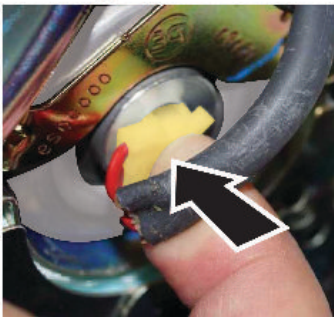
- ② Press the connector into place until it clicks.

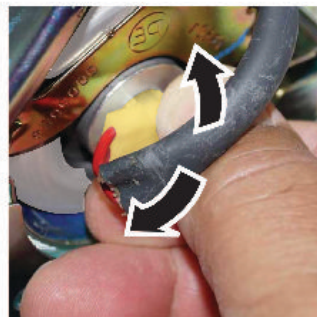
- ③ Wiggle the connector to make sure it's secure.

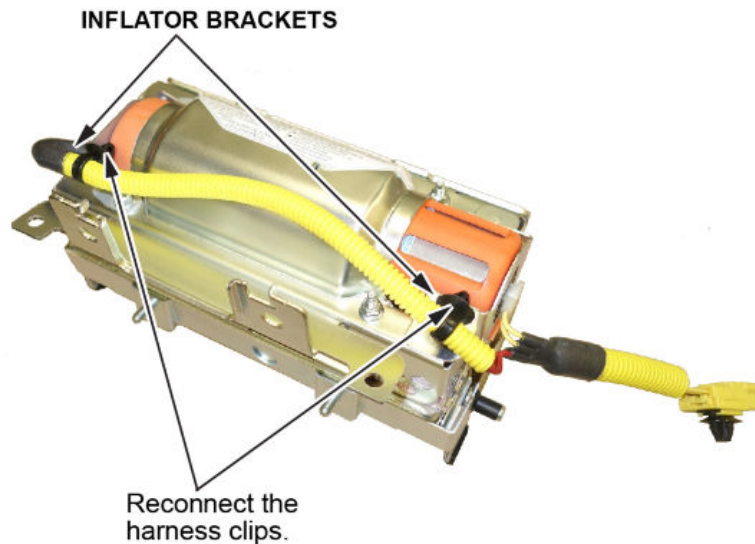
16. Connect the harness to the inflator brackets.
