Service Bulletin

19-041

Safety Recall: Takata Front Passenger's Airbag Inflator (Phase 5)

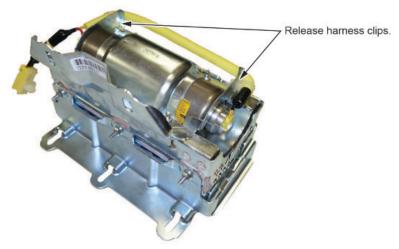
7. Remove the harness from the inflator bracket.

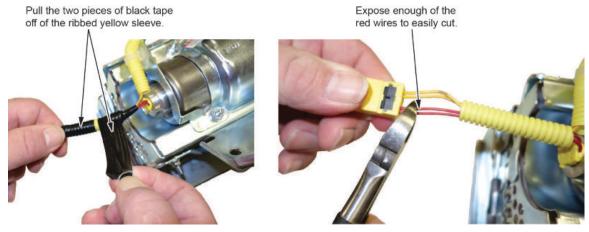
- You must cut the red wires for inflator removal and short the red wires on the inflator side as indicated to prevent accidental deployment.
- **Do not cut the yellow wires** because the airbag connector shorts these inflator wires.
- 8.1. Cut the red wires as shown.

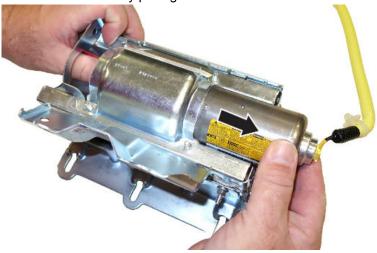
11. Remove the inflator by pulling it out.

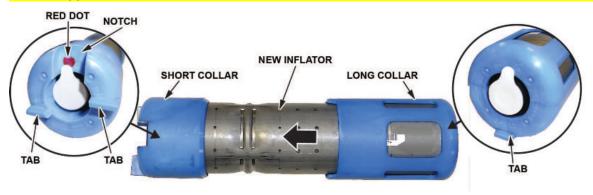
12.1. One side of the inflator has a longer collar, a single tab, and a small flat spot on the connector. The other side of the inflator has a shorter collar, two tabs, and a notch with a red dot. **Make sure you insert the end with the shorter collar into the airbag first**.

- The V-SMART tool can only validate inflators with slotted end caps. You may receive an inflator with solid
 end caps. This is the correct part to repair the vehicle, but the V-SMART will fail the validation. The VSMART validation must fail a total of three times before you can have your supervisor override the
 validation using the Supervisor Inspection Override.
- Your supervisor can be a service manager, shop foreman, team leader, etc. The supervisor must
 inspect your work to make sure the replacement inflator was installed correctly. When a supervisor
 enters his or her information, the supervisor is signing off that the technician's work was inspected
 and approved.
