SUBJECT: **NEW VEHICLE DEMONSTRATION / DELIVERY HOLD - Safety Recall 19S27**
 Certain 2019 Model Year Fiesta Vehicles
 Front Brake Caliper Seal Contamination

CERTAIN 2019 MODEL YEAR FIESTA VEHICLES — FRONT BRAKE CALIPER SEAL CONTAMINATION

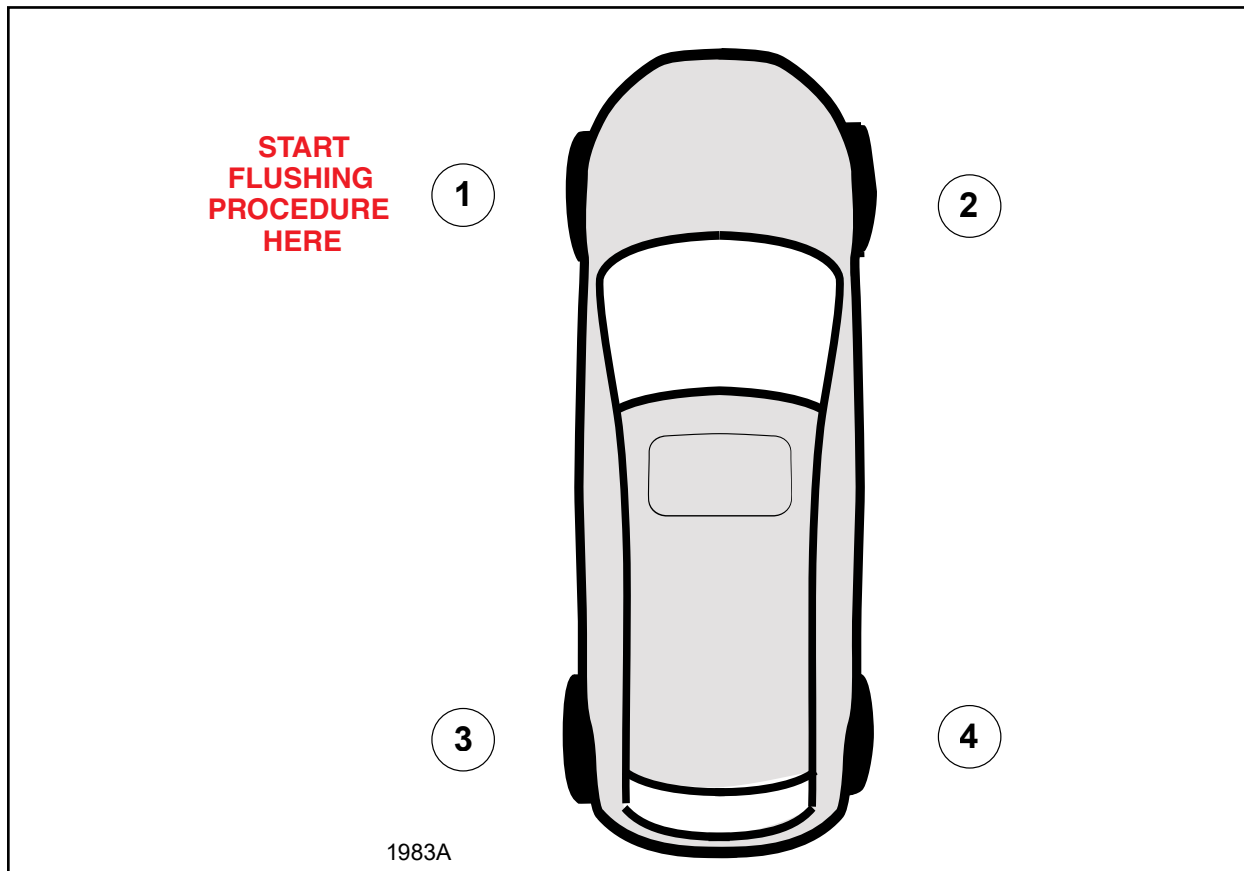
FIGURE 1

- While flushing the brakes follow the bleed order shown in Figure 1. This bleed order is unique to this recall procedure. See Figure 1.
- Flush 400 ml of fluid on each side of the front brakes.
- Flush 200 ml of fluid on each side of the rear brakes.

2. Flush the brake system, following the brake system pressure bleeding procedure steps outlined in WSM Section 206-00.

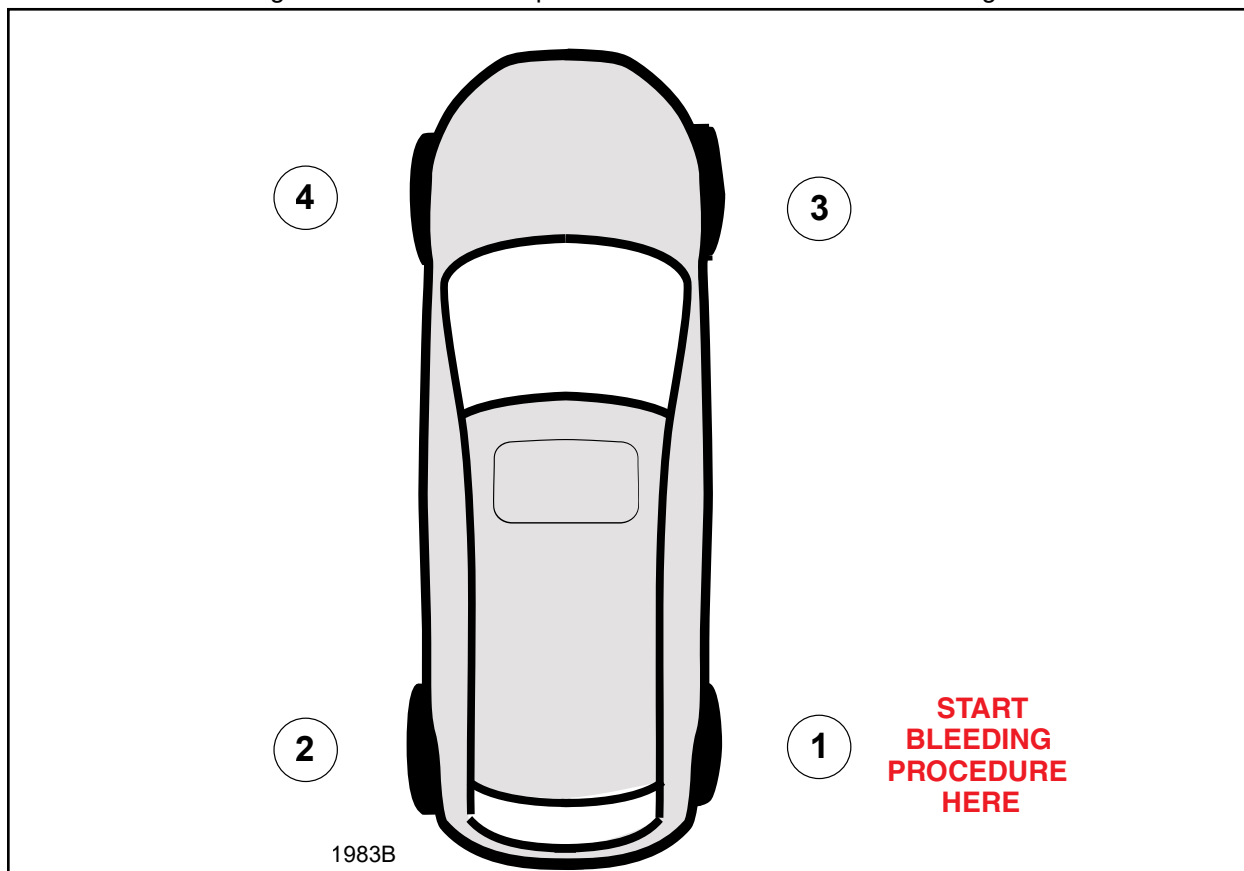
FIGURE 2

- While bleeding the brakes in this step follow in the bleed order shown in Figure 2.

4. Perform the brake system pressure bleeding procedure for the new components. Please follow the WSM procedures in Section 206-00.
