SIB 51 35 19

## RECALL 19V-755: INTERIOR TRUNK RELEASE

E-Series	Model Description	Production Date
G20	3 Series sedan	July 31, 2019 – October 2, 2019

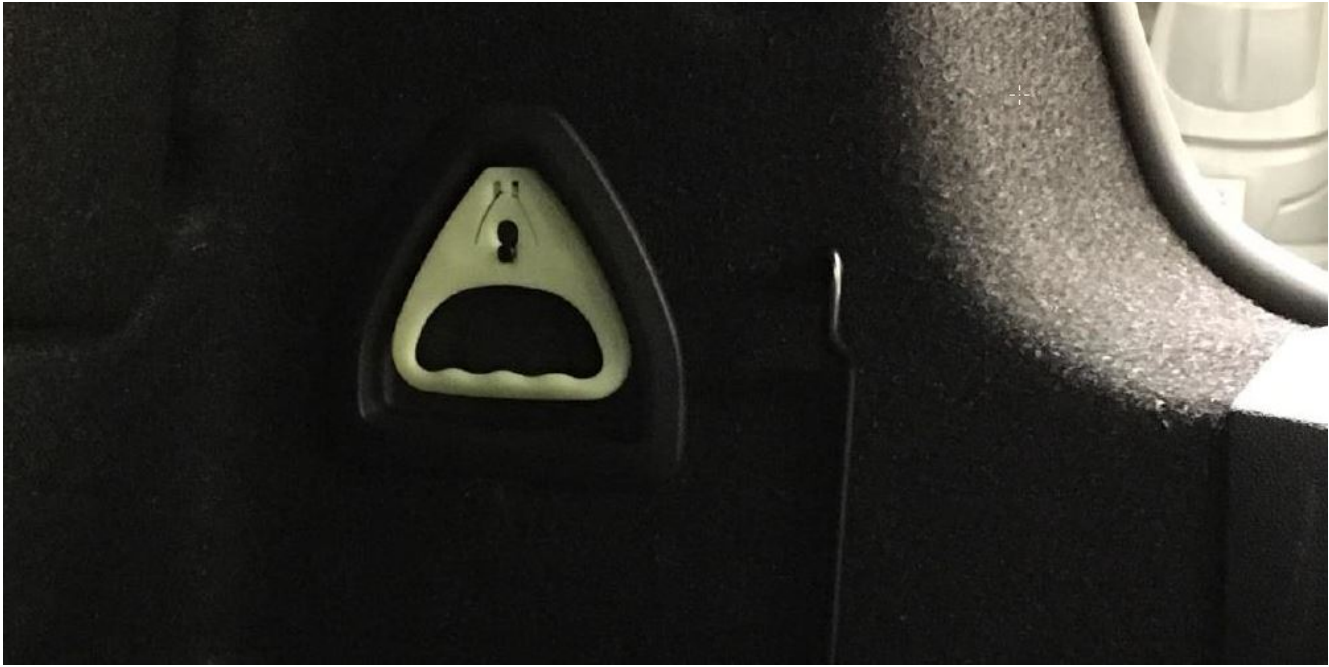
1. Open trunk lid of vehicle.
2. Manually cycle the trunk latch to the locked position while trunk lid is still open.
3. Test operation of the inside Trunk emergency unlock handle.

The Bowden cable that connects the inside Trunk emergency unlock handle to the trunk latch assembly may have not have been connected during vehicle assembly.

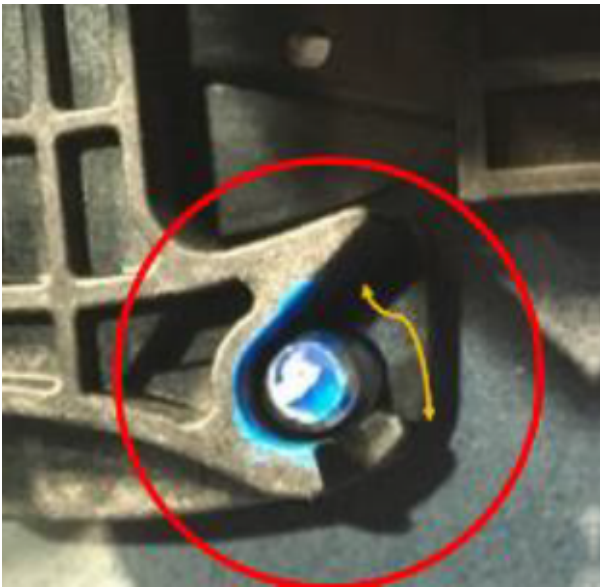
4. Does the trunk latch release?

b. No - access the trunk latch to connect the Bowden cable

- 1-Test operation of the inside Trunk emergency unlock handle
- 2-If not operating correctly, then access the trunk latch to connect the Bowden cable.
