то: Mercedes-Benz Dealer Principals, General	FROM: Gregory Gunther, Department Manager,
Managers, Sales Managers, Service Managers, Parts	Vehicle Compliance and Analysis, Engineering
Managers	Services
RE: Recall Campaign 2018020010	
Launch Notification	
Brake Booster Vacuum Hose	DATE: March 9, 2018
MY17 463 (G-Class)

Recall Campaign Bulletin

Campaign No. 2018020010, March 2018

SUBJECT: Model 463 Model Year 2017
Replace Brake Vacuum Line

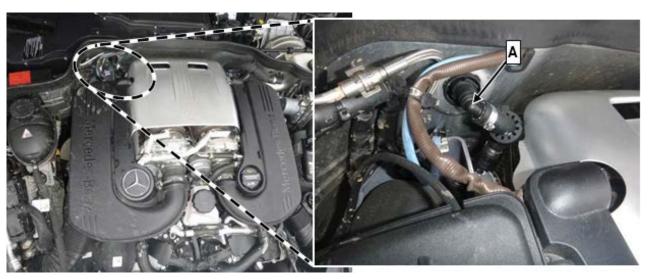
Figure 1

1. Replace vacuum line (A, figure 1).

Daimler AG ("DAG"), the manufacturer of Mercedes-Benz vehicles, has determined that on certain G-Class vehicles (463 platform) the vacuum hose for the brake booster may not have been manufactured according to current production specification. Thus, the interior wall of the four layer brake booster hose might delaminate. This might lead to a constrained vacuum supply of the brake booster. Delamination of the vacuum hose may result in reduced vacuum supply to the brake booster leading to increased braking effort by the driver. Depending on the prevailing traffic conditions, this may increase the risk of a crash. An authorized Mercedes-Benz dealer will replace the brake booster vacuum lines on the affected vehicles.
