**SAFETY RECALL NOTICE
ACTION REQUIRED**

Re: Dana, Inc., NHTSA Recall # 20E038

Inspection Work Instructions for 131536 Output Shaft.

Service Manual

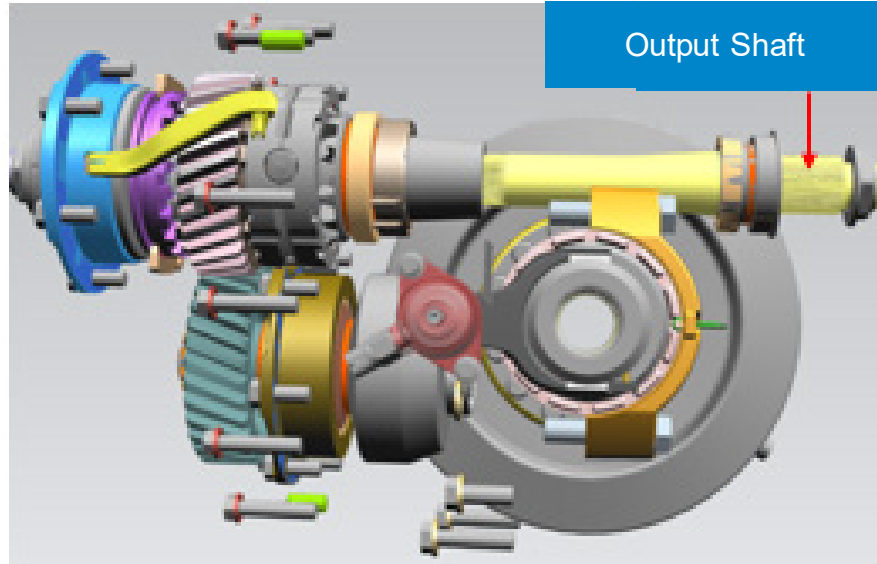
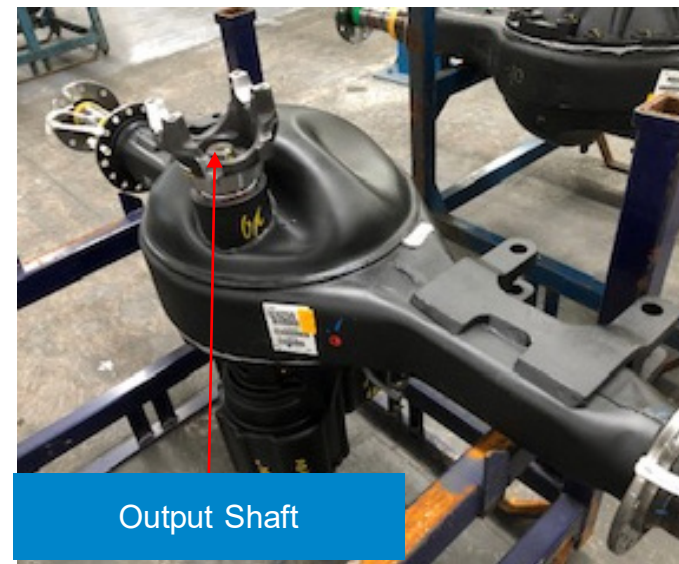
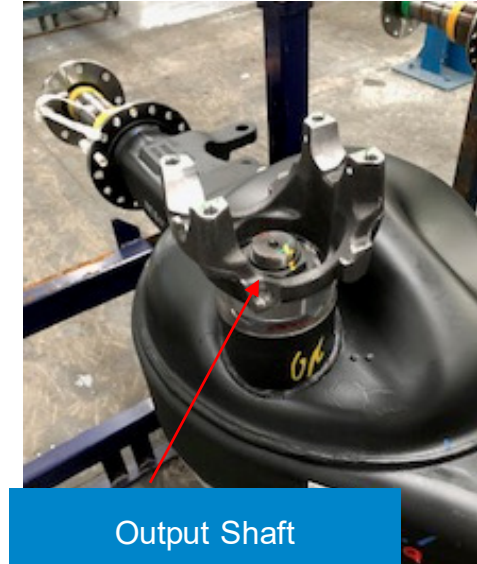
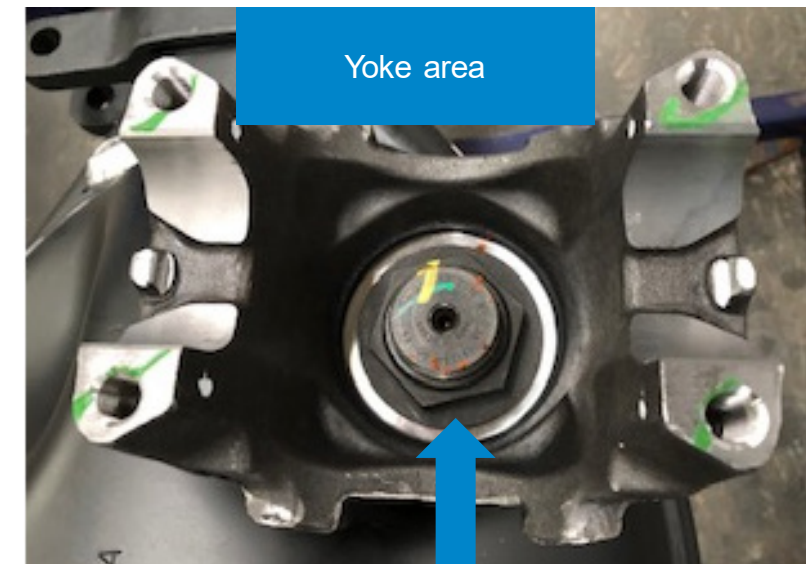
Inspection Work Instructions for Output Shaft 131536

1: From list of covered axles, inspect Julian date stamped on output shaft area. See Image

2: Identify with yellow tag all axles that are found with JD312, JD318, JD319, JD320, JD321, JD322, JD323, JD324, JD325, JD326, JD327, JD328. See image

3: Segregate as NG all axles identified with yellow tags.

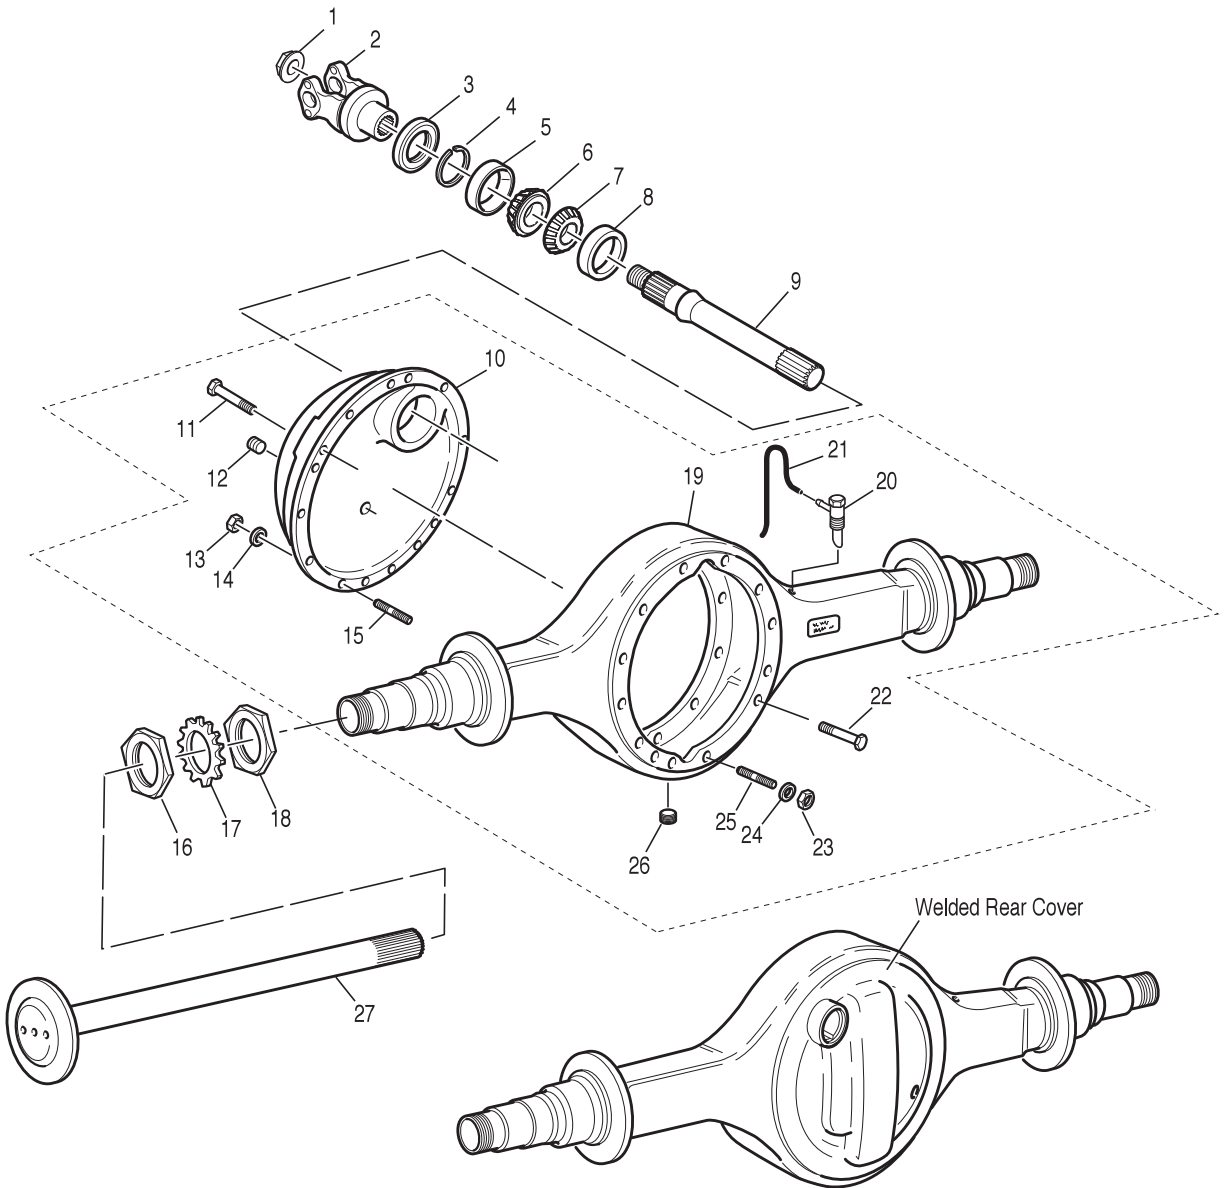
Housing and Output Shaft Assembly - Parts Exploded View

- 1 - Output shaft nut
- 2 - Output yoke
- 3 - Output seal
- 4 - Snap ring
- 5 - Outer bearing cup
- 6 - Outer bearing cone
- 7 - Inner bearing cone
- 8 - Inner bearing cup
- 9 - Output shaft

- 10 - Rear cover
- 11 - Rear cover capscrew
- 12 - Fill plug
- 13 - Rear cover nut
- 14 - Washer
- 15 - Stud
- 16 - Spindle nut - Outer
- 17 - Locking ring
- 18 - Spindle nut - Inner

- 19 - Axle housing
- 20 - Breather
- 21 - Breather hose
- 22 - Carrier capscrew
- 23 - Nut
- 24 - Washer
- 25 - Stud
- 26 - Drain plug
- 27 - Axle shaft

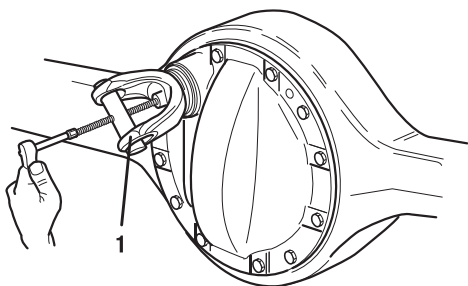
1. Disconnect the inter-axle driveline at the forward axle rear cover position.
2. Remove yoke nut (shoulder nut).
3. Remove yoke from output shaft using appropriate tool.

1 - Yoke Puller Tool

TIP: A yoke puller tool may be made from the center section of most gear puller tools, or may be purchased from your tool distributor.

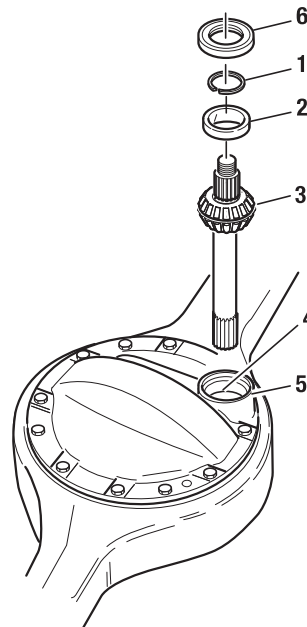
6. Remove output shaft and outer bearing cup as an assembly.

1 - Snap Ring
 2 - Outer Bearing Cup
 3 - Output Shaft Assembly
 4 - Inner Bearing Cup
 5 - Rear Cover Assembly
 6 - Output Seal

TIP: It may be helpful to loosely reinstall the yoke and shoulder nut giving the technician more of an area to grip when removing the output shaft.

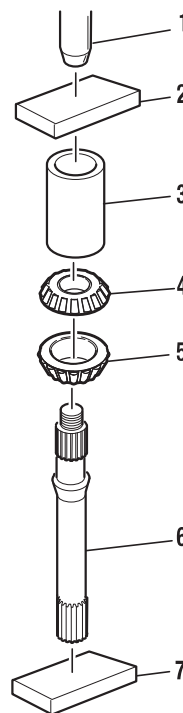
1. The output shaft bearings are assembled with both bearing cones back to back. Use a press and a sleeve to install one bearing at a time.

2. Apply pressure until the inner bearing cone touches the shoulder of the output shaft.
3. Apply pressure until the back of the outer bearing cone touches the back of the inner bearing.

- 1 - Press
- 2 - Plate
- 3 - Sleeve
- 4 - Press Bearing on Second
- 5 - Press Bearing on First
- 6 - Output Shaft
- 7 - Plate

To prevent bearing damage, use a suitable sleeve that only contacts the bearing race.

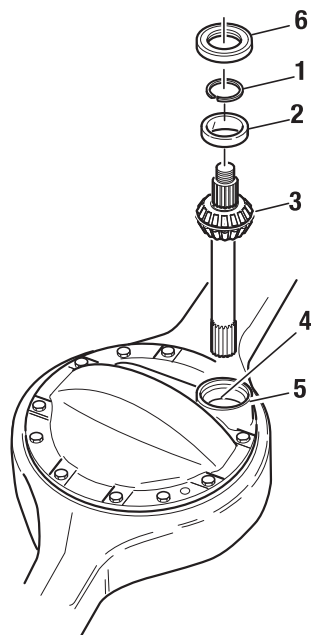
Output Shaft Assembly & Rear Cover

- 1 - Snap Ring
- 2 - Bearing Cup
- 3 - Output Shaft Assembly
- 4 - Inner Bearing Cup
- 5 - Rear Cover Assembly
- 6 - Output Seal

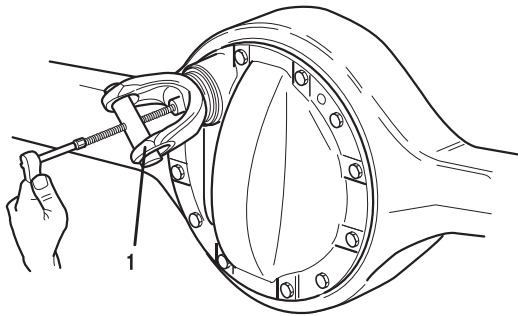
1. Inspect axle endplay at the yoke (see page 10). Service if beyond specified limit.
2. Remove the old yoke using appropriate tool. A yoke puller tool may be made from the center section of most gear puller tools, or may be purchased from your local tool distributor.

1 - Yoke Puller Tool

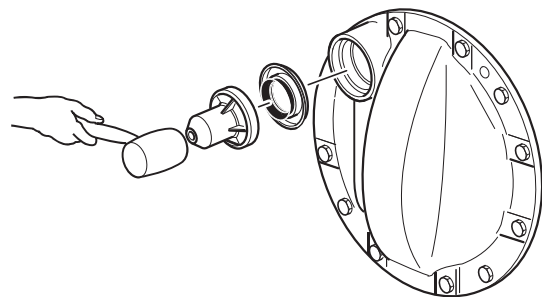
6. Handle the seal by its outside diameter avoiding any contact with the seal lips. During installation, use the proper driver to make sure that the seal is mounted properly.
7. Use a rubber mallet to drive the seal tool in until the flange bottoms on the housing cover bore face. The flange will locate the seal at the proper depth.
