**VSR-TSB-029**

NHTSA Campaign Number: 20E-070

# Vehicle Safety Recall - Technical Service Bulletin

**Attention:** Oshkosh Product Owner  
**Subject:** Bendix Pressure Switch  
**Models Affected:** Oshkosh S-Series Front Discharge Mixer  
**Model Year:** 2020  
**Date:** September 2020

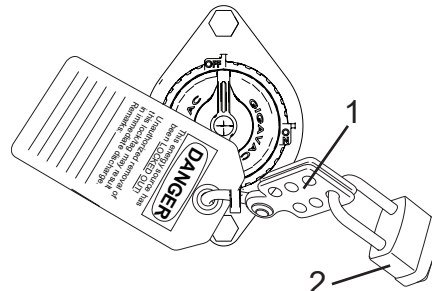
Figure A

- a. Turn the battery disconnect switch (Figure A, Item 1) counterclockwise so the hole on the switch aligns with the hole in the bracket (Figure A, Item 2).
- b. Install the safety lockout device ring (Figure B, Item 1) through the holes on the battery disconnect switch and the bracket.
- c. Install a padlock (Figure B, Item 2) onto the safety lockout device ring, lock it, and put the key in your pocket. If more than one person is working on the vehicle, each person must install his or her own padlock.

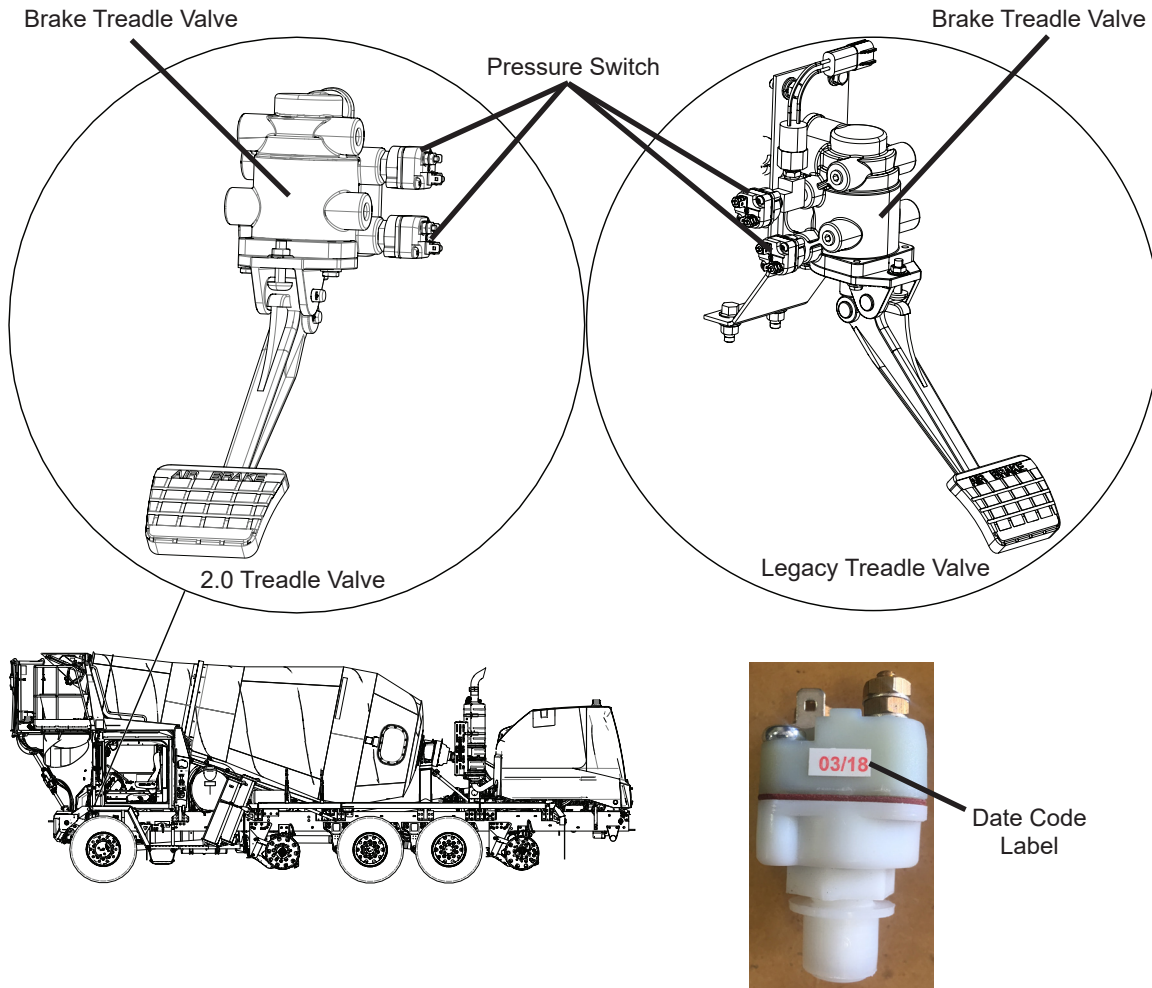
Figure 1. Brake Treadle Valve

3. Locate the two Bendix pressure switches installed on the brake treadle valve, see Figure 1.
4. Check the pressure switch lot number date code label. Suspect lots include 12/19 and 01/20. See Figure 1.

- A. If either of the pressure switches lot number date code label does not include 12/19 or 01/20 this procedure is complete and no further action is required. Remove your company's Lockout/Tagout procedure. If your company does not have a Lockout/Tagout procedure, follow OSHA 1910.147 and 1910.146 Confined Space as appropriate. Remove the wheel chocks. Return the vehicle to service.
- B. If either of the pressure switches lot number date code label includes 12/19 or 01/20 or the date code label is missing **Do not run or use the vehicle**, maintain your company's Lockout/Tagout on the vehicle, and replace the pressure switch(es) per the replacement procedure.

1. Disconnect harness connections from the pressure switch.
2. Loosen and remove the pressure switch from the brake treadle valve.
3. Apply Loctite® 567 sealant to the threads of new pressure switch.
4. Install pressure switch in brake treadle valve. Final tighten pressure switch hand tight plus 2-3 turns.
5. Reconnect harness connections to pressure switch.
