TECHNICAL INSTRUCTIONS

SAFETY RECALL 20TA02

VEHICLE MAY STALL DURING DRIVING AT HIGHER SPEED

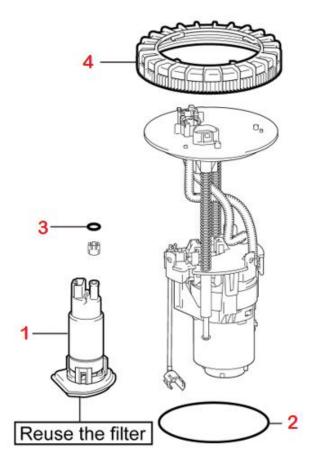
4Runner

Replacement Items in red

No.	Contents of Part Kit's	Quantity	Tape Color	Remarks
1	FUEL PUMP	1		
2	FUEL SUCTION TUBE SET GASKET	1		
3	O-RING	1	Yellow	15.2mm
4	FUEL PUMP GAUGE RETAINER	1

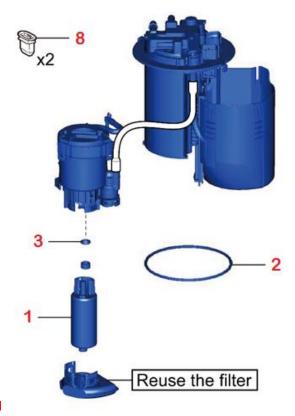
AVALON 2018

Replacement items in red

No.	Contents of Part Kit's	Quantity	Tape Color	Remarks
1	FUEL PUMP	1		
2	FUEL SUCTION TUBE SET GASKET	1		
3	O-RING	1	Yellow	15.2mm
4	O-RING	1	Red	Not used
5	O-RING		Sky Blue	Not used
6	O-RING	1	Green	Not used
7	FUEL TANK PIPE SETTING HOLDER	1	White	Not used
8	REAR SEAT CUSHION LOCK HOOK	2

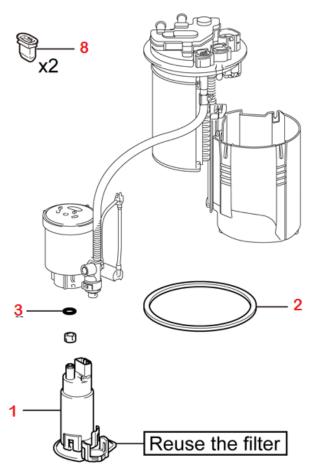
AVALON 2019

Replacement items in red

No.	Contents of Part Kit's	Quantity	Tape Color	Remarks
1	FUEL PUMP	1		
2	FUEL SUCTION TUBE SET GASKET	1		
3	O-RING	2*	Gold	15.2mm
4	REAR SEAT CUSHION LOCK HOOK (included in the gasket kit)	2		Not used
5	O-RING	1	Red	Not used
6	O-RING	1	Green	Not used
7	FUEL TANK PIPE SETTING HOLDER	1	White	Not used
8	REAR SEAT CUSHION LOCK HOOK (part # 04009-95106)	2

*only 1 O-Ring will be used. Discard the 2nd O-Ring.

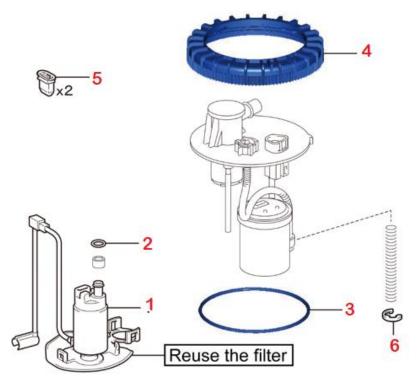
COROLLA

Replacement items in red

No.	Contents of Part Kit's	Quantity	Tape Color	Remarks
1	FUEL PUMP	1		
2	O-RING	1	(not labeled)	13.2mm
3	FUEL SUCTION TUBE SET GASKET	1		
4	FUEL PUMP GAUGE RETAINER	1		
5	REAR SEAT CUSHION LOCK HOOK	2		
6	FUEL PIPE SETTING HOLDER	1

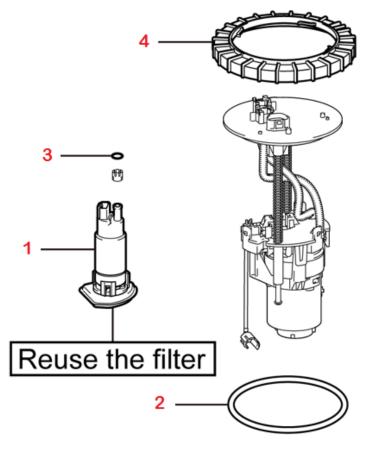
FJ CRUISER

Replacement items in red

No.	Contents of Part Kit's	Quantity	Tape Color	Remarks
1	FUEL PUMP	1		
2	FUEL SUCTION TUBE SET GASKET	1		
3	O-RING	1	Yellow	15.2mm
4	FUEL PUMP GAUGE RETAINER	1

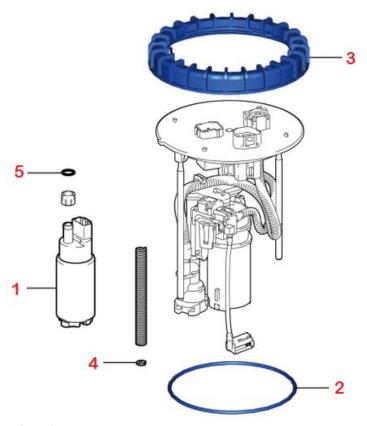
HIGHLANDER

Replacement items in red

No.	Contents of Part Kit's	Quantity	Tape Color	Remarks
1	FUEL PUMP	1		
2	FUEL SUCTION TUBE SET GASKET	1		
3	FUEL PUMP GAUGE RETAINER	1		
4	FUEL TANK PIPE SETTING HOLDER	1		
5	O RING	1	(not labeled)

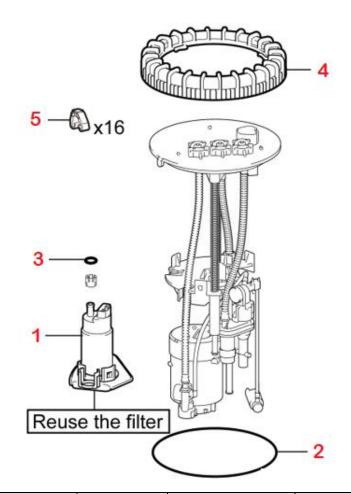
LANDCRUISER

Replacement items in red

No.	Contents of Part Kit's	Quantity	Tape Color	Remarks
1	FUEL PUMP	1		
2	FUEL SUCTION TUBE SET GASKET	1		
3	O-RING	1	Yellow	15.2mm
4	FUEL PUMP GAUAGE RETAINER	1		
5	TUBE JOINT CLIPS	16

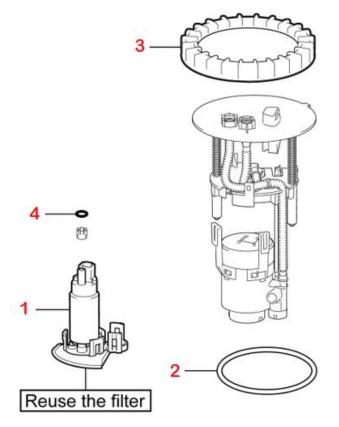
SEQUOIA TUNDRA

Replacement items in red

No.	Contents of Part Kit's	Quantity	Tape Color	Remarks
1	FUEL PUMP	1		
2	FUEL SUCTION TUBE SET GASKET	1		
3	FUEL PUMP GAUGE RETAINER	1		
4	O-RING	1	(not labeled)

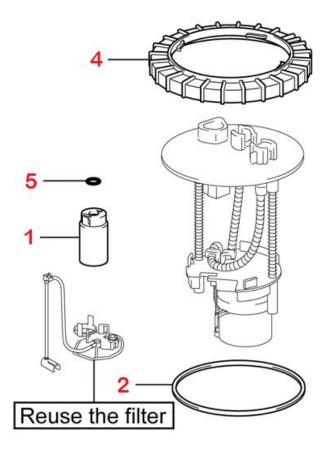
TACOMA 2TR-FE 2.7

Replacement items in red

No.	Contents of Part Kit's	Quantity	Tape Color	Remarks
1	FUEL PUMP	1		
2	FUEL SUCTION TUBE SET GASKET	1		
3	O-RING	1	Yellow	15.2mm (not used)
4	FUEL PUMP GAUGE RETAINER	1		
5	O-RING	1		13.2mm

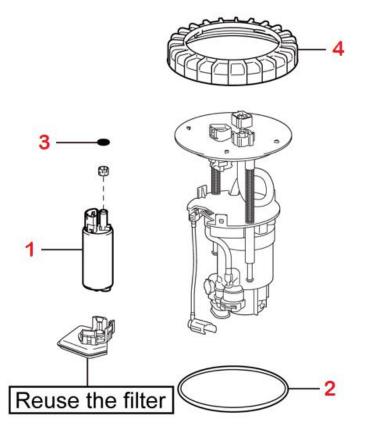
TACOMA 2GR-FKS 3.5

Replacement items in red

No.	Contents of Part Kit's	Quantity	Tape Color	Remarks
1	FUEL PUMP	1		
2	FUEL SUCTION TUBE SET GASKET	1		
3	O-RING	1	Yellow	15.2mm
4	FUEL PUMP GAUGE RETAINER	1

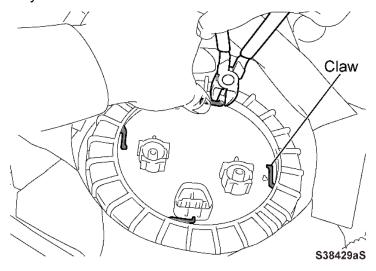
REMOVAL TIP: PLASTIC RING RETAINERS

If removing the Plastic Ring type retainers, cut the 4 internal claws to prevent the Fuel Tube assembly from rotating during removal. This could cause damage to the fuel level sender, fuel tank, or fuel tube assembly.

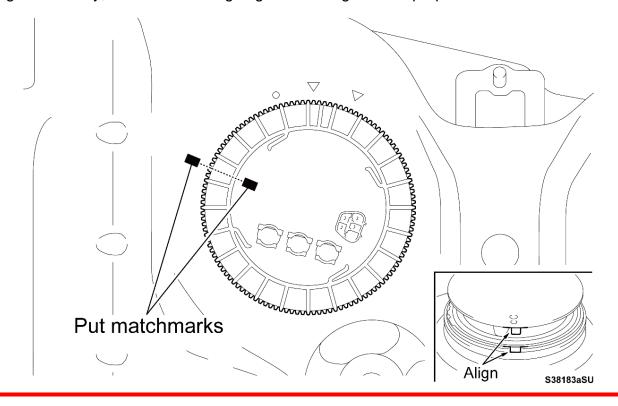
REMOVAL TIP: TUBE ASSY ALIGNMENT

For vehicles with the plastic retainer rings, place matchmarks on both the Fuel Tube Assembly and the fuel tank. During disassembly, confirm that the Fuel Tube Assembly does not rotate. During reassembly, this will aid in aligning the locating tabs for proper installation.

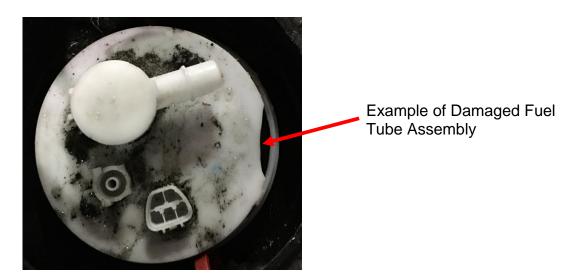
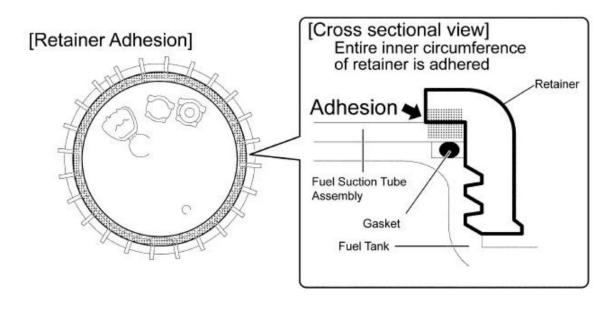
REMOVAL TIP: COROLLA RETAINER RING REMOVAL

Corolla models have been identified to experience breakage of the Fuel Tube Assembly during disassembly. In order to prevent damage to the Fuel Tube Assembly during removal, perform the procedure detailed in the following steps.

The damage during disassembly is caused by adhesion, or "sticking", of the Retainer Ring and the Fuel Tube Assembly. When the Retainer Ring is rotated on the stationary Fuel Tube assembly, the portions that are "stuck" together are under a very high load and may break off.

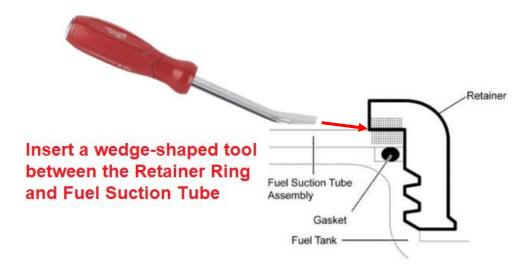
REMOVAL TIP: COROLLA RETAINER RING REMOVAL (cont.)

It will be necessary to separate the bond between the Retainer Ring and Fuel Tube Assembly before starting to remove the Retainer Ring. An effective method to separate this bond is the insert a wedge-shaped tool between the two pieces.

<u>Tool selection is critical for this procedure</u>. The tool needs to be able to slide flat across the surface of the Fuel Tube Assembly without digging into the Fuel Tube Assembly and causing damage. The tool tip also needs to have a wedge shape so that it can push upward on the Retainer Ring. The handle needs to be angled from tip to provide clearance of the electrical and fuel line connections. Metal trim tools and <u>small</u> pry bars are good examples of tools that work well. A screwdriver will not be acceptable.

- 1. Using the proper tool as described above, place the tool at the junction between the Retainer Ring and the Fuel Tube Assembly.
- 2. Using a small hammer, <u>gently</u> tap inward on the tool to force the Retainer Ring to flex enough the create the separation between the two pieces.
- 3. Gently rotate the tool upward a small amount to confirm the separation.
- 4. Remove the tool from under the Retainer Ring.
- 5. Continue this same process at 8 to 10 additional points around the Retainer Ring.
- 6. Remove the Retainer Ring using the appropriate tools.
- 7. Inspect the top of the Fuel Tube Assembly for cracking or damage on both sides. Do not reuse the Fuel Tube Assembly if it is damaged.

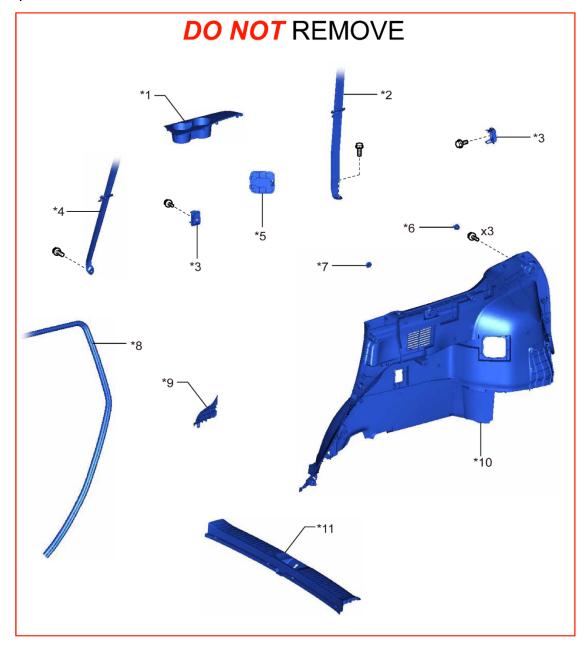
DISASSEMBLY PROCEDURE: HIGHLANDER

To access the Fuel Tube Assembly on the Highlander, it is not necessary to remove many of the interior Side Panel components as detailed in the Repair Manual. The following diagrams will detail the parts that are NOT NECESSARY to remove.

*1	NO. 2 DECK SIDE TRIM COVER	*2	REAR NO. 2 SEAT OUTER BELT ASSEMBLY LH
*3	ROPE HOOK	*4	REAR NO. 1 SEAT OUTER BELT ASSEMBLY LH
*5	DECK TRIM SIDE SERVICE HOLE COVER	*6	NO. 1 LUGGAGE COMPARTMENT TRIM HOOK
*7	DECK TRIM POCKET COVER	*8	REAR DOOR OPENING TRIM WEATHERSTRIP LH
*9	FRONT DECK SIDE TRIM COVER LH	*10	DECK TRIM SIDE PANEL ASSEMBLY LH
*11	REAR FLOOR FINISH PLATE	-	-

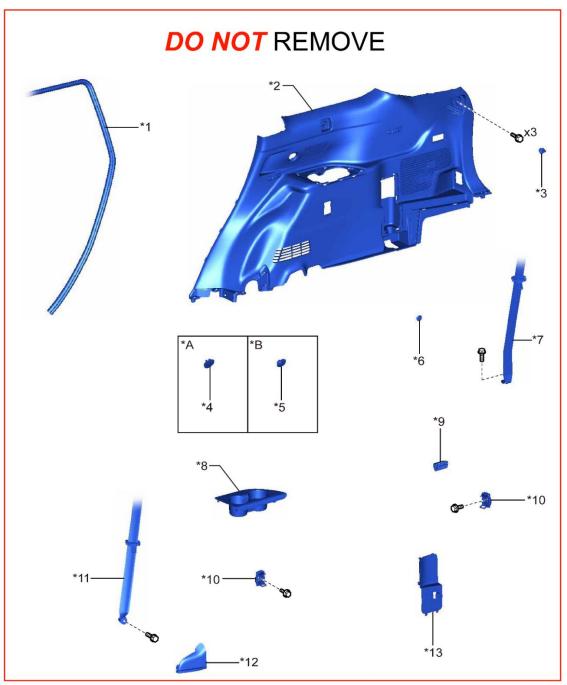
DISASSEMBLY PROCEDURE: HIGHLANDER (cont.)

*1 REAR DOOR OPENING TRIM WEATHERSTRIP RH	
*5 COOLER (NO. 2 ROOM TEMP. SENSOR) THERMISTOR *6 DECK TRIM POCKET COVER	
*7 REAR NO. 2 SEAT OUTER BELT ASSEMBLY RH	
*9 NO. 1 LUGGAGE COMPARTMENT LIGHT ASSEMBLY *10 ROPE HOOK	
*11 REAR NO. 1 SEAT OUTER BELT ASSEMBLY RH	
*13 DECK TRIM SIDE BELT HOLE COVER RH

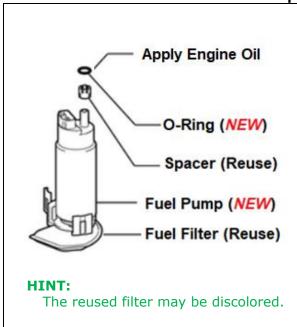
Example Procedure:

- Remove the original O-Ring, Spacer and Fuel Filter from the original Fuel Pump.
- Discard the original O-Ring and Fuel Pump, saving the Spacer and Fuel Filter.
- Install the original Spacer onto the NEW Fuel Pump.
- Install the NEW O-Ring onto the NEW Fuel Pump. Refer to the Component Diagram to determine to proper O-Ring, as identified by the colored tape on the bag.
- Apply a small amount of engine oil to the *NEW* O-Ring to assure correct installation into the Tube Assembly.
- Install the original Fuel Filter onto the NEW Fuel Pump.
- Refer to the <u>Components diagrams</u> to review the other <u>NEW</u> parts to install.
- Apply engine oil to the NEW O-ring before assembly to assure correct installation into the Fuel Suction Tube.

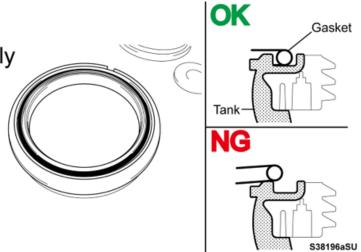
INSTALLATION TIP: PLASTIC RETAINER

Set **NEW** gasket properly

DO NOT apply silicon grease

Put the retainer around the arm so that it is not necessary to change hands to keep pressing down the fuel suction tube. (Plastic Retainer)

Keep pressing down the fuel suction tube while installing the retainer.
