TECHNICAL INSTRUCTIONS

SAFETY RECALL 20TA02

VEHICLE MAY STALL DURING DRIVING AT HIGHER SPEED

2018 – 2019 Sequoia
2018 – 2019 Tundra
2018 – 2019 Corolla
2018 – 2019 Tacoma

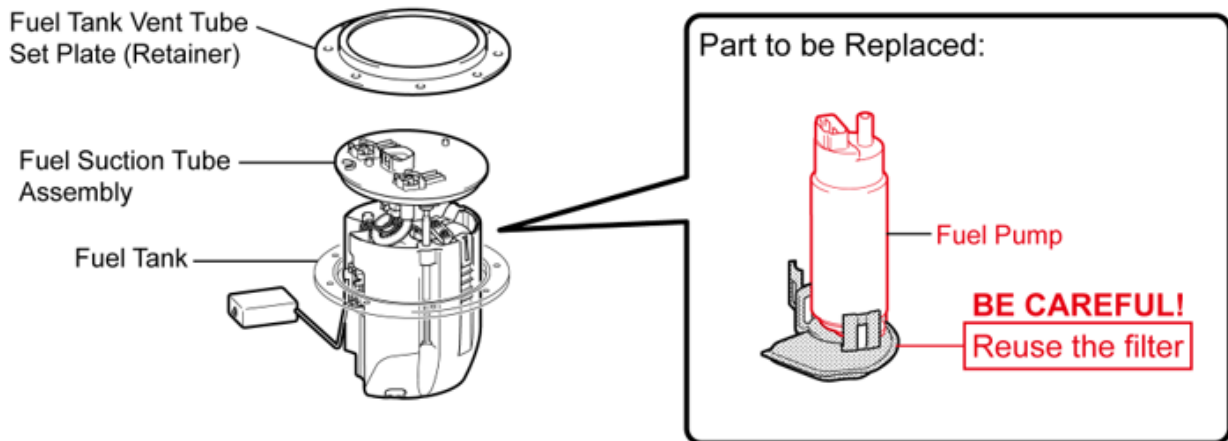
S38182aSU

The subject vehicles are equipped with a low-pressure fuel pump which may stop operating. If this were to occur, warning lights and messages may be displayed on the instrument panel, and the engine may run rough. This may result in a vehicle stall, and the vehicle may be unable to be restarted. If a vehicle stall occurs while driving at higher speeds, this could increase the risk of a crash.

*The configuration of the parts will differ depending on the specification.

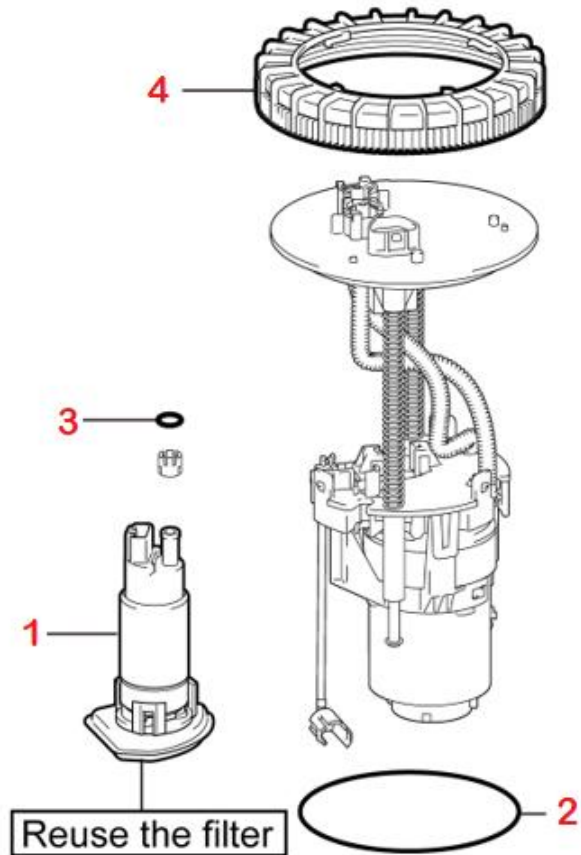
4Runner

Replacement Items in red

No.	Contents of Part Kit's	Quantity	Tape Color	Remarks
1	FUEL PUMP	1		
2	FUEL SUCTION TUBE SET GASKET	1		
3	O-RING	1	Yellow	15.2mm
4	FUEL PUMP GAUGE RETAINER	1

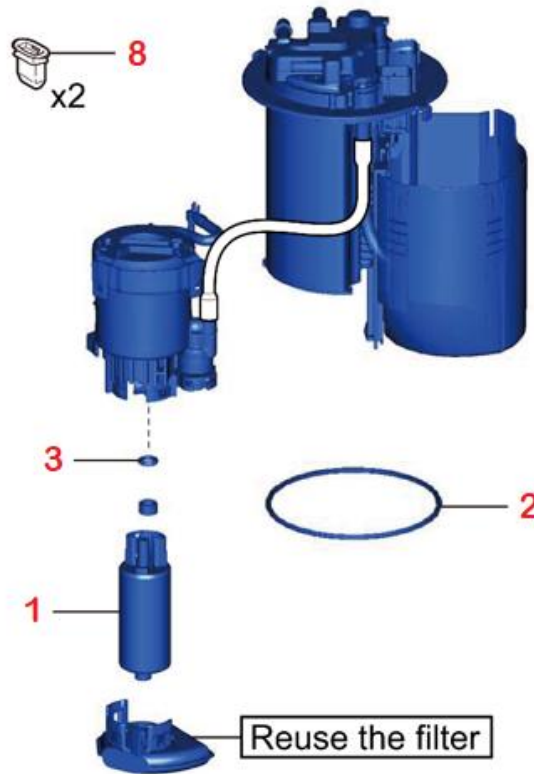
AVALON 2018

Replacement items in red

No.	Contents of Part Kit's	Quantity	Tape Color	Remarks
1	FUEL PUMP	1		
2	FUEL SUCTION TUBE SET GASKET	1		
3	O-RING	1	Yellow	15.2mm
4	O-RING	1	Red	Not used
5	O-RING		Sky Blue	Not used
6	O-RING	1	Green	Not used
7	FUEL TANK PIPE SETTING HOLDER	1	White	Not used
8	REAR SEAT CUSHION LOCK HOOK	2

Note: Some items in the Fuel Pump Replacement Kit will not be used.

Dispose (Not used)
 4—● 5—● 6—● 7—● S38348aS

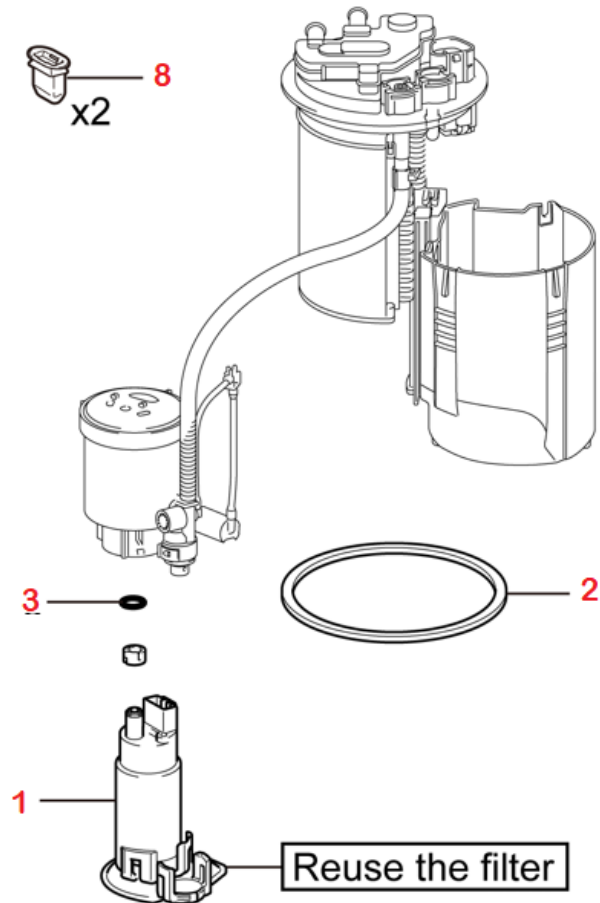
AVALON 2019

Replacement items in red

No.	Contents of Part Kit's	Quantity	Tape Color	Remarks
1	FUEL PUMP	1		
2	FUEL SUCTION TUBE SET GASKET	1		
3	O-RING	2*	Gold	15.2mm
4	REAR SEAT CUSHION LOCK HOOK (included in the gasket kit)	2		Not used
5	O-RING	1	Red	Not used
6	O-RING	1	Green	Not used
7	FUEL TANK PIPE SETTING HOLDER	1	White	Not used
8	REAR SEAT CUSHION LOCK HOOK (part # 04009-95106)	2

*only 1 O-Ring will be used. Discard the 2nd O-Ring.

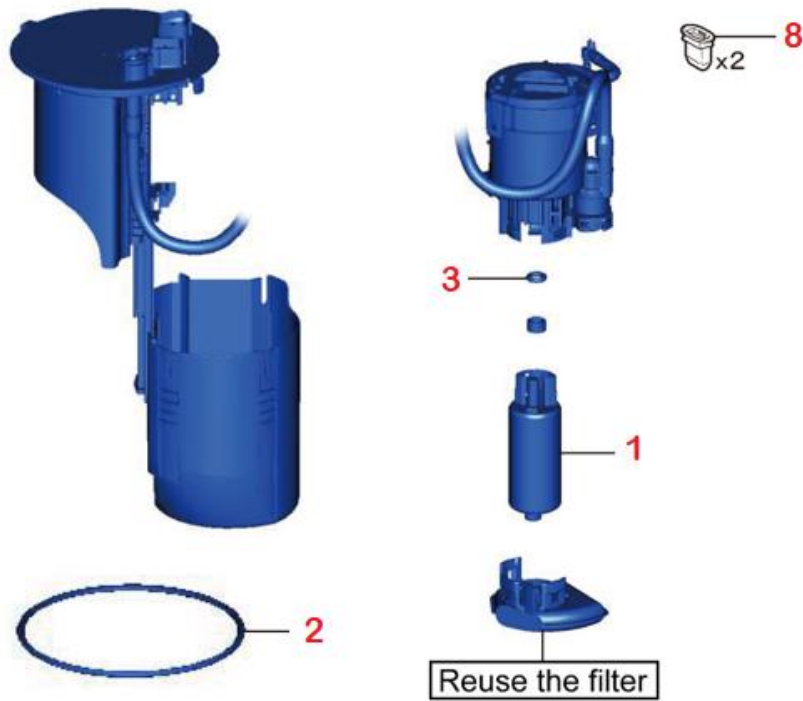
CAMRY

Replacement items in red

No.	Contents of Part Kit's	Quantity	Tape Color	Remarks
1	FUEL PUMP	1		
2	FUEL SUCTION TUBE SET GASKET	1		
3	O-RING	2*	Gold	15.2mm
4	REAR SEAT CUSHION LOCK HOOK (included in the gasket kit)	2		Not used
5	O-RING	1	Red	Not used
6	O-RING	1	Green	Not used
7	FUEL TANK PIPE SETTING HOLDER	1	White	Not used
8	REAR SEAT CUSHION LOCK HOOK (part # 04009-95106)	2

*only 1 O-Ring will be used. Discard the 2nd O-Ring.

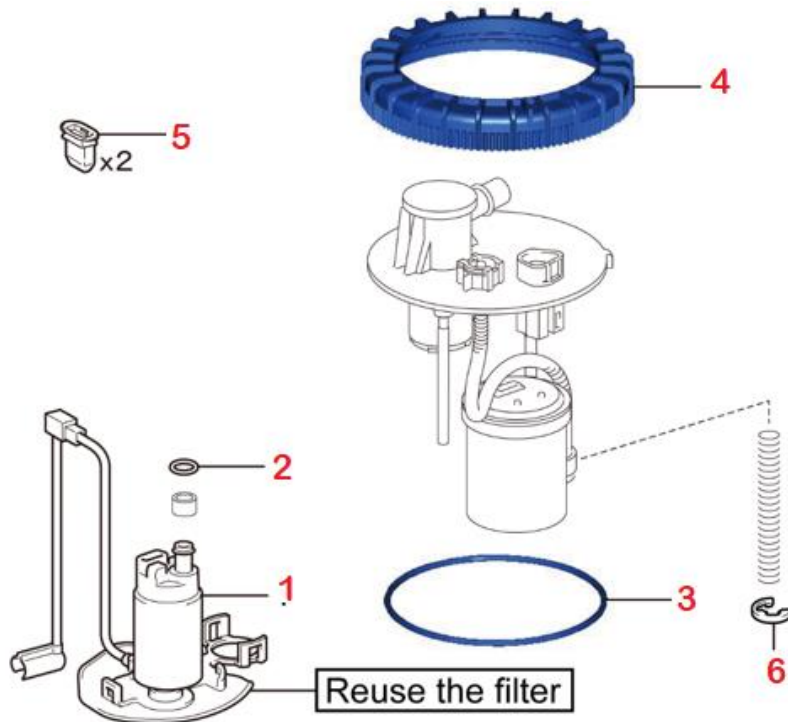
COROLLA

Replacement items in red

No.	Contents of Part Kit's	Quantity	Tape Color	Remarks
1	FUEL PUMP	1		
2	O-RING	1	(not labeled)	13.2mm
3	FUEL SUCTION TUBE SET GASKET	1		
4	FUEL PUMP GAUGE RETAINER	1		
5	REAR SEAT CUSHION LOCK HOOK	2		
6	FUEL PIPE SETTING HOLDER	1

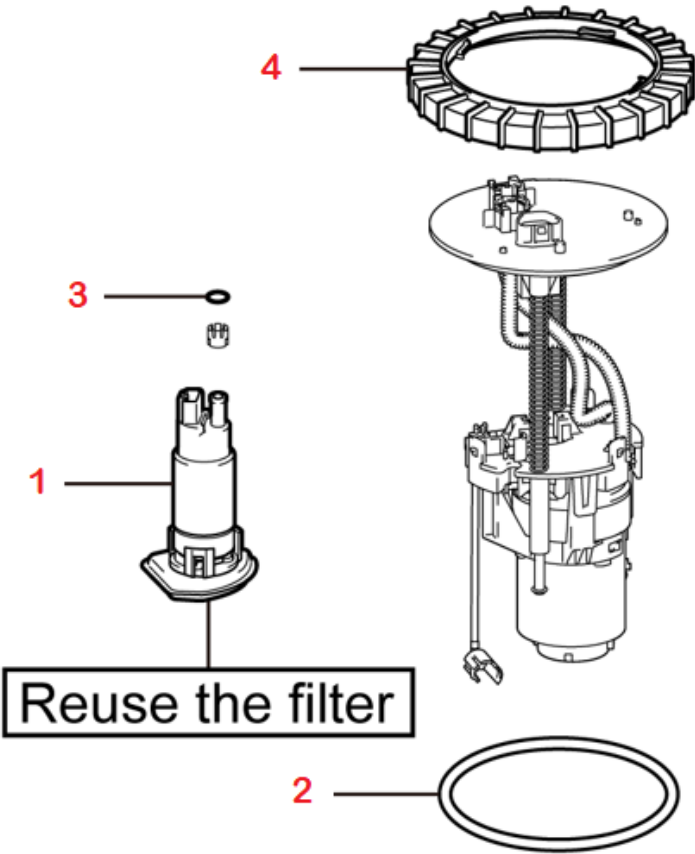
FJ CRUISER

Replacement items in red

No.	Contents of Part Kit's	Quantity	Tape Color	Remarks
1	FUEL PUMP	1		
2	FUEL SUCTION TUBE SET GASKET	1		
3	O-RING	1	Yellow	15.2mm
4	FUEL PUMP GAUGE RETAINER	1

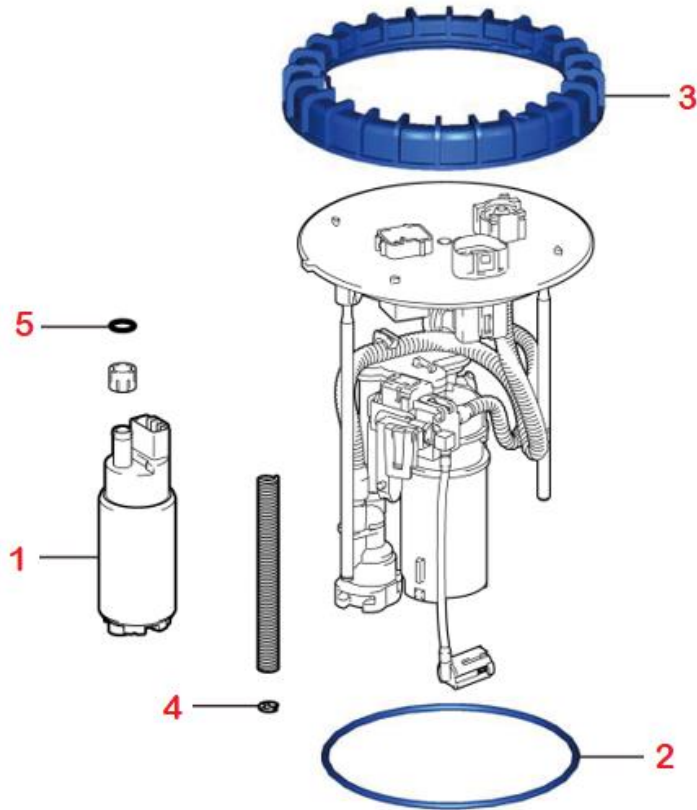
HIGHLANDER

Replacement items in red

No.	Contents of Part Kit's	Quantity	Tape Color	Remarks
1	FUEL PUMP	1		
2	FUEL SUCTION TUBE SET GASKET	1		
3	FUEL PUMP GAUGE RETAINER	1		
4	FUEL TANK PIPE SETTING HOLDER	1		
5	O RING	1	(not labeled)

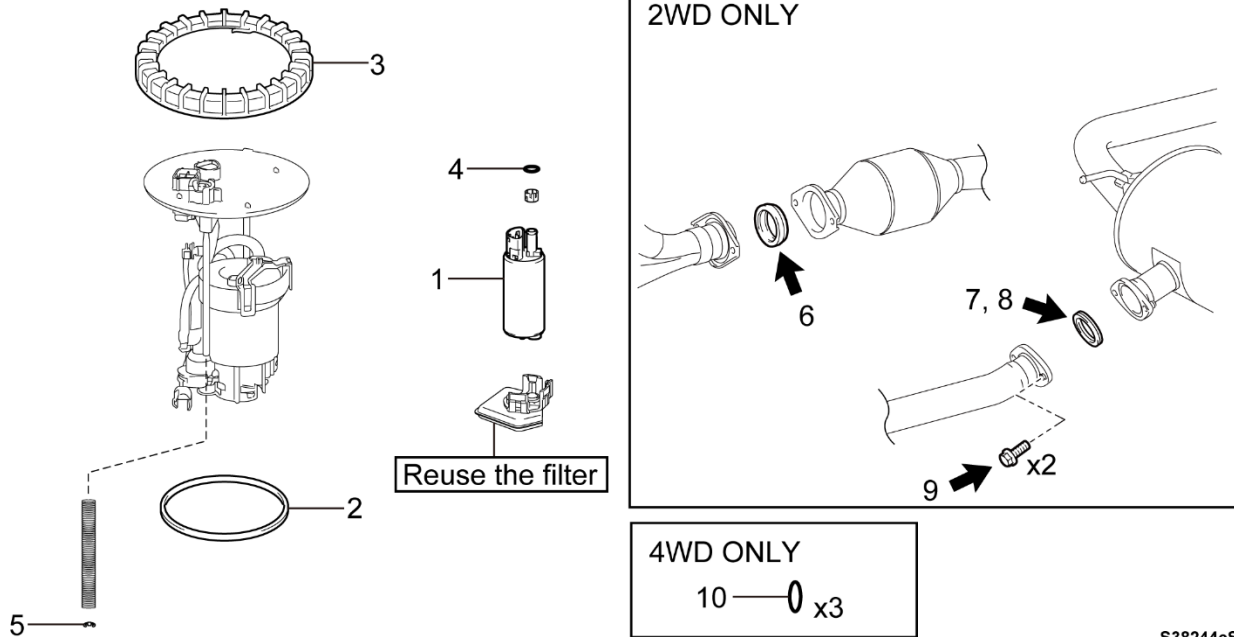
SIENNA

Replacement items in red

No.	Contents of Part Kit's	Quantity	Tape Color	Remarks
1	FUEL PUMP	1		
2	FUEL SUCTION TUBE SET GASKET	1		
3	FUEL PUMP GAUGE RETAINER	1		
4	O-RING	1	(not labeled)	
5	FUEL TANK PIPE SETTING HOLDER	1		
6	EXHASUT PIPE GASKET (2WD)	1		16.4mm
7	EXHASUT PIPE GASKET (2WD)	1		
8	EXHASUT PIPE GASKET (2WD)	1		
9	FLANGE BOLT (2WD)	2		
10	DRAIN PLUG GASKET (4WD)	3

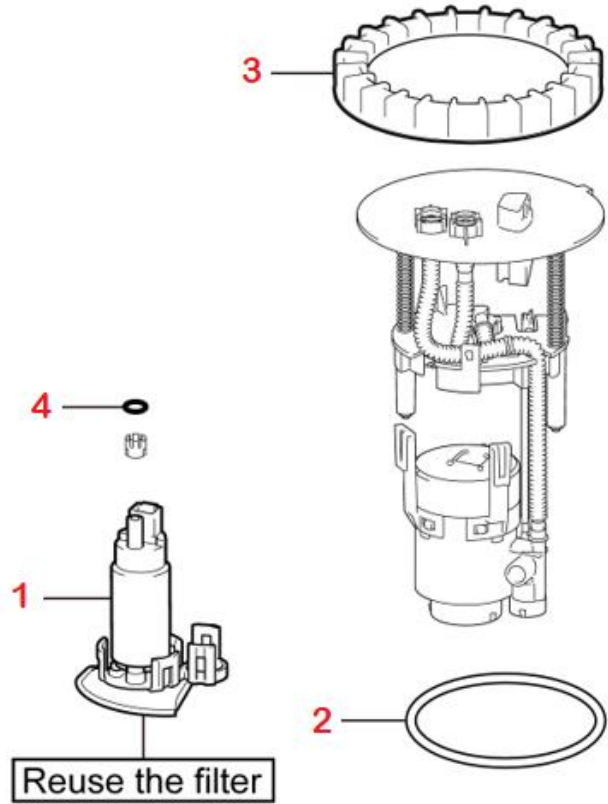
SEQUOIA
TUNDRA

Replacement items in red

No.	Contents of Part Kit's	Quantity	Tape Color	Remarks
1	FUEL PUMP	1		
2	FUEL SUCTION TUBE SET GASKET	1		
3	FUEL PUMP GAUGE RETAINER	1		
4	O-RING	1	(not labeled)

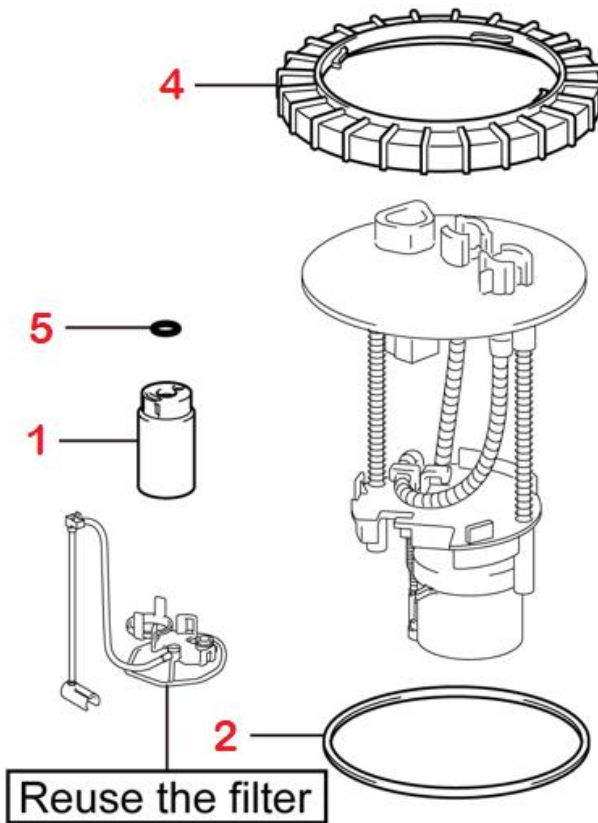
TACOMA
2TR-FE 2.7

Replacement items in red

No.	Contents of Part Kit's	Quantity	Tape Color	Remarks
1	FUEL PUMP	1		
2	FUEL SUCTION TUBE SET GASKET	1		
3	O-RING	1	Yellow	15.2mm (not used)
4	FUEL PUMP GAUGE RETAINER	1		
5	O-RING	1		13.2mm

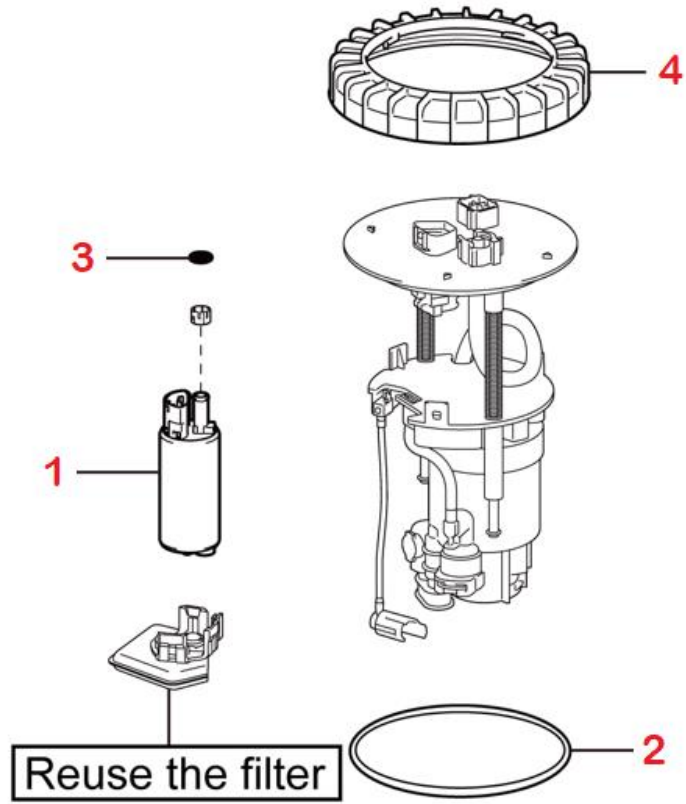
TACOMA
2GR-FKS 3.5

Replacement items in red

No.	Contents of Part Kit's	Quantity	Tape Color	Remarks
1	FUEL PUMP	1		
2	FUEL SUCTION TUBE SET GASKET	1		
3	O-RING	1	Yellow	15.2mm
4	FUEL PUMP GAUGE RETAINER	1

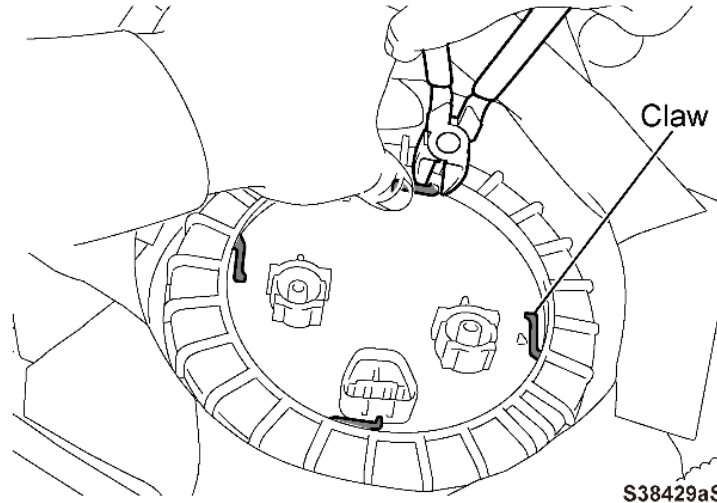
If removing the Plastic Ring type retainers, cut the 4 internal claws to prevent the Fuel Tube assembly from rotating during removal. This could cause damage to the fuel level sender, fuel tank, or fuel tube assembly.

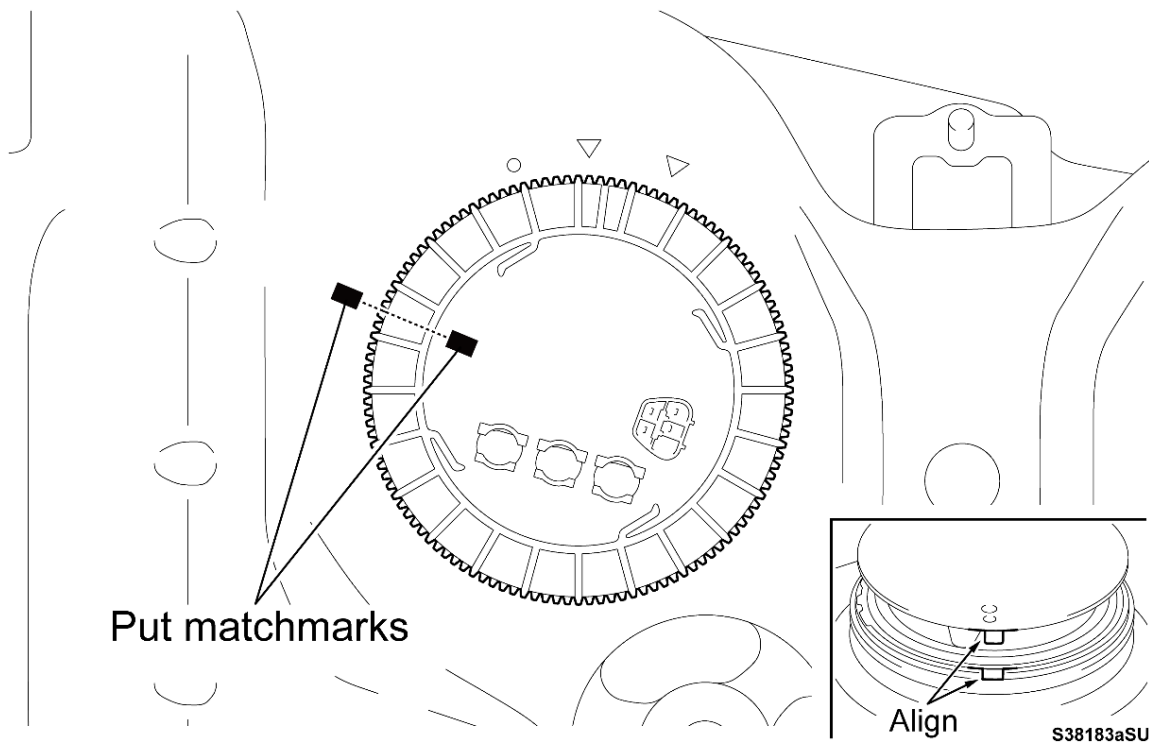
For vehicles with the plastic retainer rings, place matchmarks on both the Fuel Tube Assembly and the fuel tank. During disassembly, confirm that the Fuel Tube Assembly does not rotate. During reassembly, this will aid in aligning the locating tabs for proper installation.

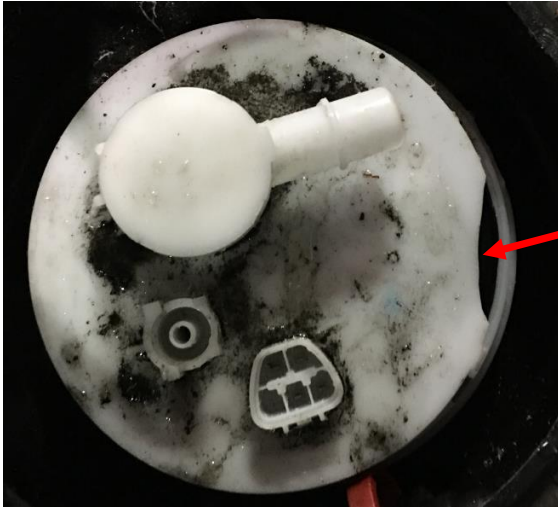
Example of Damaged Fuel Tube Assembly

The damage during disassembly is caused by adhesion, or “sticking”, of the Retainer Ring and the Fuel Tube Assembly. When the Retainer Ring is rotated on the stationary Fuel Tube assembly, the portions that are “stuck” together are under a very high load and may break off.

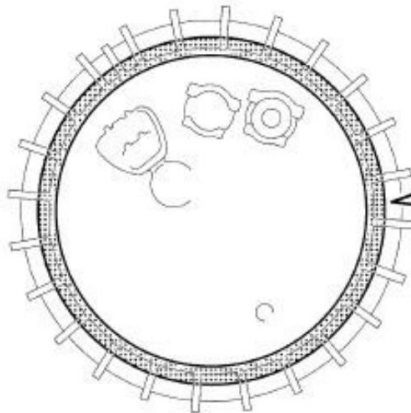
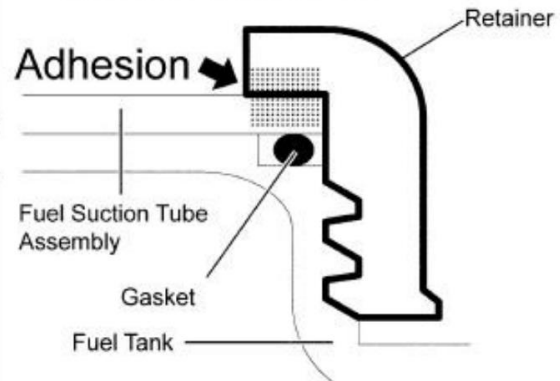
[Retainer Adhesion]

[Cross sectional view]

Entire inner circumference of retainer is adhered

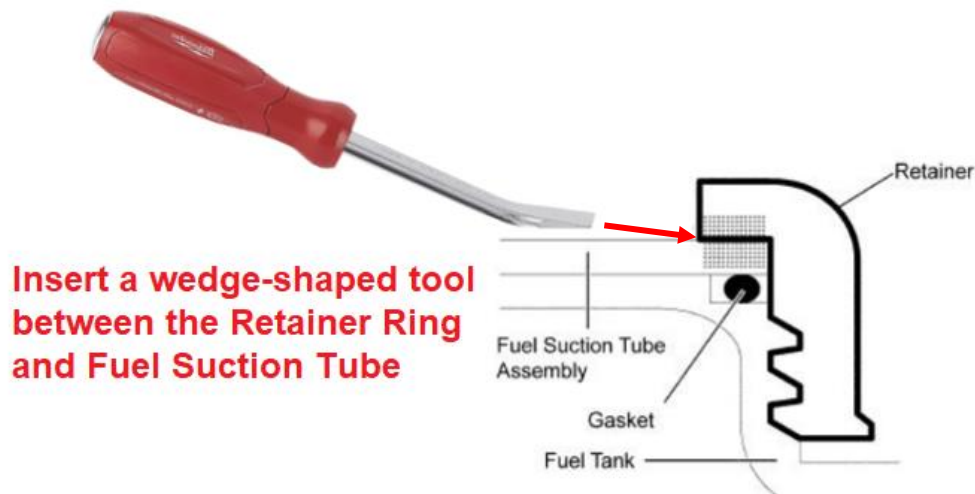
It will be necessary to separate the bond between the Retainer Ring and Fuel Tube Assembly before starting to remove the Retainer Ring. An effective method to separate this bond is the insert a wedge-shaped tool between the two pieces.

Tool selection is critical for this procedure. The tool needs to be able to slide flat across the surface of the Fuel Tube Assembly without digging into the Fuel Tube Assembly and causing damage. The tool tip also needs to have a wedge shape so that it can push upward on the Retainer Ring. The handle needs to be angled from tip to provide clearance of the electrical and fuel line connections. Metal trim tools and small pry bars are good examples of tools that work well. A screwdriver will not be acceptable.

1. Using the proper tool as described above, place the tool at the junction between the Retainer Ring and the Fuel Tube Assembly.
2. Using a small hammer, gently tap inward on the tool to force the Retainer Ring to flex enough to create the separation between the two pieces.
3. Gently rotate the tool upward a small amount to confirm the separation.
4. Remove the tool from under the Retainer Ring.
5. Continue this same process at 8 to 10 additional points around the Retainer Ring.
6. Remove the Retainer Ring using the appropriate tools.
7. Inspect the top of the Fuel Tube Assembly for cracking or damage on both sides. Do not reuse the Fuel Tube Assembly if it is damaged.

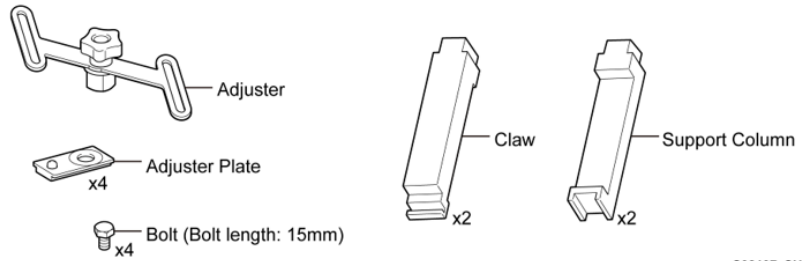
Campaign Tool Cam Lock Set:

An updated set of Cam Lock Claws and Support Columns are being supplied to each dealership for this campaign. The configuration of the retainer engagement sections of the claws have been modified from the SST that is referenced in the repair manual. The **NEW** claws have an improved design that enables a firm attachment to the retainer. In addition, 2 support columns are provided which will support the retainer more securely during installation and removal. Be sure to assemble and use the tools using the following procedures:

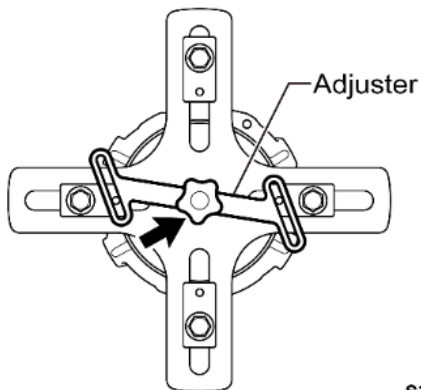
Lightly tighten the adjuster

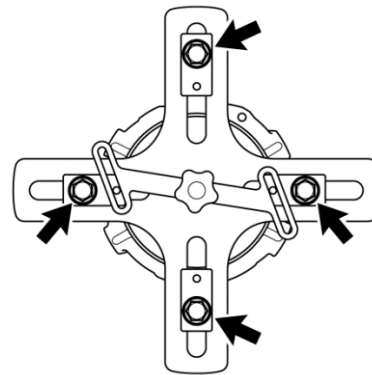
Fully tighten the 4 bolts

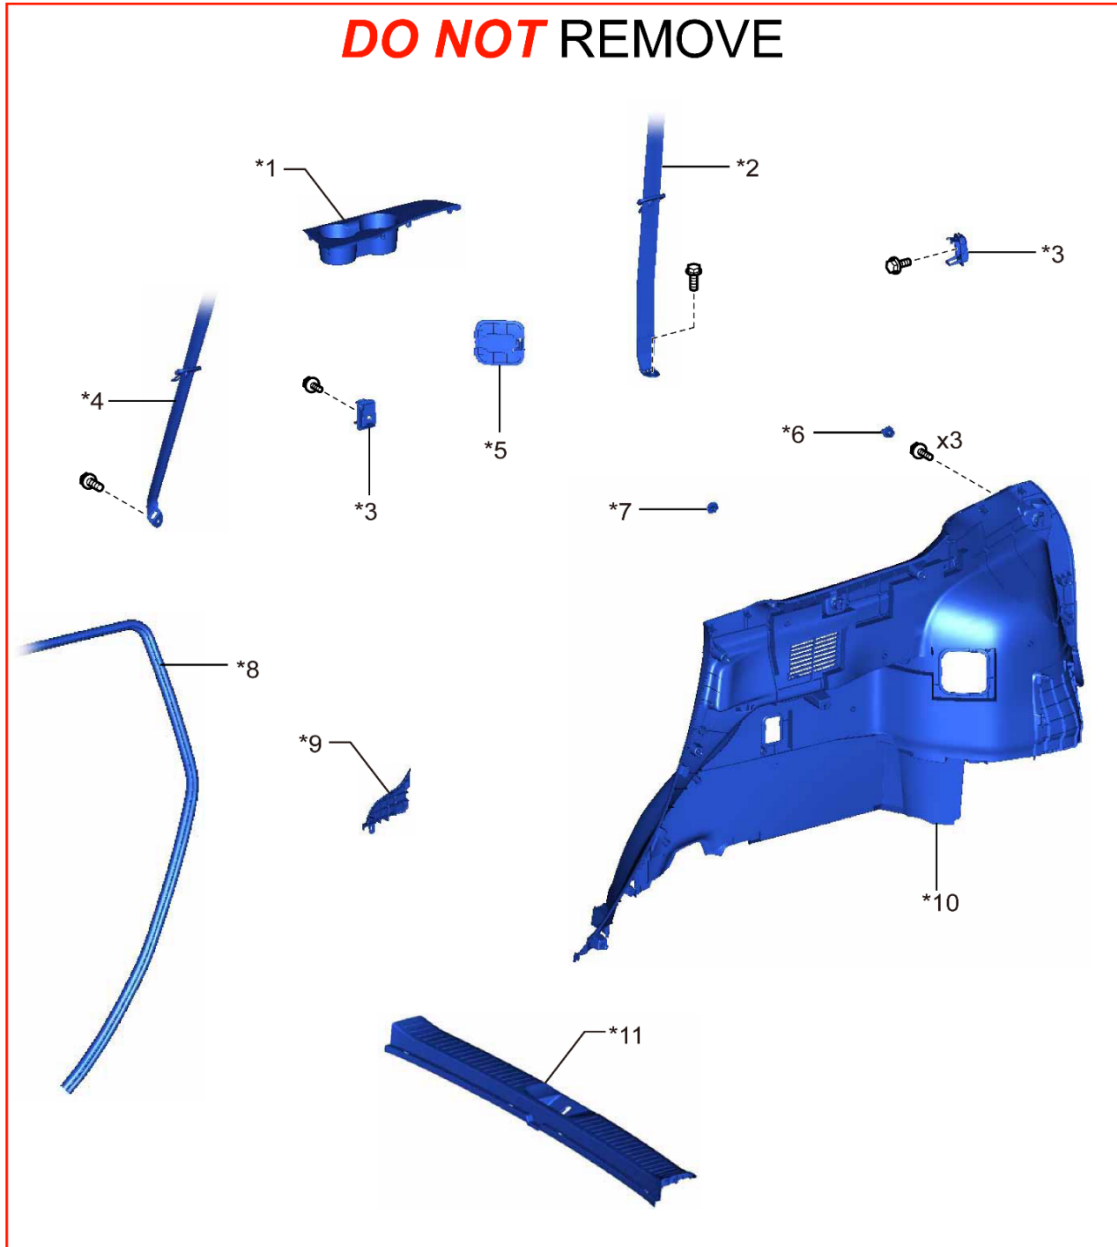
S54079aS

To access the Fuel Tube Assembly on the Highlander, it is not necessary to remove many of the interior Side Panel components as detailed in the Repair Manual. The following diagrams will detail the parts that are NOT NECESSARY to remove.

*1	NO. 2 DECK SIDE TRIM COVER	*2	REAR NO. 2 SEAT OUTER BELT ASSEMBLY LH
*3	ROPE HOOK	*4	REAR NO. 1 SEAT OUTER BELT ASSEMBLY LH
*5	DECK TRIM SIDE SERVICE HOLE COVER	*6	NO. 1 LUGGAGE COMPARTMENT TRIM HOOK
*7	DECK TRIM POCKET COVER	*8	REAR DOOR OPENING TRIM WEATHERSTRIP LH
*9	FRONT DECK SIDE TRIM COVER LH	*10	DECK TRIM SIDE PANEL ASSEMBLY LH
*11	REAR FLOOR FINISH PLATE	-	-

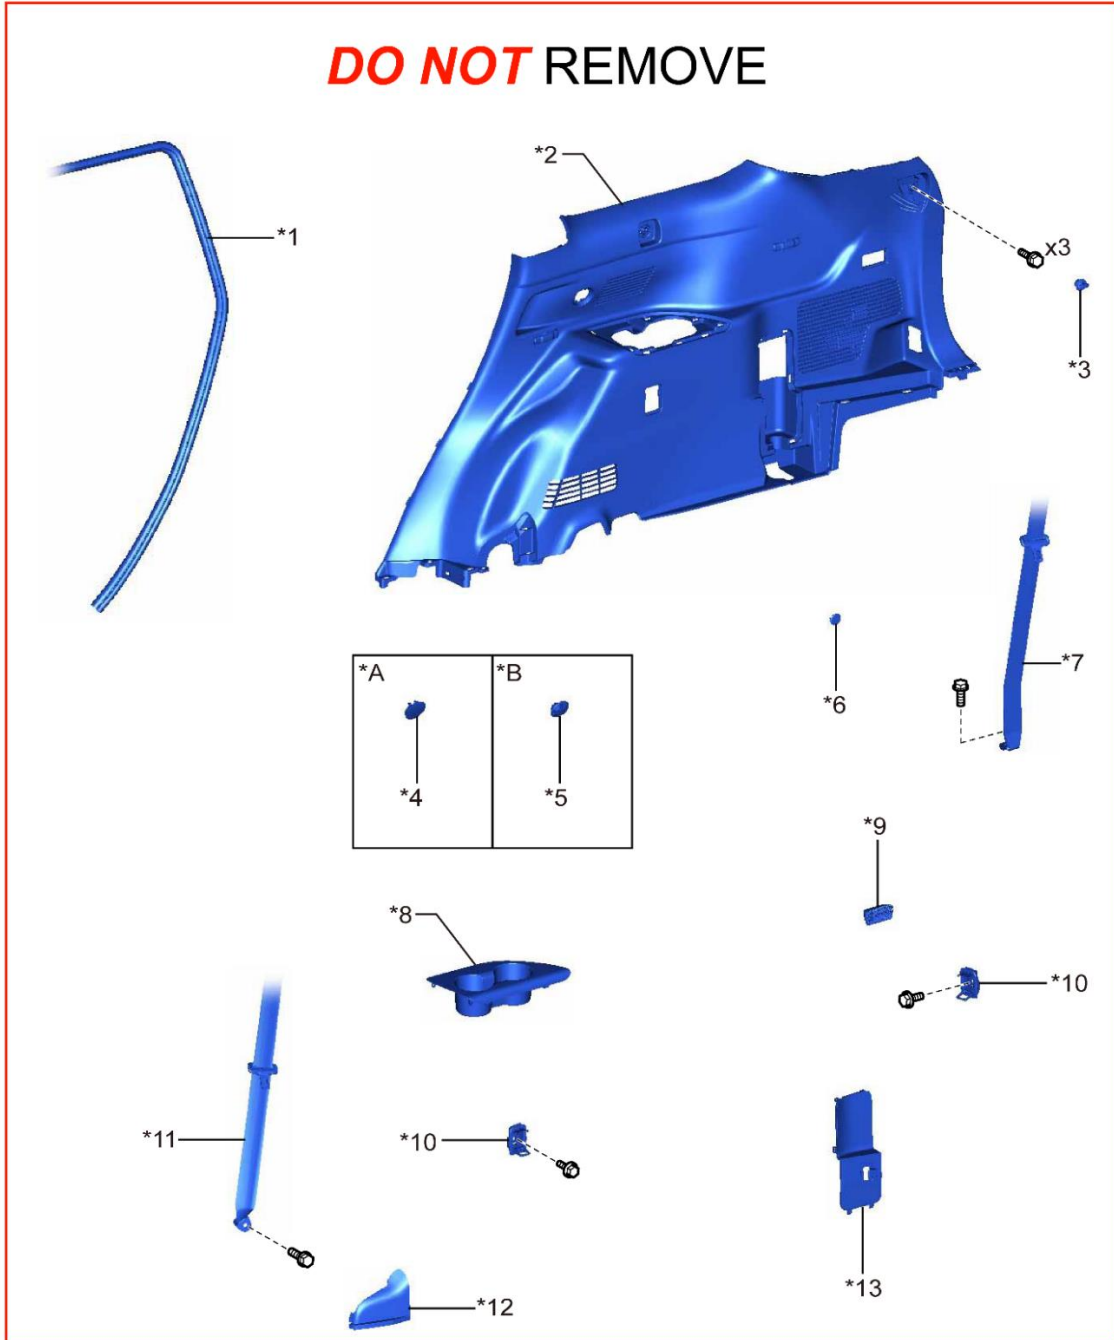
S54080aS

*A	w/o Rear Automatic Air Conditioning System	*B	w/ Rear Automatic Air Conditioning System
*1	REAR DOOR OPENING TRIM WEATHERSTRIP RH	*2	DECK TRIM SIDE PANEL ASSEMBLY RH
*3	NO. 1 LUGGAGE COMPARTMENT TRIM HOOK	*4	SIDE TRIM COVER RH
*5	COOLER (NO. 2 ROOM TEMP. SENSOR) THERMISTOR	*6	DECK TRIM POCKET COVER
*7	REAR NO. 2 SEAT OUTER BELT ASSEMBLY RH	*8	NO. 1 DECK SIDE TRIM COVER
*9	NO. 1 LUGGAGE COMPARTMENT LIGHT ASSEMBLY	*10	ROPE HOOK
*11	REAR NO. 1 SEAT OUTER BELT ASSEMBLY RH	*12	FRONT DECK SIDE TRIM COVER RH
*13	DECK TRIM SIDE BELT HOLE COVER RH	-	-

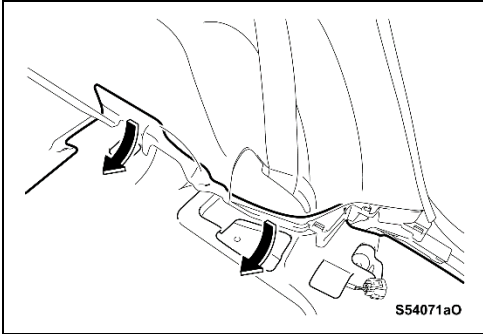
- a. Pull out the front floor carpet from the inside of deck trim side panel as shown in the illustration.

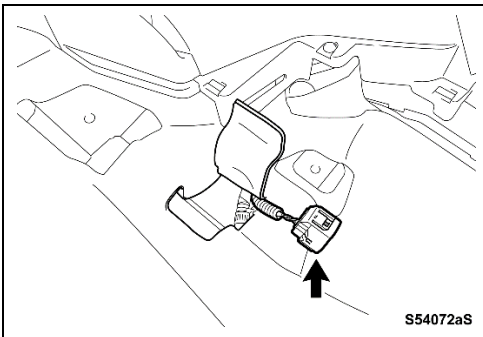
- b. **w/ Rear Seat Heater only:** Push out the harness from the opening of front floor carpet. (Use the same procedures for the LH side and RH side.)

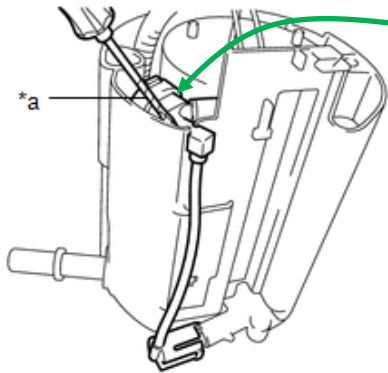
Repair Manual: Using a screwdriver (*a) with its tip wrapped in protective tape, remove the jet pump from the No. 1 fuel sub-tank.

Tube still attached

Replacement O-Ring will be installed in this location

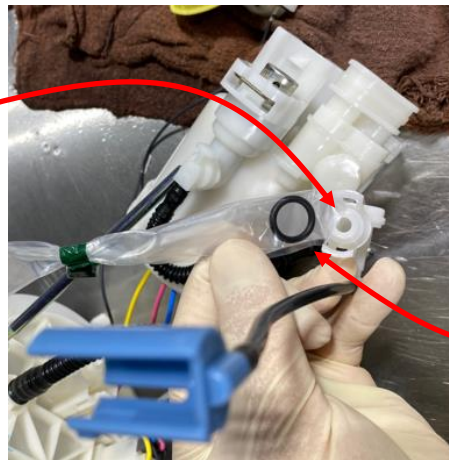
Tube incorrectly removed from jet pump

Replacement O-ring is the incorrect size

DO NOT disconnect the tube from the jet pump

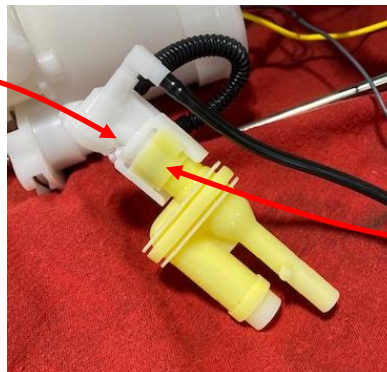
Replacement O-Ring is NOT provided for this location

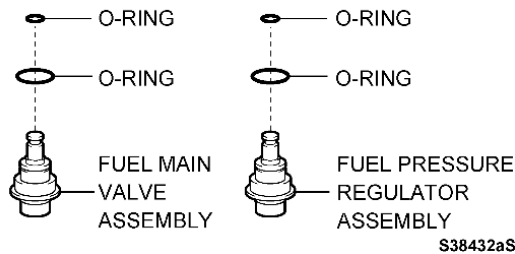
DO NOT remove

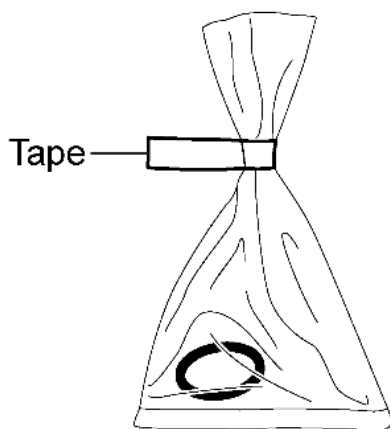
S38058aSU

The part kits may come with O-Rings of different sizes. They are very difficult to tell apart visually. To identify the different size O-Rings, they will be wrapped in individual plastic bags with a piece of **COLORED TAPE** sealing it. The **COLOR OF THE TAPE** will identify the O-Ring size. **REFER TO THE COMPONENT DIAGRAMS TO DETERMINE TO CORRECT O-RING**, as identified by the tape color.

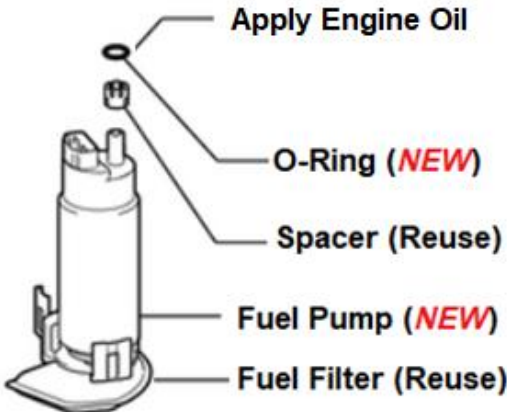
HINT:
The reused filter may be discolored.

- Remove the original O-Ring, Spacer and Fuel Filter from the original Fuel Pump.
- Discard the original O-Ring and Fuel Pump, saving the Spacer and Fuel Filter.
- Install the original Spacer onto the **NEW** Fuel Pump.
- Install the **NEW** O-Ring onto the **NEW** Fuel Pump. Refer to the Component Diagram to determine to proper O-Ring, as identified by the colored tape on the bag.
- Apply a small amount of engine oil to the **NEW** O-Ring to assure correct installation into the Tube Assembly.
- Install the original Fuel Filter onto the **NEW** Fuel Pump.
- Refer to the Components diagrams to review the other **NEW** parts to install.
