### TECHNICAL INSTRUCTIONS FOR SAFETY RECALL 20TA02

#### VEHICLE MAY STALL DURING DRIVING AT HIGHER SPEED

2018 – 2019 Sequoia  
2018 – 2019 Tundra  
2018 – 2019 Corolla

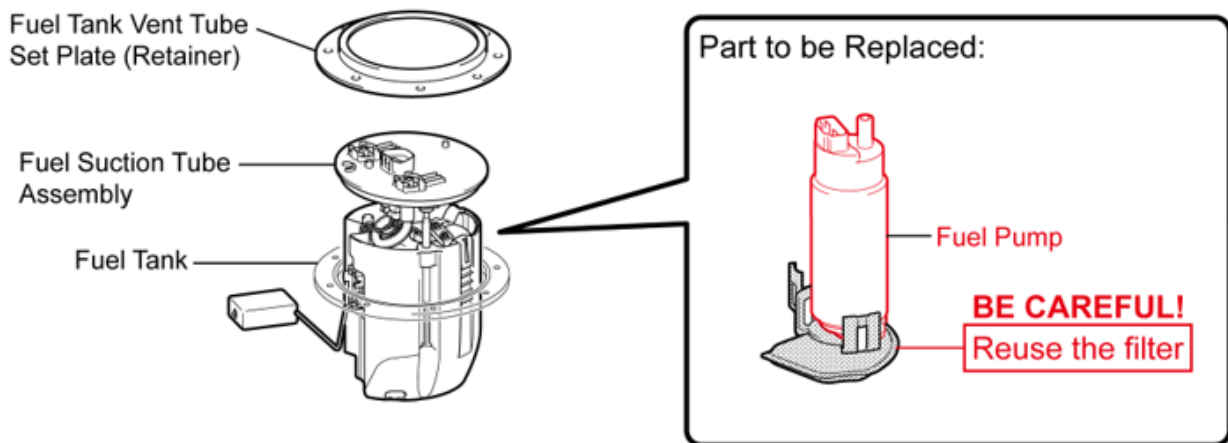
S38182aSU

The subject vehicles are equipped with a low-pressure fuel pump which may stop operating. If this were to occur, warning lights and messages may be displayed on the instrument panel, and the engine may run rough. This may result in a vehicle stall, and the vehicle may be unable to be restarted. If a vehicle stall occurs while driving at higher speeds, this could increase the risk of a crash.

\*The configuration of the parts will differ depending on the specification.

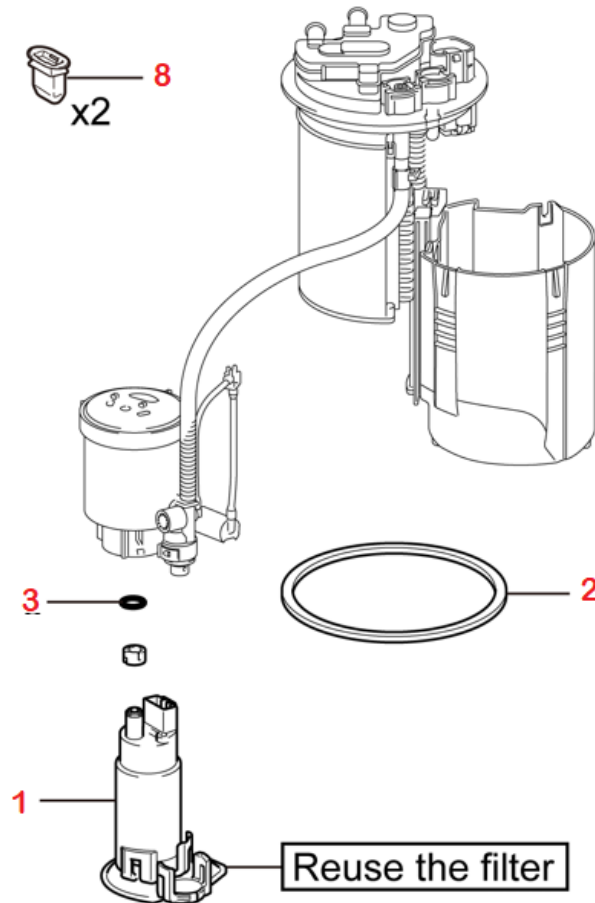
**AVALON 2019**

Replacement items in red

No.	Contents of Part Kit's	Quantity	Tape Color	Remarks
1	FUEL PUMP	1		
2	FUEL SUCTION TUBE SET GASKET	1		
3	O-RING	2*	Gold	15.2mm
4	REAR SEAT CUSHION LOCK HOOK (included in the gasket kit)	2		Not used
5	O-RING	1	Red	Not used
6	O-RING	1	Green	Not used
7	FUEL TANK PIPE SETTING HOLDER	1	White	Not used
8	REAR SEAT CUSHION LOCK HOOK (part # 04009-95106)	2

\*only 1 O-Ring will be used. Discard the 2<sup>nd</sup> O-Ring.

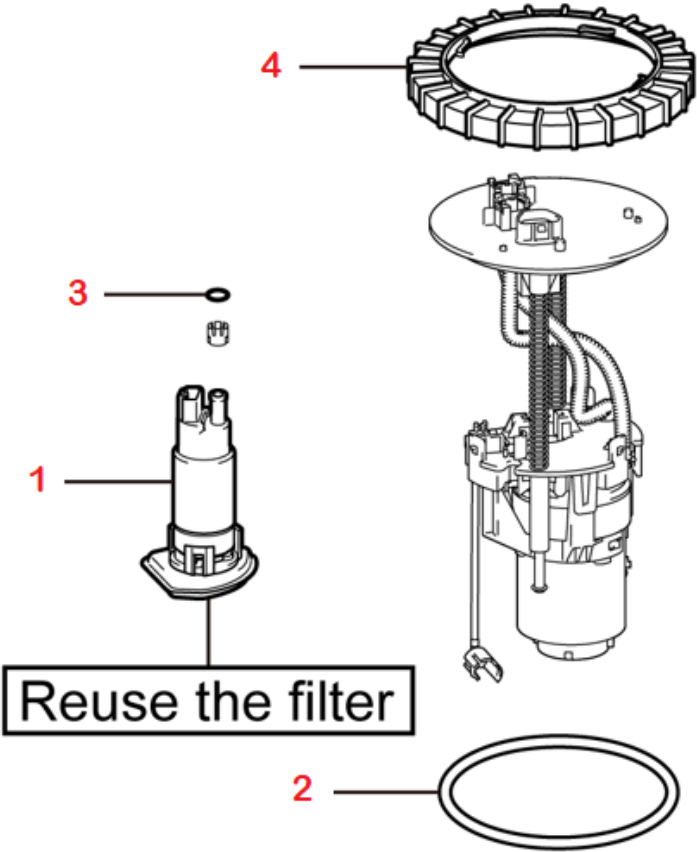
FJ CRUISER

Replacement items in red

No.	Contents of Part Kit's	Quantity	Tape Color	Remarks
1	FUEL PUMP	1		
2	FUEL SUCTION TUBE SET GASKET	1		
3	O-RING	1	Yellow	15.2mm
4	FUEL PUMP GAUGE RETAINER	1

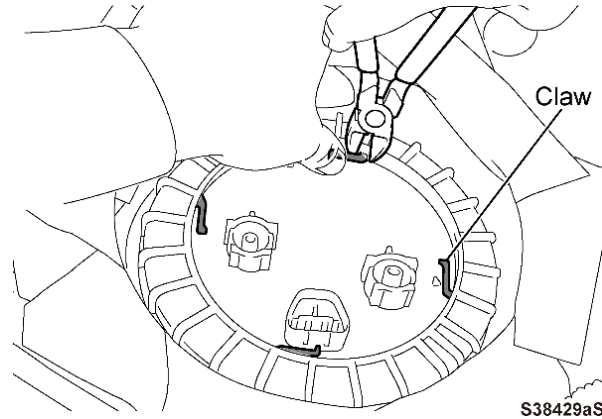
If removing the Plastic Ring type retainers, cut the 4 internal claws to prevent the Fuel Tube assembly from rotating during removal. This could cause damage to the fuel level sender, fuel tank, or fuel tube assembly.

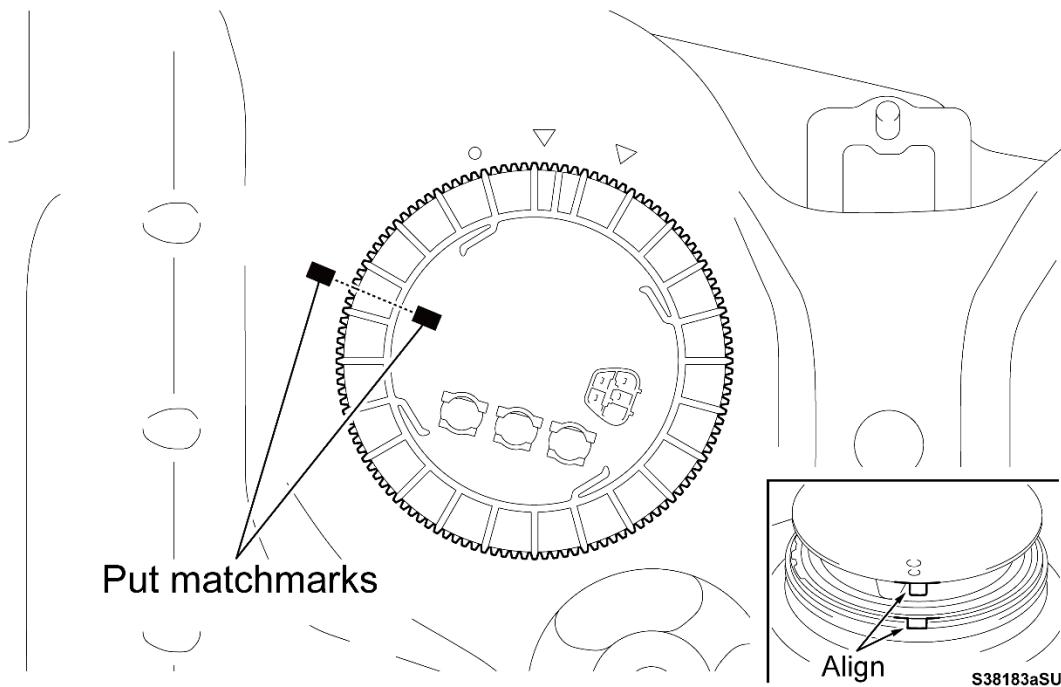
For vehicles with the plastic retainer rings, place matchmarks on both the Fuel Tube Assembly and the fuel tank. During disassembly, confirm that the Fuel Tube Assembly does not rotate. During reassembly, this will aid in aligning the locating tabs for proper installation.

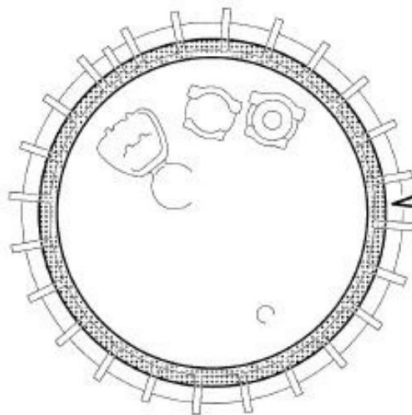
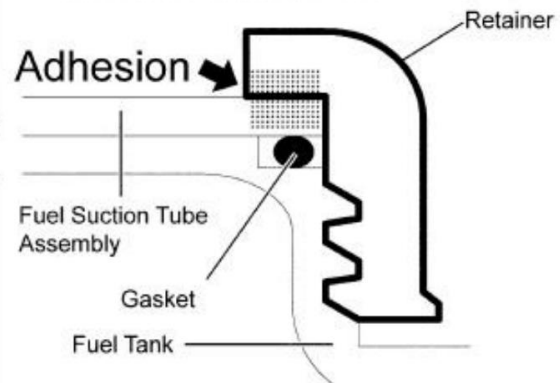
[Retainer Adhesion]

The damage during disassembly is caused by adhesion, or “sticking”, of the Retainer Ring and the Fuel Tube Assembly. When the Retainer Ring is rotated on the stationary Fuel Tube assembly, the portions that are “stuck” together are under a very high load and may break off.

[Cross sectional view]

Entire inner circumference of retainer is adhered

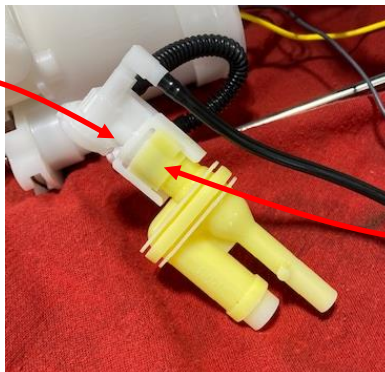
#### Example of Incorrect Disassembly:

Tube incorrectly removed from jet pump

Replacement O-ring is the incorrect size

DO NOT disconnect the tube from the jet pump

Replacement O-Ring is NOT provided for this location

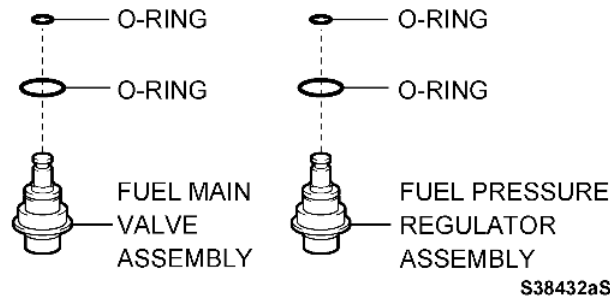
### DO NOT remove

When replacing the fuel pump, it is not necessary to remove the Fuel Main Valve or Fuel Pressure Regulator. These O-Rings are NOT included in the parts kit.

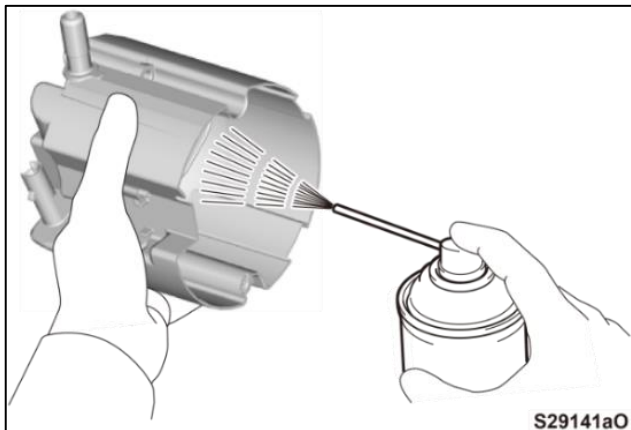
- a. Using brake cleaner, clean the sub-tank assembly.

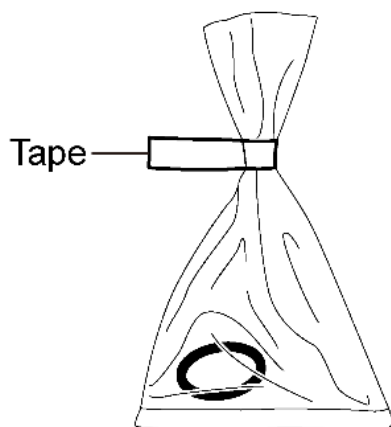
S38058aSU

The part kits may come with O-Rings of different sizes. They are very difficult to tell apart visually. To identify the different size O-Rings, they will be wrapped in individual plastic bags with a piece of **COLORED TAPE** sealing it. The **COLOR OF THE TAPE** will identify the O-Ring size. **REFER TO THE COMPONENT DIAGRAMS TO DETERMINE TO CORRECT O-RING**, as identified by the tape color.

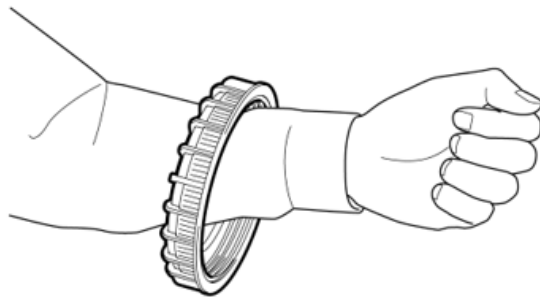
S38184aSU

Put the retainer around the  
arm so that it is not necessary  
to change hands to keep  
pressing down the fuel  
suction tube.  
(Plastic Retainer)

Keep pressing down the fuel suction  
tube while installing the retainer.
