October 1, 2020

Version 1

Safety Recall: Driver's Frontal Airbag Inflator (NADI-Factory Installed)

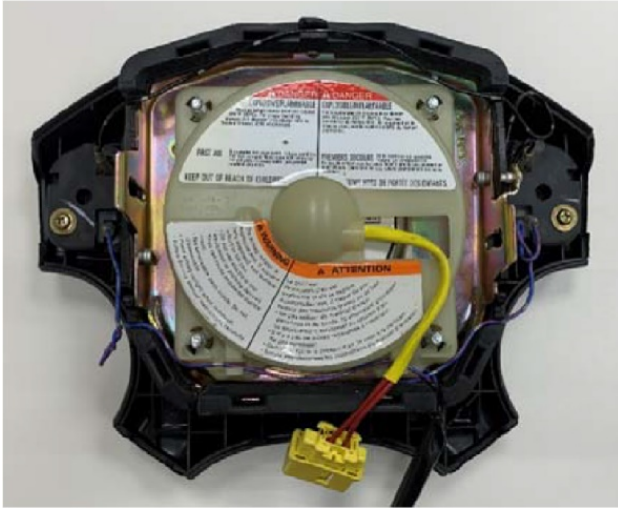
With Cover

- To successfully complete this inspection and verification procedure, be sure to use the V-SMART tool along with the following steps in this bulletin.
 - Before using the tool, review the job aid *Using V-SMART for NADI Recalls*. Keep in mind there is another job aid called *Using V-SMART*, but be sure not to use it. It does not include NADI Recall information.
6. Check if the airbag module has a plastic inflator cover.

- If it does, go to step 7.
- If it does not, go to step 10.

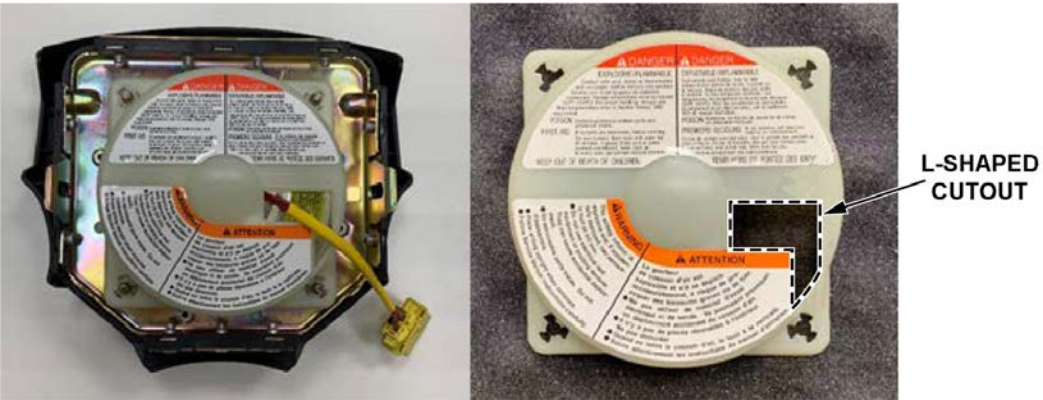
- **Inflator cover Type 2** has an L-shaped cutout at the right side of the cover.

- If the inflator cover is **Type 1** or **2**, go to step 8.
- If the inflator cover is **Type 3**, this campaign does not apply. Go to step 23 to complete the V-SMART procedure and install the airbag module.

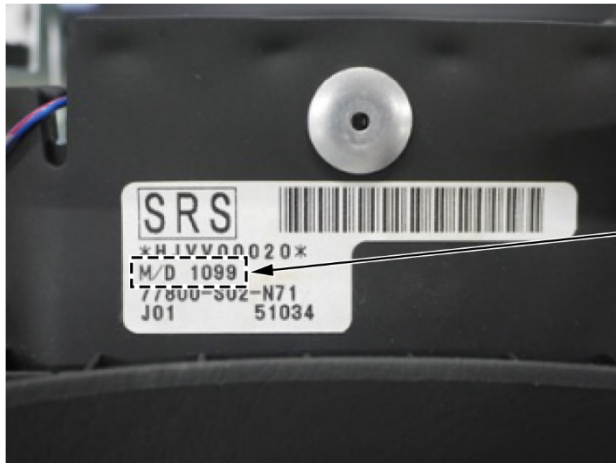
11. Check the **M/D** number on the airbag module serial number label.

Check the last two M/D numbers.

- If the last two numbers are **95, 96, 97, 98, or 99**, go to step 12.
- If the label is missing, or is unreadable, go to step 12.

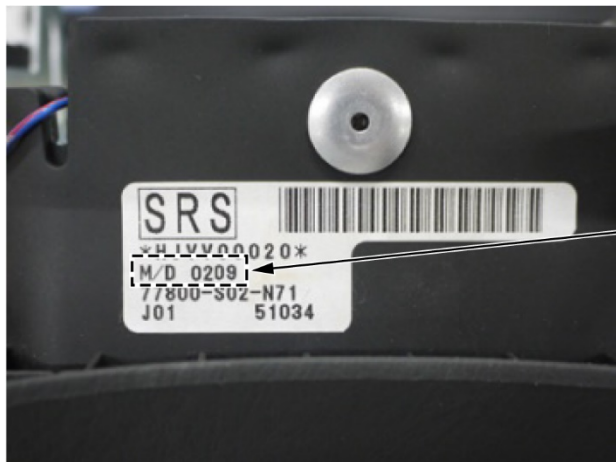
Check the last two M/D numbers.

- If the last two numbers are **not 95, 96, 97, 98, or 99**, this campaign does not apply. Go to step 23 to complete the V-SMART procedure and install the airbag module.

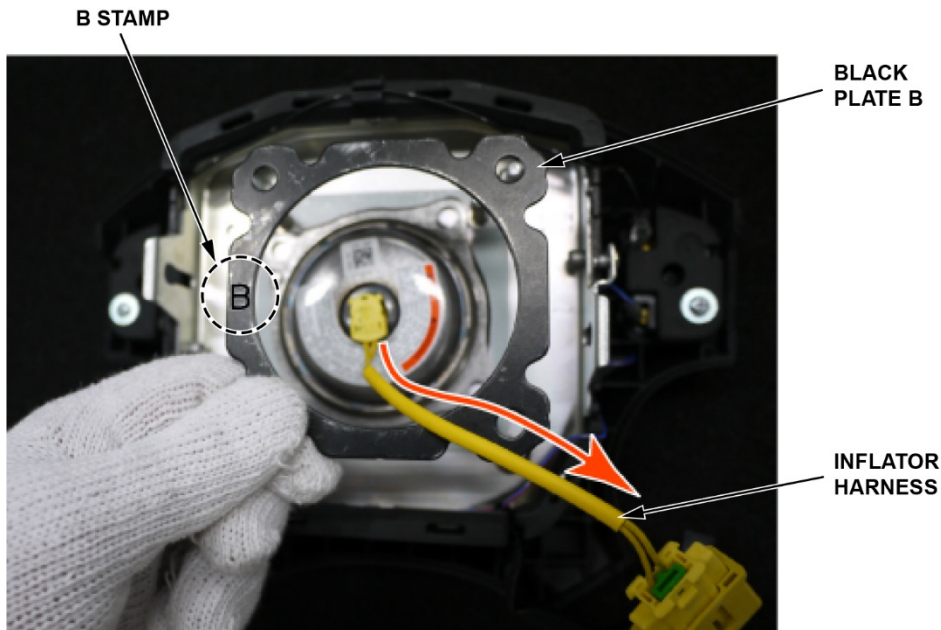
Black plate B may have scuffs and paint peeling that occurred during packaging. There is nothing wrong with it.

17. Make sure the **B** stamp on black plate B is positioned on the left side. Then, pass the inflator harness through the opening.

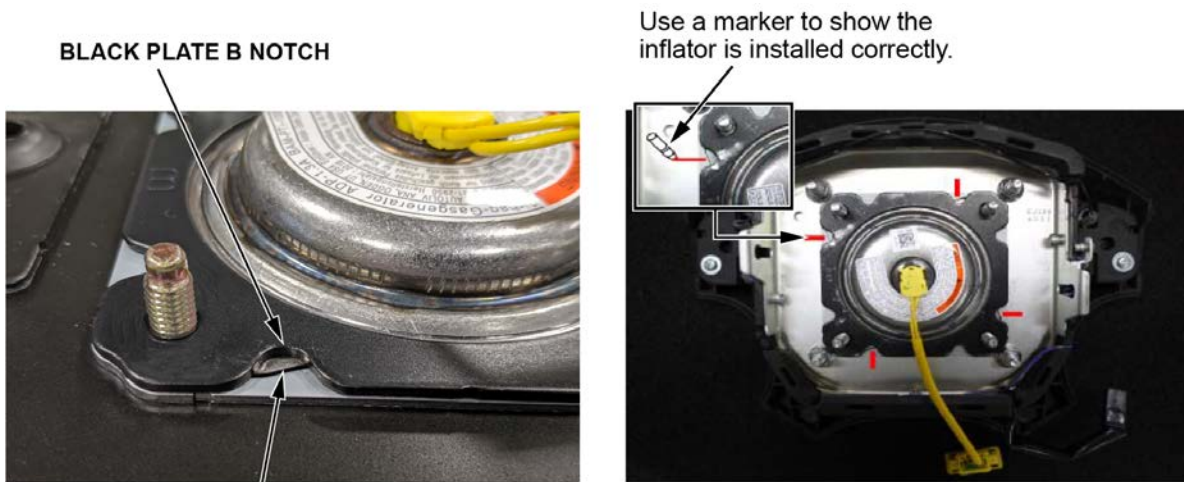
NOTE: Make sure the inflator is within the opening of silver plate A and they are not overlapping. Check all four notches on black plate B carefully.

19. Make sure the inflator is installed correctly by checking the four notches on black plate B. The inflator should be within the opening of silver plate A, and not overlapping. Using a marker, mark each of the four notches after you made sure it is installed correctly. If the inflator is not installed correctly, go back to step 16.
