Safety Recall: Driver's Frontal Airbag Inflator (NADI-Factory Installed)

AFFECTED VEHICLES

BACKGROUND

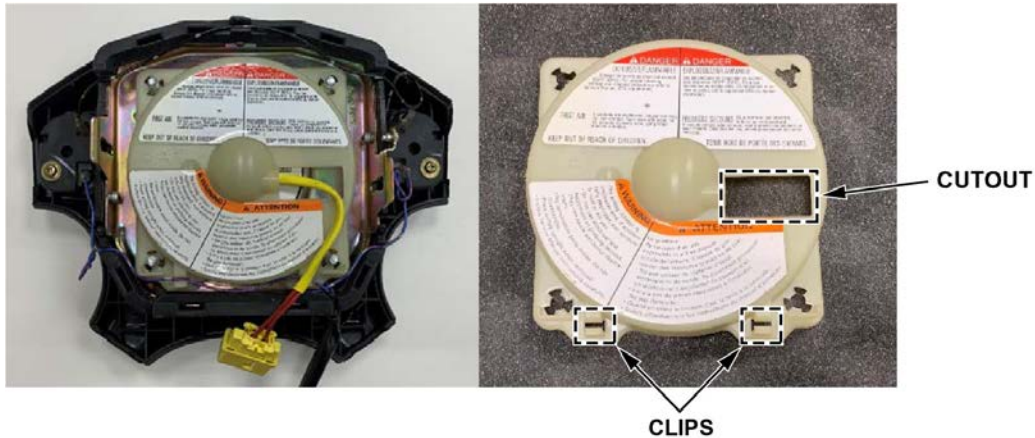
- **Inflator cover Type 1** has a cutout on the right side of the cover, and two clips at the bottom of the cover that holds the horn wire.

- If the inflator cover is **Type 1** or **2**, go to step 8.
- If the inflator cover is **Type 3**, this campaign does not apply. Go to step 23 to complete the V-SMART procedure and install the airbag module.

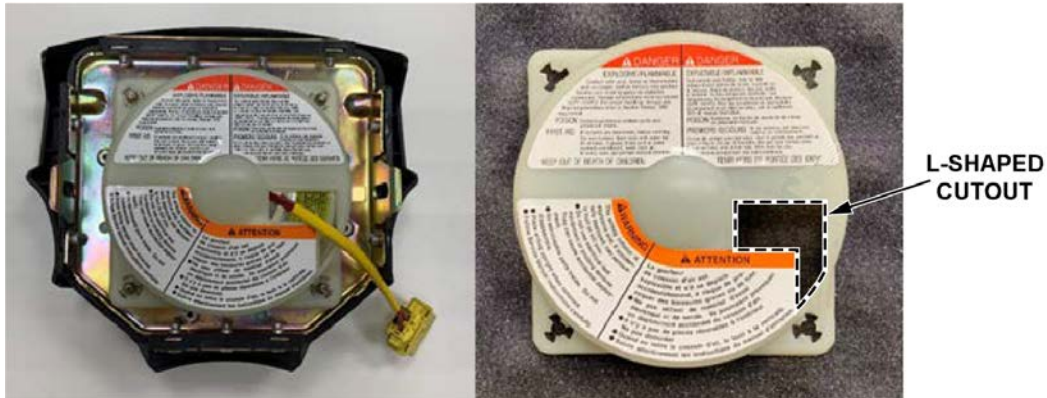
- **Inflator cover Type 2** has an L-shaped cutout at the right side of the cover.

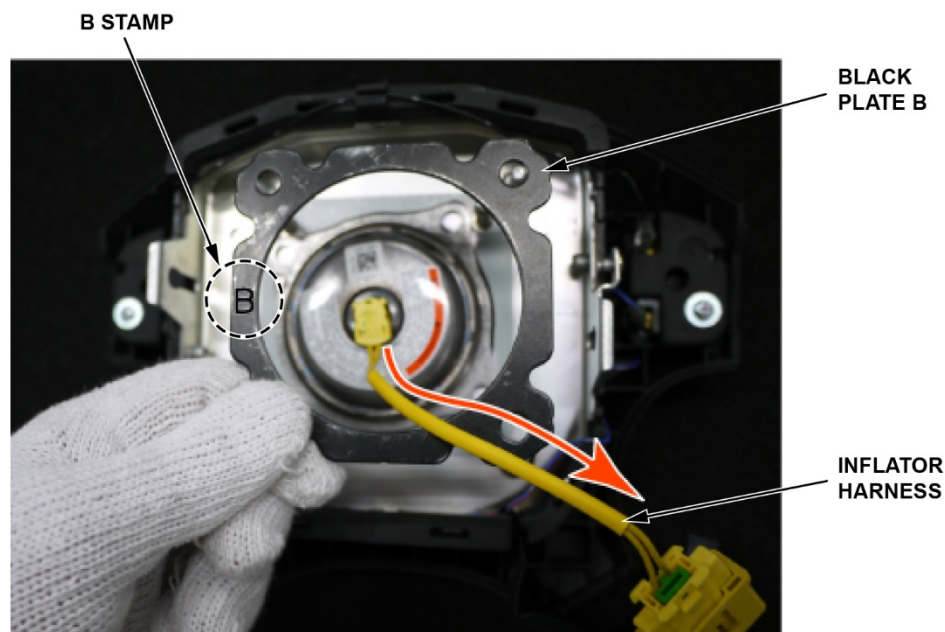
17. Make sure the **B** stamp on black plate B is positioned on the left side. Then, pass the inflator harness through the opening.

Black plate B may have scuffs and paint peeling that occurred during packaging. There is nothing wrong with it.
