October 1, 2020

Version 1

Safety Recall: Driver's Frontal Airbag Inflator (NADI-Service Part)

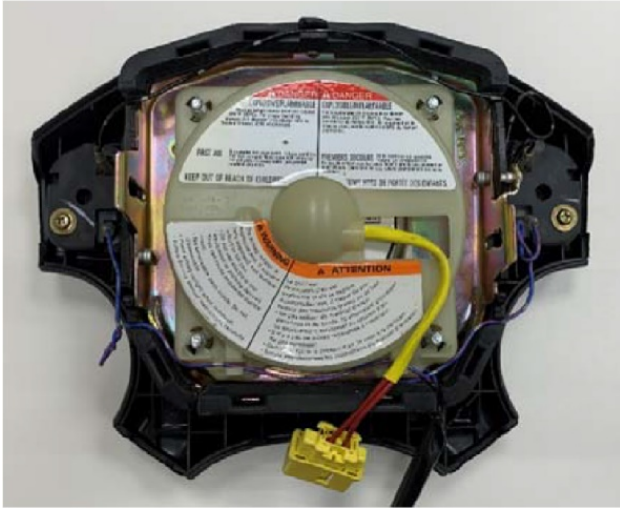
With Cover

- To successfully complete this inspection and verification procedure, be sure to use the V-SMART tool along with the following steps in this bulletin.
 - Before using the tool, review the job aid *Using V-SMART for NADI Recalls*. Keep in mind there is another job aid called *Using V-SMART*, but be sure not to use it. It does not include NADI Recall information.
6. Check if the airbag module has a plastic inflator cover.

- If it does, go to step 7.
- If it does not, go to step 10.

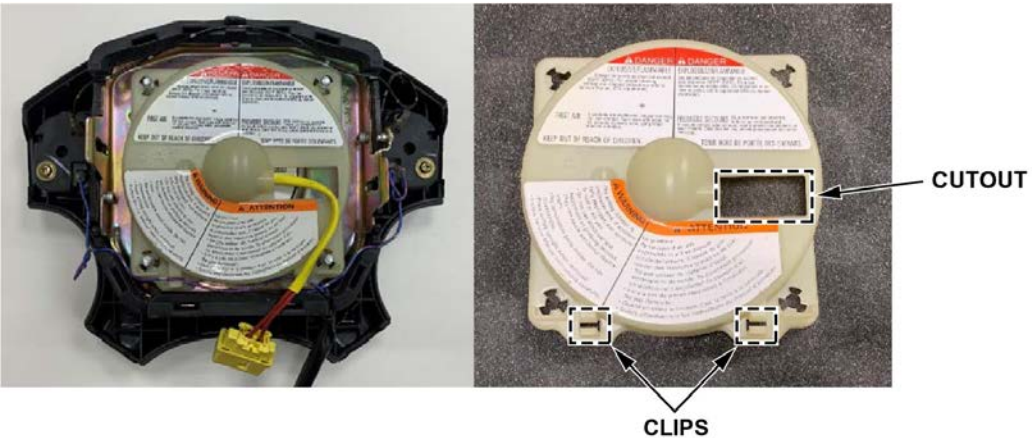
- **Inflator cover Type 1** has a cutout on the right side of the cover, and two clips at the bottom of the cover that holds the horn wire.

- If the inflator cover is **Type 1** or **2**, go to step 8.
- If the inflator cover is **Type 3**, this campaign does not apply. Go to step 23 to complete the V-SMART procedure and install the airbag module.

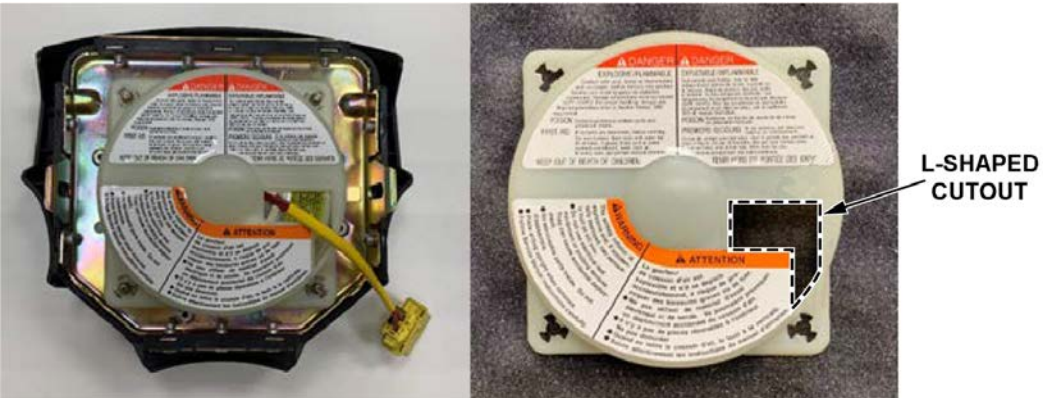
- **Inflator cover Type 2** has an L-shaped cutout at the right side of the cover.

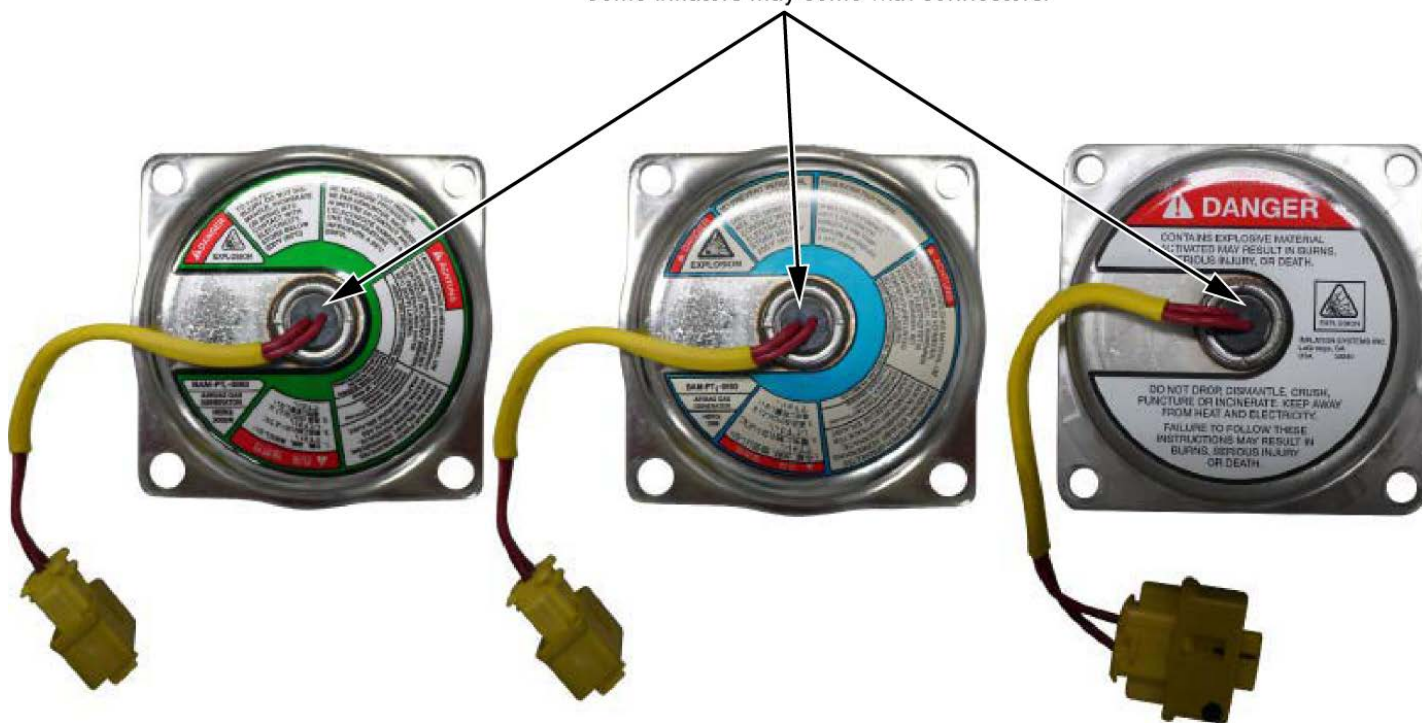
10. Compare the inflator label to the inflator labels shown below.

Some inflator harnesses may be connected to the inflator with a connector and not by epoxy as shown below.

Inflators with epoxy shown.
Some inflators may come with connectors.

- If the inflator label matches one of the inflators shown, go to step 11.
- If the inflator label does not match any of the inflators shown, this campaign does not apply. Go to step 23 to complete the V-SMART procedure and install the airbag module.

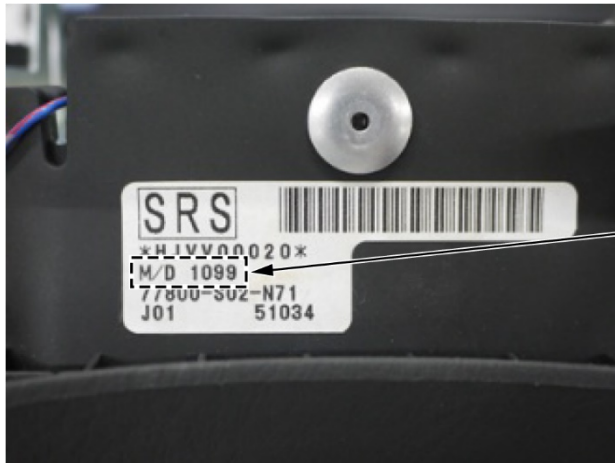
11. Check the **M/D** number on the airbag module serial number label.

- If the last two numbers **are 95, 96, 97, 98, or 99**, go to step 12.
- If the label is missing, or is unreadable, go to step 12.

Check the last two
M/D numbers.

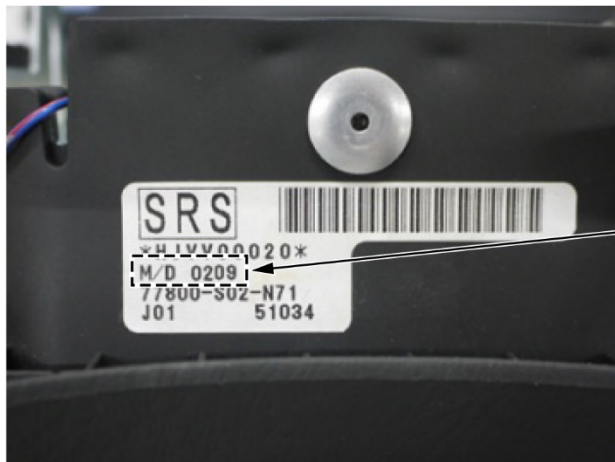
- If the last two numbers **are not 95, 96, 97, 98, or 99**, this campaign does not apply. Go to step 23 to complete the V-SMART procedure and install the airbag module.

Check the last two
M/D numbers.

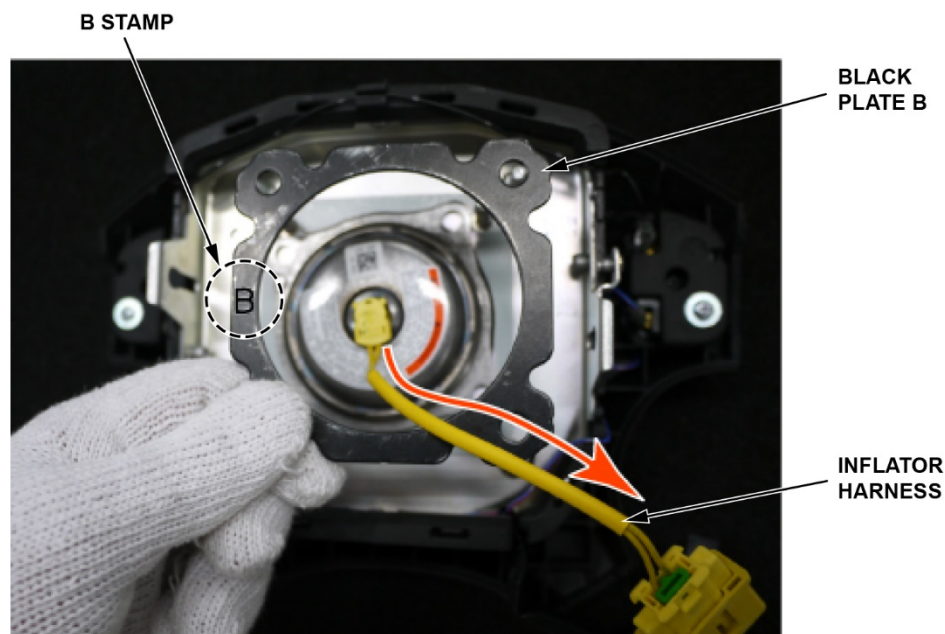
17. Make sure the **B** stamp on black plate B is positioned on the left side. Then, pass the inflator harness through the opening.

Black plate B may have scuffs and paint peeling that occurred during packaging. There is nothing wrong with it.
