## Safety Recall: Driver's Frontal Airbag Inflator (NADI-Service Part)

Supersedes 20-074, dated October 1, 2020, to revise the information highlighted in yellow

Certain vehicles may have had the original driver's airbag module replaced with one that was equipped with a Takata Non-Azide Driver's airbag Inflator (NADI) that may contain an aluminum seal that could allow moisture to enter into the inflator. If the propellant in the inflator absorbs a large amount of moisture, the airbag may deploy slowly. If the propellant degrades due to drying or other factors, excessive internal pressure may be generated in the inflator during deployment, which may cause the inflator container to rupture.

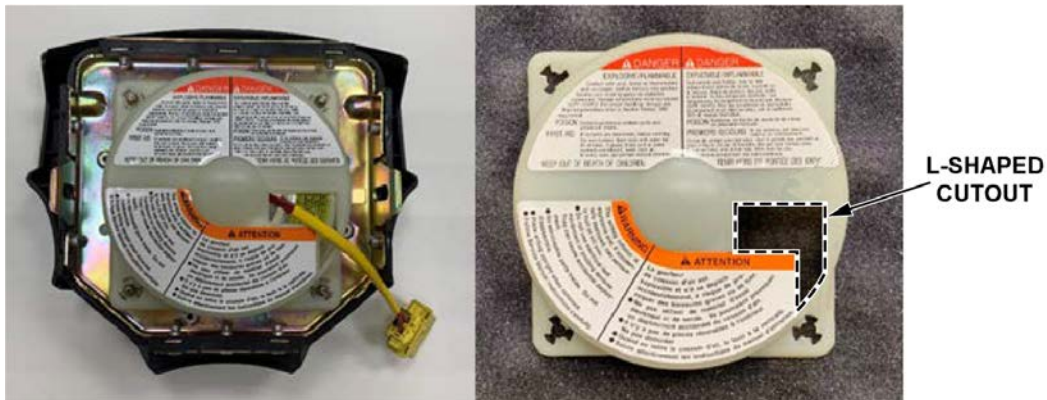
- **Inflator cover Type 2** has an L-shaped cutout at the right side of the cover.

- If the inflator cover is **Type 1** or **2**, go to step 8.
- If the inflator cover is **Type 3**, this campaign does not apply. Go to step 23 to complete the V-SMART procedure and install the airbag module.

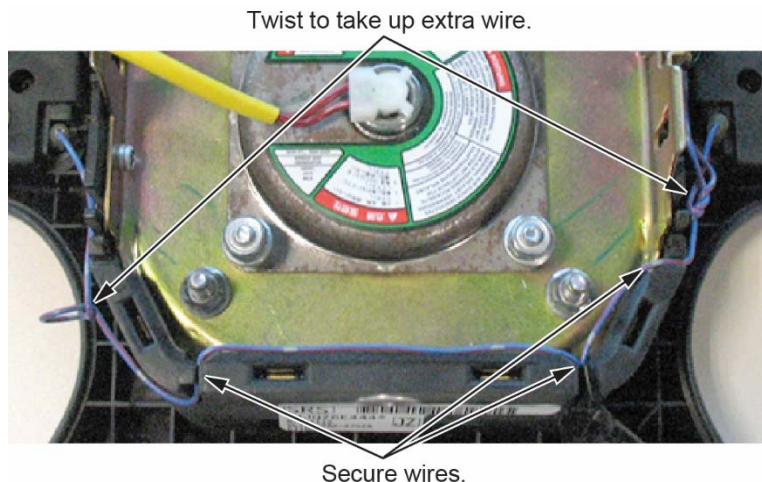
8. Remove the inflator cover (if equipped), and throw it away.
9. *Type 1 cover only:* Route the horn harness through the airbag module slot, and secure it. Then, twist any excess wire, and tuck it out of the way.
