TECHNICAL INSTRUCTIONS

SAFETY RECALL 20TA04

**CERTAIN ENGINE BLOCKS CAN CAUSE ENGINE FAILURE LEADING TO
ENGINE STALL (non-hybrid) and/or FIRE RISK**

CERTAIN 2020 AVALON HV

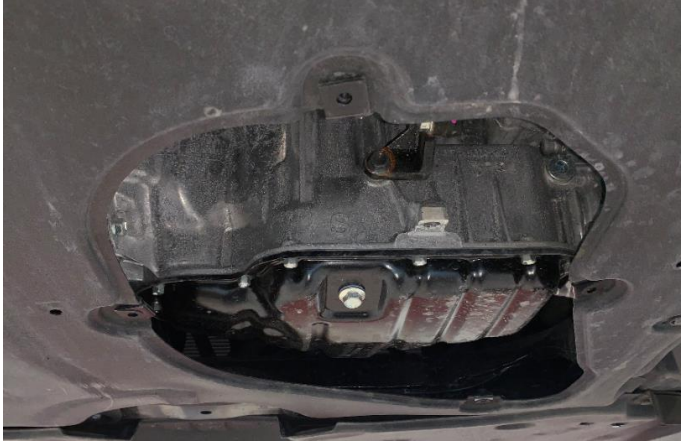
1. REMOVE CENTER No. 4 ENGINE UNDER COVER

- Raise the car on a lift to gain access to the bottom of the vehicle.
- Remove the 4 screws to remove the Center No. 4 Engine Under Cover below the engine oil pan.

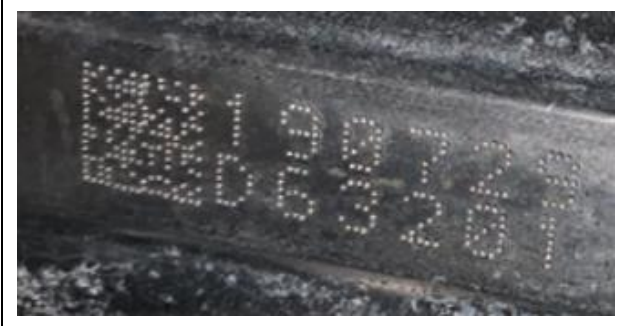
3. TAKE A PHOTO OF THE BLOCK ID No.

- a. Use a digital camera to take a photo of the Block ID No. Be sure to place the camera as straight and level as possible to the surface of the stamping.

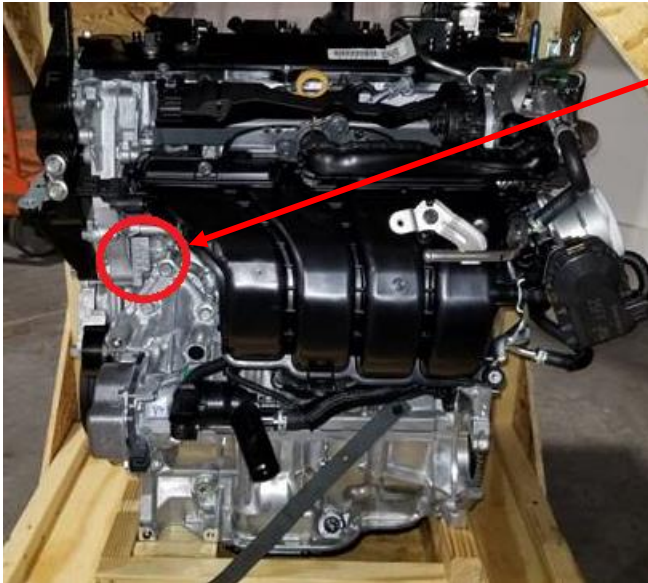
Engine Serial Number location

Example:
G052976A25A
