SIB 32 01 20

RECALL CAMPAIGN 20V-083: THROTTLE CABLE

E-Series	Model Description
K09	C 400 X

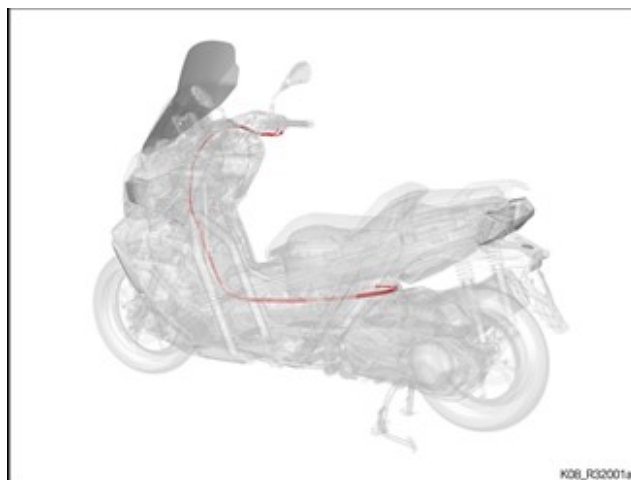
Figure 1: Routing of throttle cable

The position of the throttle cable may cause an accumulation of water in the throttle cable sleeves that will not drain when riding in the rain for an extended period of time or when thoroughly cleaning the bike.

When riding in outside temperatures below freezing, this can lead to stiff movement up to the complete freezing of the throttle cables, and lead to a critical riding situation.

1. Perform the **TEMPORARY** conversion of the throttle cables as described in the attached repair instruction 00 60 360 "Reworking the accelerator cables and throttle grip".
2. Inform the customer about the circumstance, and not to wash the vehicle intensively in the area of the throttle grip.
