Smoke Detector location Recall

Description

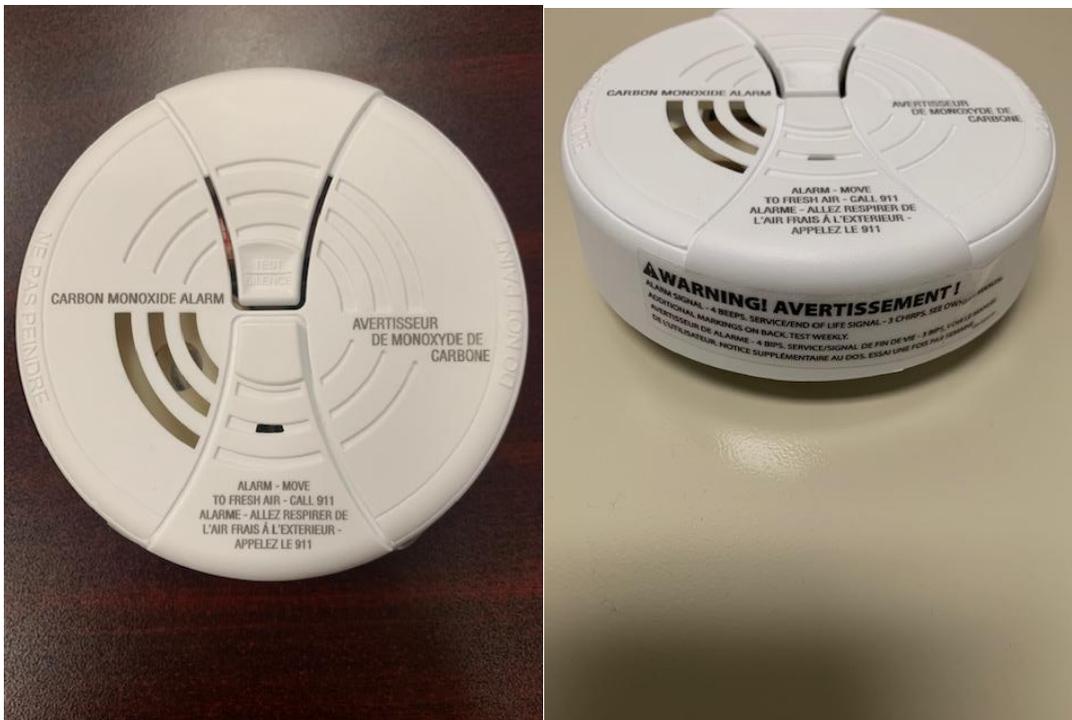
The pictures above show the C/O detector which should be located in the bedroom if the unit is not equipped with the combination LP-C/O detector. The C/O detector has gray lettering that says, “Carbon Monoxide Alarm” on the face and a warning sticker located on the side.

On certain fifth wheel trailers the smoke detector may not have been properly located inside of the bedroom area. If the unit has a C/O detector and smoke detector please verify that the smoke detector is NOT located in the bedroom. If the smoke detector is in the bedroom it needs to be switched with the C/O detector located at the top of the stairs. If the unit is equipped with a combination LP-C/O detector and switching the smoke detector is not an option then an additional smoke alarm needs to be installed in the main body of the unit. Please see pictures below to show the difference between the C/O detector and smoke detector.

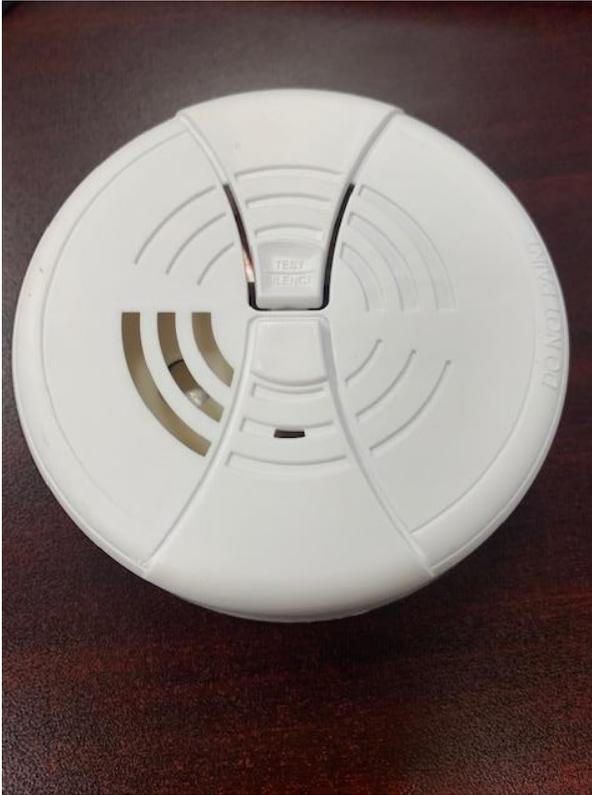
Pictured below is the smoke detector which has no gray lettering written on it. The smoke detector needs to be located in the main body of the unit.

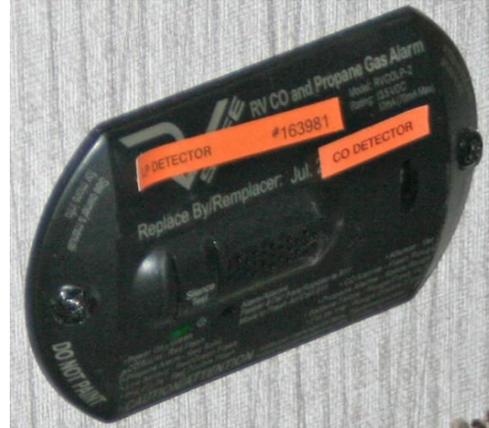
Unit will not have a separate C/O detector (pictured on 1st page) if it has this style LP-C/O detector (pictured above) in the unit. Units with this style LP-C/O detector cannot have the C/O and smoke detector switched and will require that an additional smoke detector be installed in the main body of the unit, if the smoke detector is located in the bedroom.
