SERVICE BULLETIN

SVC2020-083

**PRODUCT
SAFETY
RECALL**

**BC1500 Wheel and Tire
Assembly Replacement Kit
(IK00-3922)**

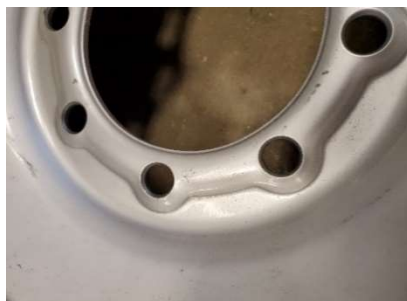
Defective Supplier Wheel
Improper Lug Nut Seat
and Potential Cracks
 Identified by continuously raised lug nut surface

- have an incorrect lug nut contact area causing wheel lug nuts to loosen; and/or
- can develop possible cracks causing the tire to lose air pressure.

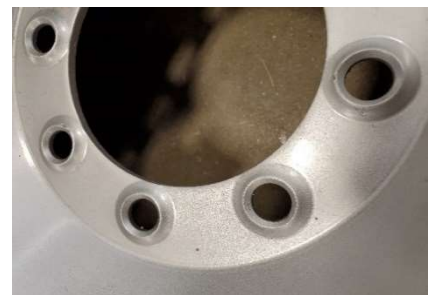
Properly Manufactured Wheel
Correct Lug Nut Seat
 Identified by raised surface only around lug nut location

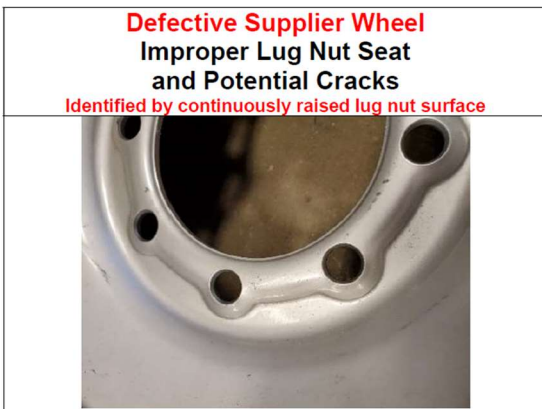
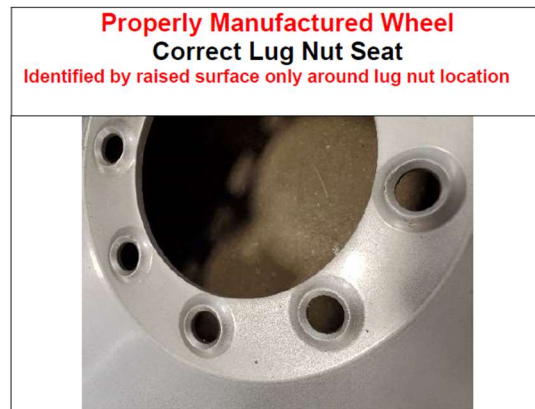
- have an incorrect lug nut contact area causing the wheel lug nuts to loosen; and/or
- can develop possible cracks causing the tire to lose air pressure.

Both conditions may increase the risk of wheel loss and the risk of a crash. **Death or serious injury** is possible. Property damage may also occur.

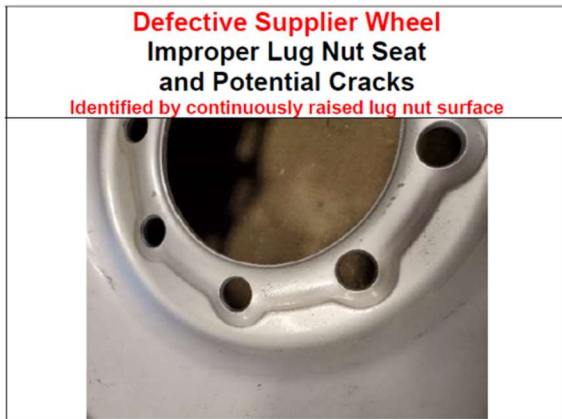
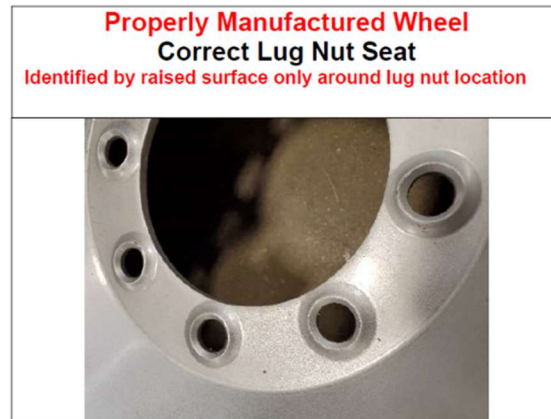
- have an incorrect lug nut contact area causing the wheel lug nuts to loosen; and/or
- can develop possible cracks causing the tire to lose air pressure.

Both conditions may increase the risk of wheel loss and the risk of a crash. **Death or serious injury** is possible. Property damage may also occur.

1. **WHEEL AND LUG NUT INSPECTION.** **Inspect** each brush chipper wheel by referencing the photos to identify if defective supplier wheels are installed. If you own more than one affected brush chipper, you will receive a letter for each machine. The Model and VIN is shown on the top left corner of this letter and the

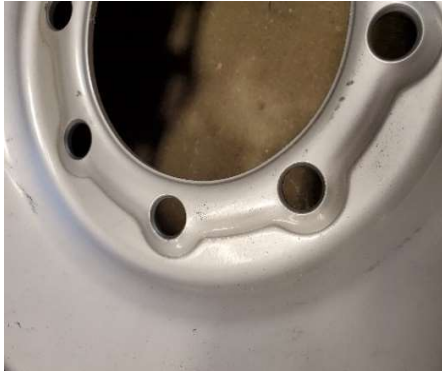
Defective Supplier Wheel

**Improper Lug Nut Seat
and Potential Cracks**

Identified by continuously raised lug nut surface

- 1) If **defective wheels are installed** (left photo above),
- 2) Contact your local Vermeer dealer immediately to arrange installation of IK00-3922 Wheel and Tire Assembly Replacement Kit.
- 3) Prior to having this field remedy kit installed,
 - a) **If one or more lug nut is missing or loose**, using a calibrated torque wrench, torque to 210 ft-lb (285 Nm).
 - b) **Tire Pressure.** If their pressure is not at 80 psi (550 kPa), the wheel may have a crack. The crack may not be visible
 - c) **Verify torque** on each lug nut [210 ft-lb (285 Nm)] and **tire pressure** [80 psi (550 kPa)] **as part of your pre-trip inspection every day or at a minimum every 150 miles (250 km)** until IK00-3922: Wheel and Tire Assembly Replacement Kit is installed by your Vermeer dealer.
- 4) **Do not** tow the brush chipper without all lug nuts properly installed or with low tire pressure.

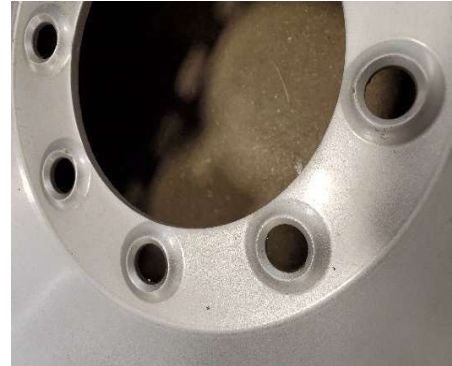
Properly Manufactured Wheel

Correct Lug Nut Seat

Identified by raised surface only around lug nut location

If **properly manufactured wheels are installed** (right photo on above), take photos of **each** wheel, **complete and return Page 2 of this Wheel and Lug Nut Inspection form and photos** to: safetyform@vermeer.com. Vermeer Corporation will record in its records that your brush chipper is not affected by this product safety recall and mail a Vermeer Parts Certificate for \$50.00 USD redeemable at your local Vermeer dealer.
