Mercedes-Benz

Campaign No. 2020070005, August 2020

SUBJECT: **Model G-Class vehicles (463 platform)**
Model Year 2019-2020
Check Differential Locking System

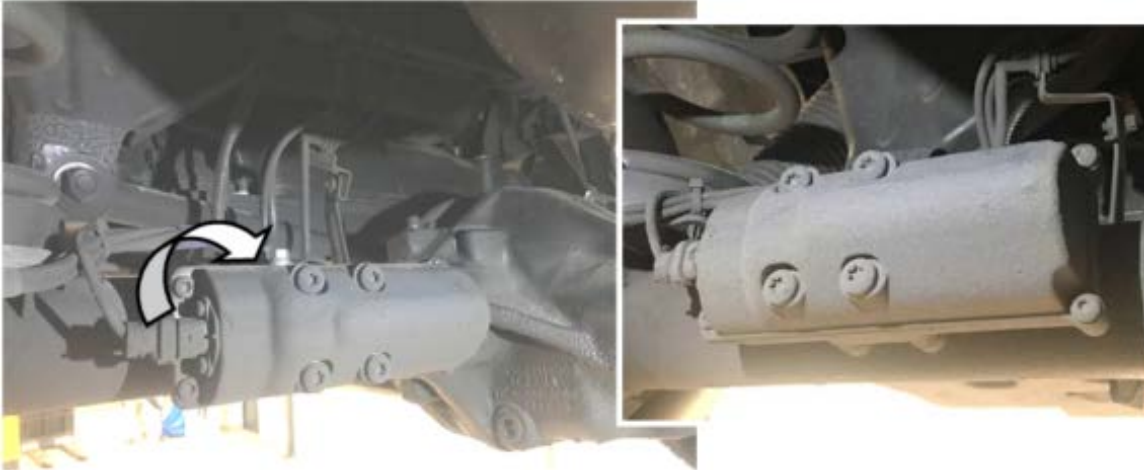
Figure 2

3. Check part number at top at actuator of differential lock of **rear axle** using a mirror (**Figure 2**).

i No actuator with the part number **A 463 906 34 01** may be installed.

i If part number of actuator at rear axle cannot be read off due to undercoat / paint coat or parts sticker is no longer legible, the actuator will be replaced.

- a. Part number **illegible** or **corresponds to A 463 906 33 01** and/or **A 463 906 34 01**: Perform **work procedure**.
- b. Part number does **NOT** correspond to **A 463 906 33 01** and does **NOT** correspond to **A 463 906 34 01**: **End measure**.

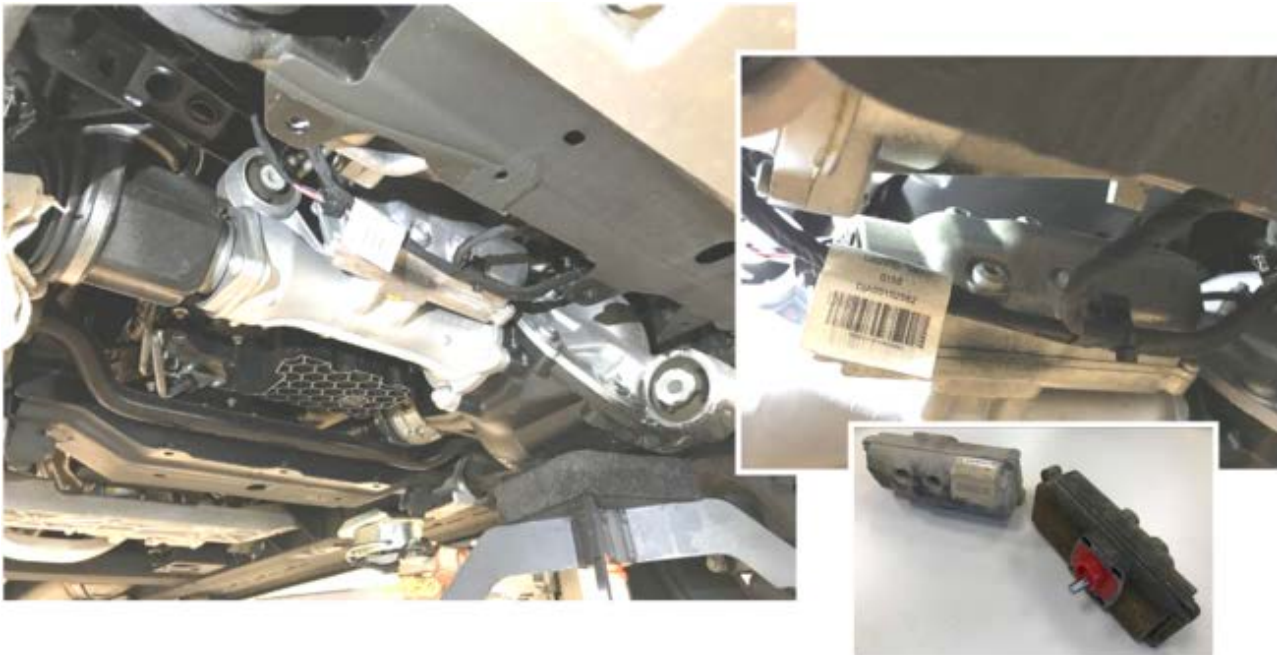
Figure 3

i **New actuator must *not be painted*.(Figure 3)**

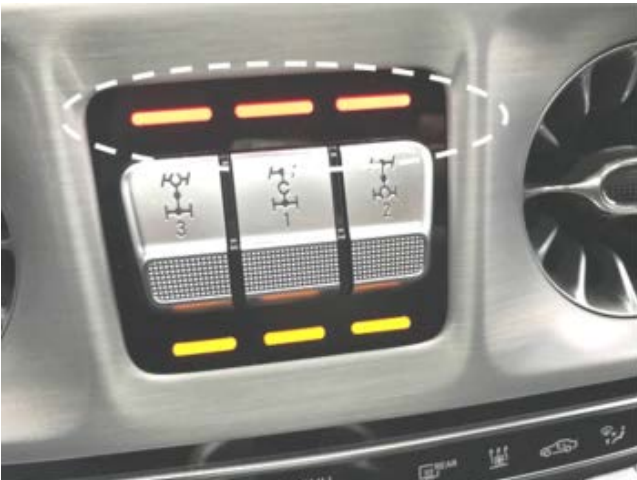
Figure 7

i For this purpose, start the engine – engage low range "N" position – actuate transfer case differential lock switch/rear axle differential lock switch/front axle differential lock switch – drive in gentle figure 8 lines at walking pace in an open area until the **red feedback of all three locks** appears on **operating switch (figure 7)** – deactivate locks and low range.
