Dealer Service Instructions for:

# Safety Recall W12 / NHTSA 20V-124 Clutch

**2018 – 2020(JL) Jeep® Wrangler**

**2020 (JT) Jeep® Gladiator**

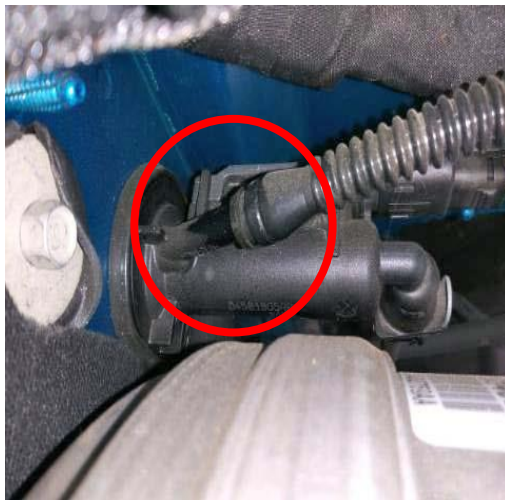
**SAMPLE of Leak/Seepage**

1. Locate and cut the clip holding the wire harness to the low pressure reservoir hose and **Discard** the clip (Figure 1).
2. Visually inspect the low pressure reservoir hose for any leaks/seepage (See Sample Pictures Below), if leak or seepage, deformation, or wear is found replace the reservoir hose (Figure 1).
