Dealer Service Instructions for:

# Safety Recall W12 / NHTSA 20V-124 Clutch

**2018 – 2020(JL) Jeep® Wrangler**

**2020 (JT) Jeep® Gladiator**

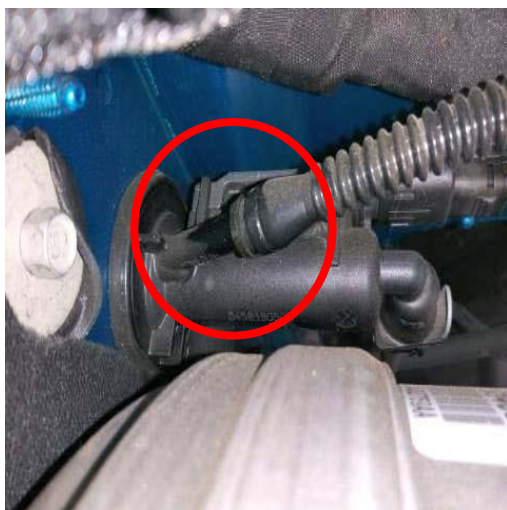
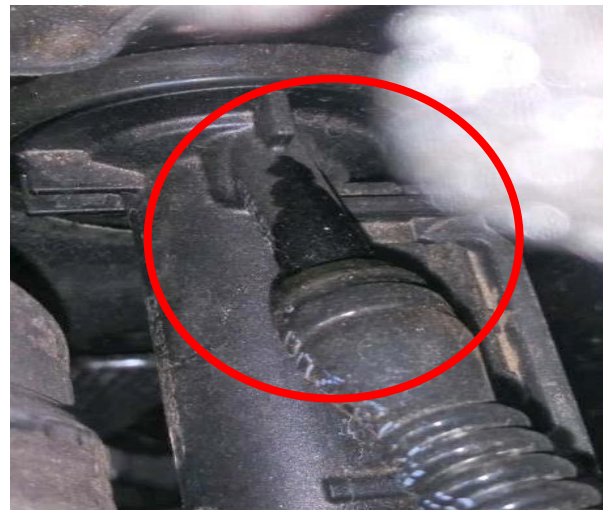
SAMPLE of Leak/Seepage

1. Locate and cut the clip holding the wire harness to the low pressure reservoir hose and **Discard** the clip (Figure 1).
2. **Visually inspect the low pressure reservoir hose for any leaks/seepage (See Sample Pictures Below), if leak or seepage, deformation, or wear is found replace the reservoir hose (Figure 1).**
