RECALL CAMPAIGN BULLETIN

RS20-003

VOLUNTARY SAFETY RECALL CAMPAIGN 2012-2018 NV CARGO AND PASSENGER VAN DRIVER SIDE AIR BAG MODULE

CAMPAIGN ID #:PC740APPLIED VEHICLES:2012-2018 NV Cargo and Passenger Van (F80)

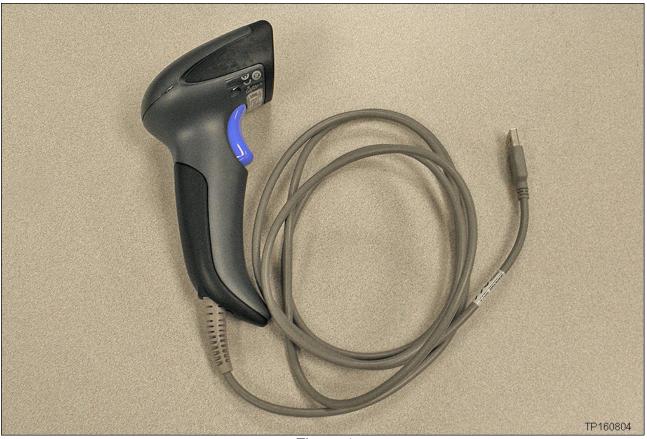
Figure 1

Quick Scan Tool (J-52352)

- Each dealer has been shipped one Quick Scan Tool (J-52352).
- Additional tools can be obtained from Tech•Mate by calling 1-800-662-2001 or visiting their website at nissantechmate.com.
