SIB 65 09 20

RECALL CAMPAIGN 20V-243: HEAD AIR BAG (LEFT-SIDE)

This Service Information Bulletin (Revision 2) replaces SI B65 09 20 **dated May 2020**.

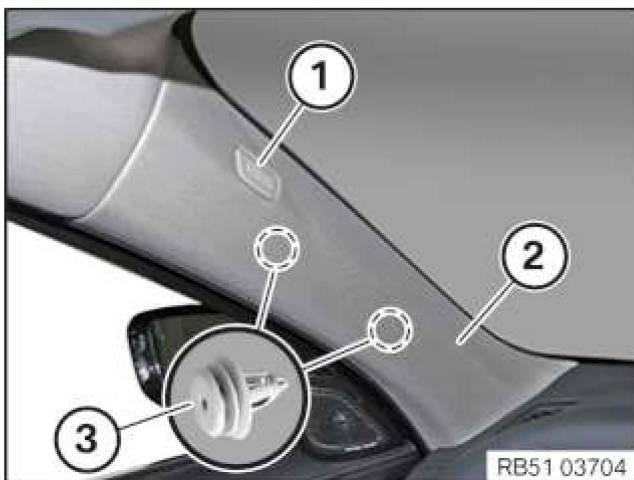
- Unclip cover panel (1) and unscrew the bolt below it.
- Detach A-pillar trim panel (2) from the clips (3) and remove upward.

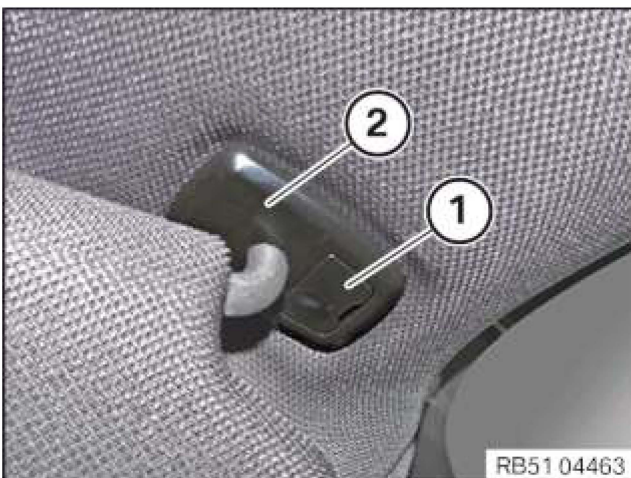
- Pull out the cover (1).
- Detach the sun visor (2) from the counter support.
- Disengage the sun visor (2) in front downward and guide it out of the headlining to the rear.
- Unlock associated plug connection and disconnect.

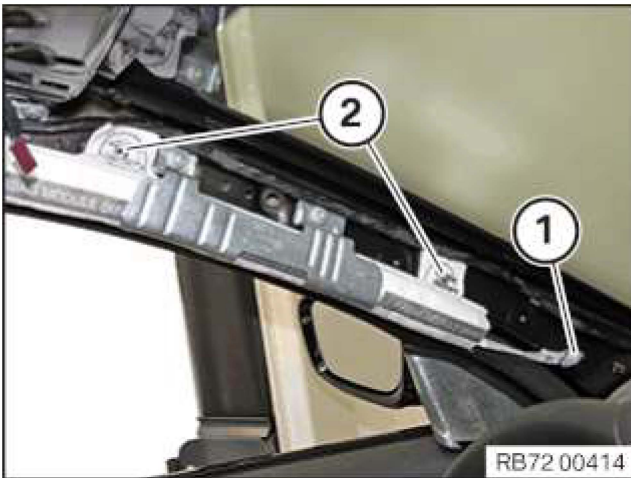
- Loosen screw (1).
- Unlock and detach the clamps (2) with the special tool 2 230 142 .

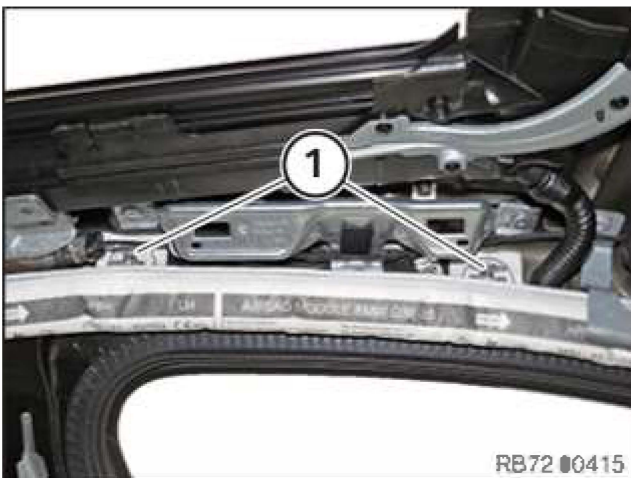
- Unlock and detach the clamps (1) with the special tool 2 230 142 .

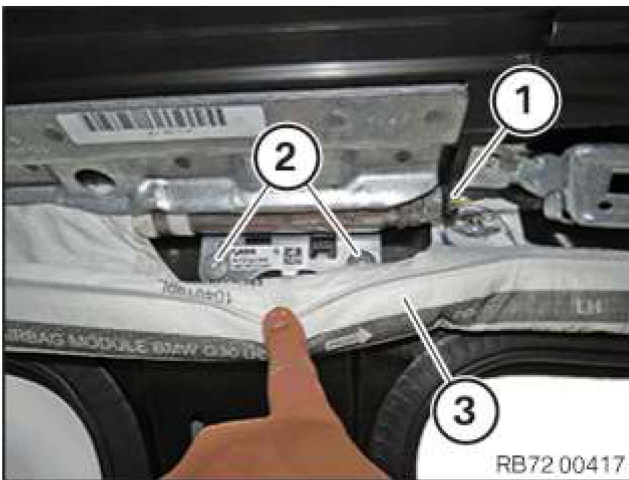
- Unlock and detach the clamps (1) with the special tool 2 230 142 .
- Loosen screw (2).

- Unlock plug connection (1) and disconnect.
- Loosen screws (2).
- Take off the folding pack (3) with the gas generator.

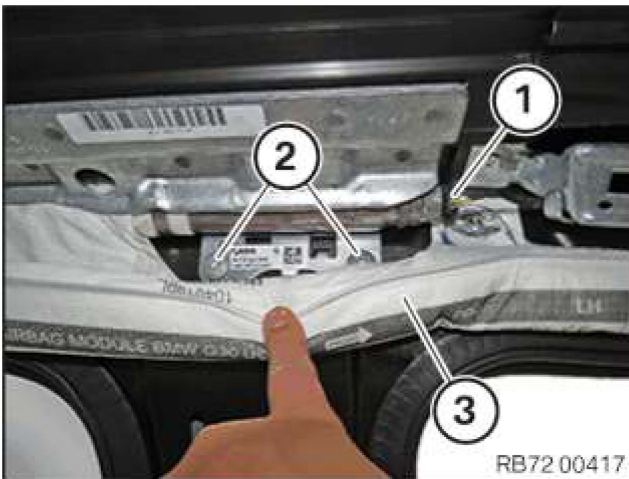
- Insert the folding pack (3) with the gas generator.
- Tighten down screws (2).

Tightening torques

Head airbag

8Nm

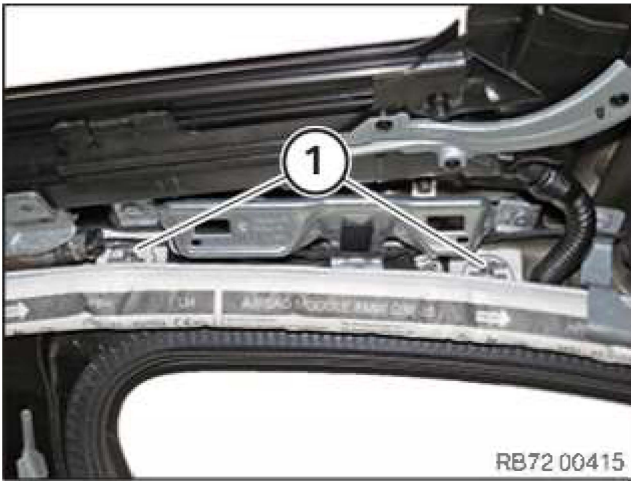
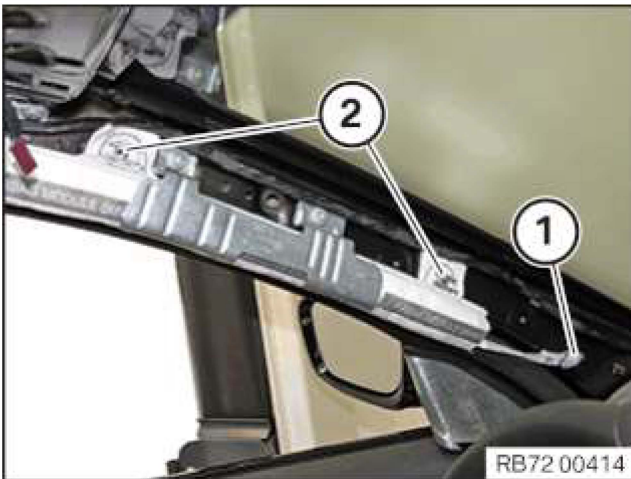
- Insert the clamps (1).
- Make sure that the clamps (1) are correctly fitted in the body.
- Tighten down screw (2).

8Nm

- Insert the clamps (1).
- Make sure that the clamps (1) are correctly fitted in the body.

- Insert the clamps (2).
- Make sure that the clamps (2) are correctly fitted in the body.
- Tighten down screw (1).

Head airbag
8Nm
