SIB 65 09 20

RECALL CAMPAIGN 20V-243: HEAD AIR BAG (LEFT-SIDE)

This Service Information Bulletin (Revision 2) replaces SI B65 09 20 **dated May 2020**.

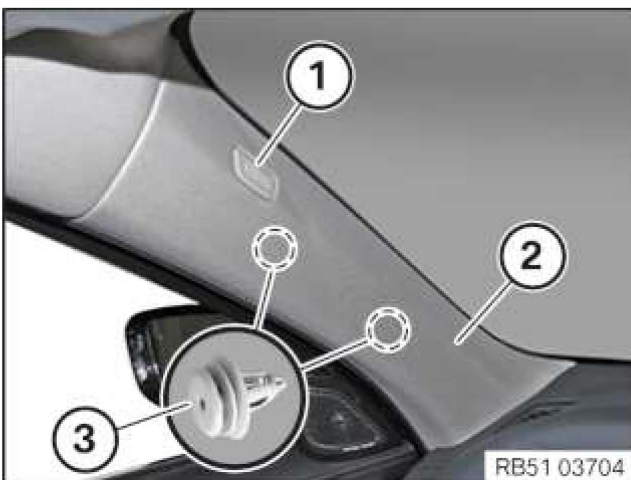
- Unclip cover panel (1) and unscrew the bolt below it.
- Detach A-pillar trim panel (2) from the clips (3) and remove upward.

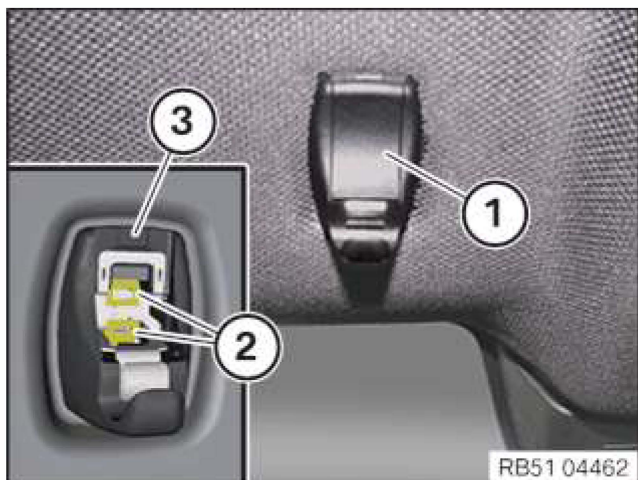
► Remove the counter support for the sun visor

- Pull out the cover (1).
- Push the clamps (2) together and pull the counter support (3) out of the headlining.

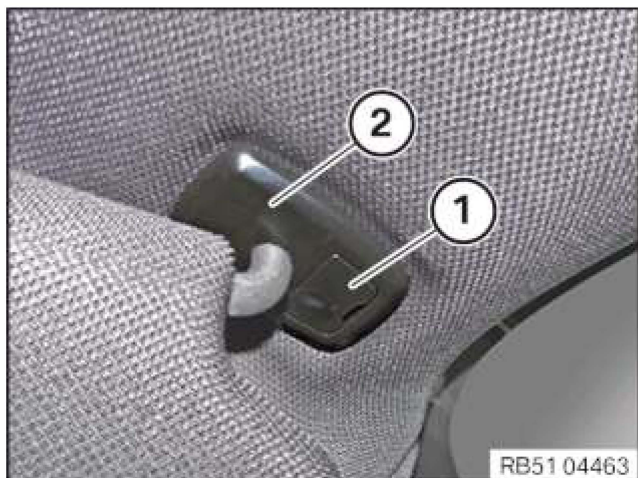
► Remove sun visor

- Pull out the cover (1).
- Detach the sun visor (2) from the counter support.
- Disengage the sun visor (2) in front downward and guide it out of the headlining to the rear.
- Unlock associated plug connection and disconnect.

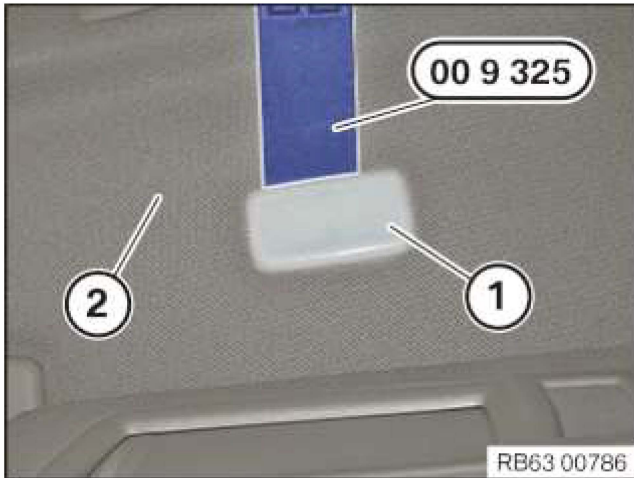
- Lever out the vanity mirror light (1) using special tool 0 496 569 (00 9 325) from the headlining (2).

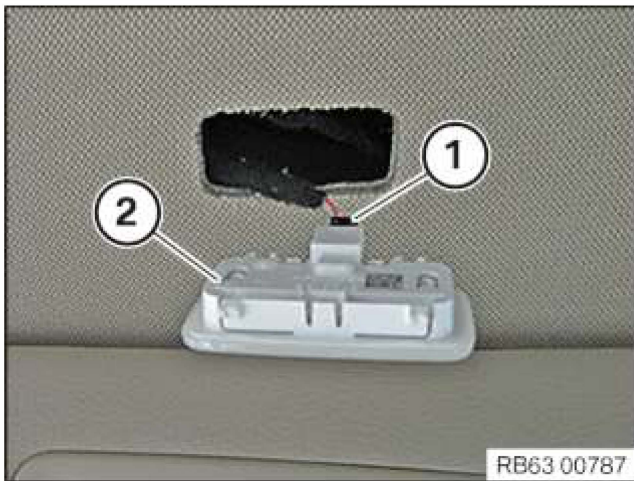
- Unlock and disconnect connector (1).
- Remove the vanity mirror light (2).

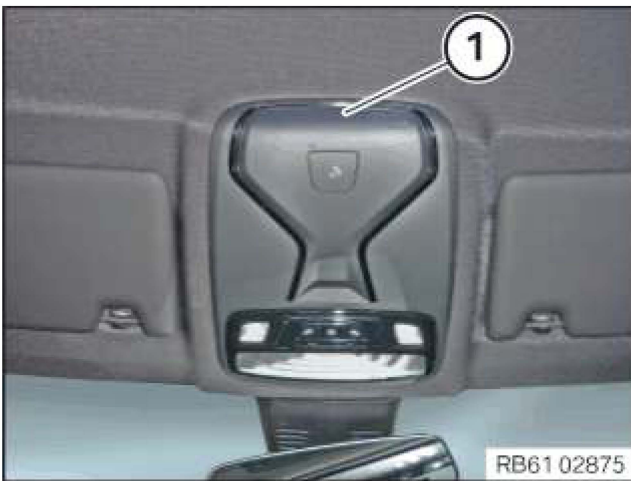
- Unclip the cover (1).

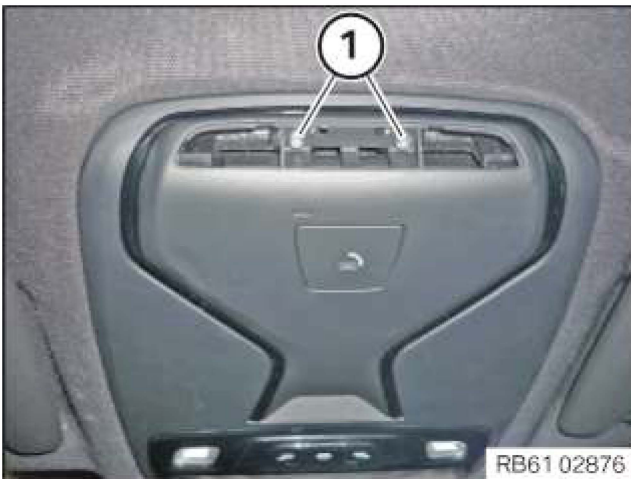
- Loosen screws (1).
- Unclip the roof function center (FZD) (1) from the clamps (2).
- Ease out the Roof function center (FZD) (1) from the guides (3).

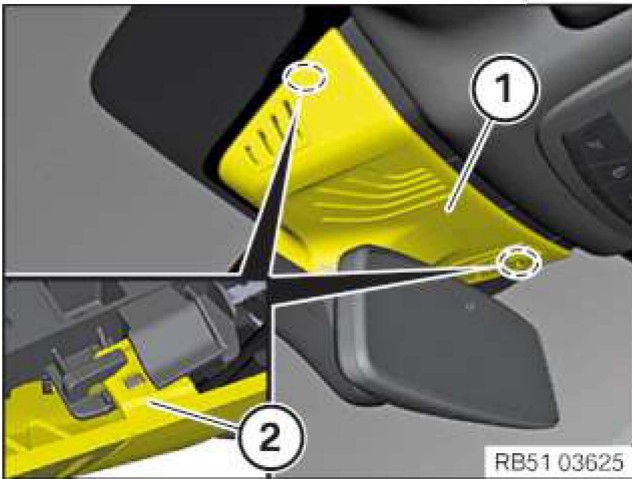
- Push the cover (1) upwards slightly in the marked areas and unclip it from the detents (2) towards the rear.

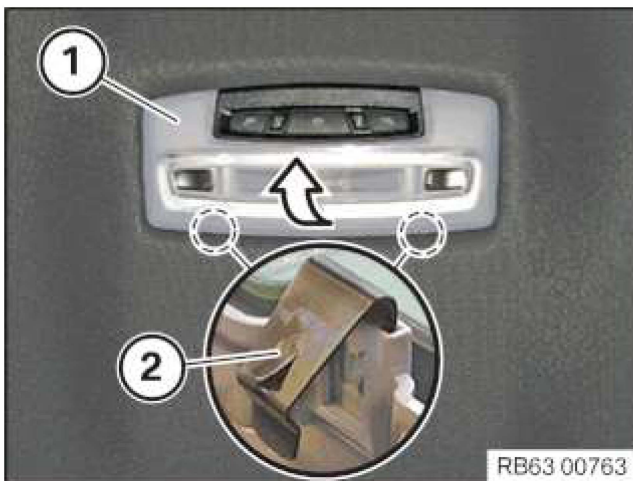
- Lever out the interior roof light (1) from the clamps (2) in the arrow direction using the special tool 0 496 569 (00 9 325).
- Disconnect the respective plug connection.

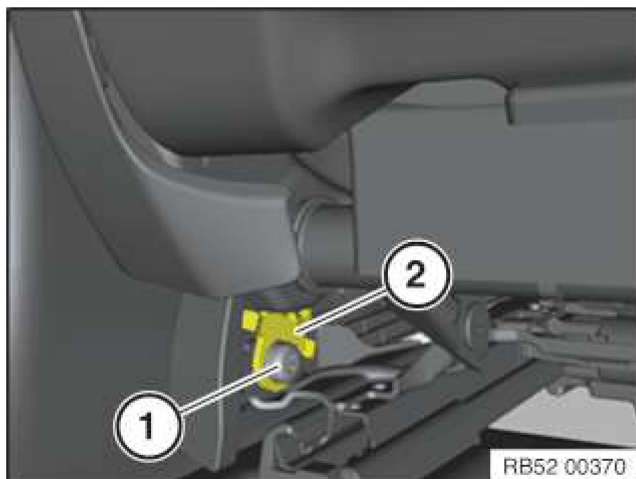
- Adjust the front seat completely to the front and top.
- Loosen screw (1).
- Remove end lining (2).

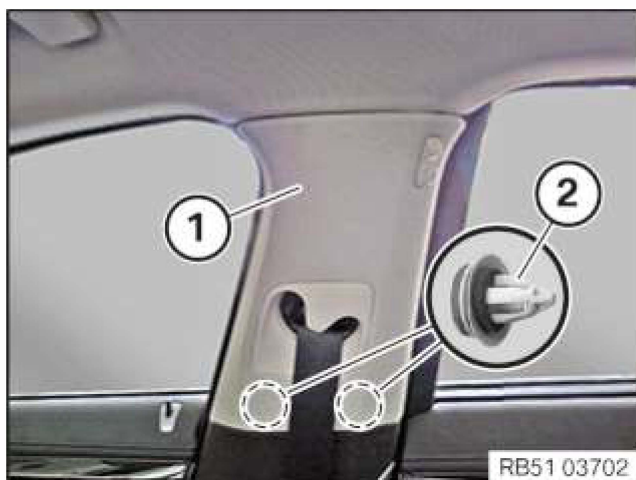
- Release the B-pillar trim panel (1) from the clips (2) and remove downwards out of the roofliner.
- Remove the B-pillar trim panel (1) and thread out the safety belt at the same time.

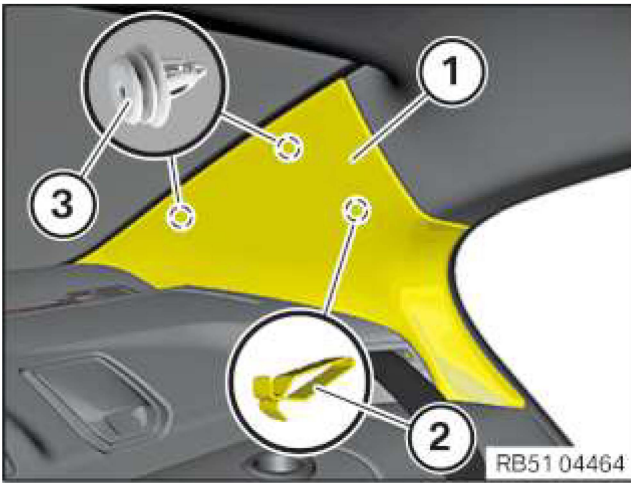
- Disengage the C-pillar trim panel (1) inward from

the clamp (2) and the clips (3).

- Feed the C-pillar trim panel (1) out and upwards.

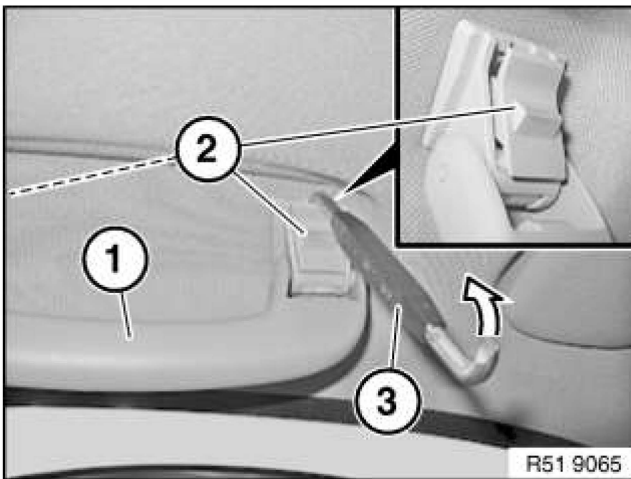
► Removing the grab handle

- Expand the grab handle (1) towards the bottom.
- Disengage and remove the locking insert (2) with an angle screwdriver (3) as shown.

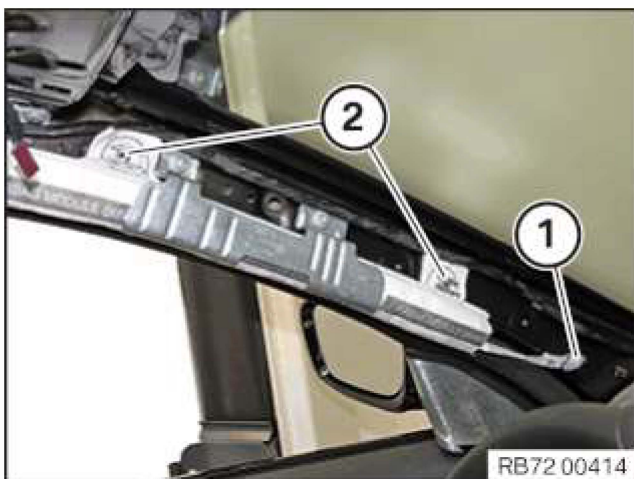
Remove head airbag.

- Loosen screw (1).
- Unlock and detach the clamps (2) with the special tool 2 230 142 .

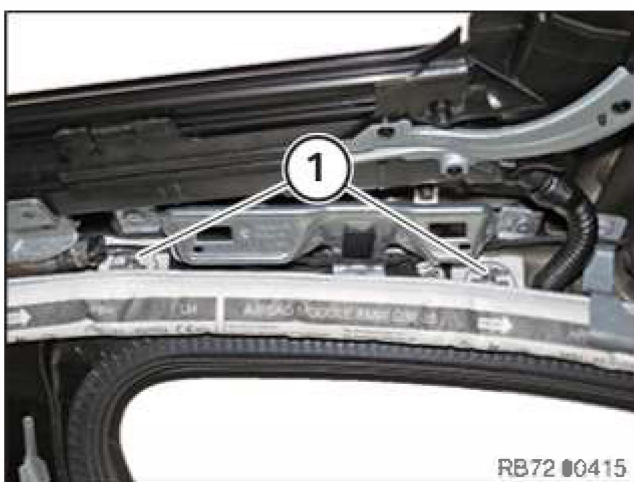
- Unlock and detach the clamps (1) with the special tool 2 230 142 .

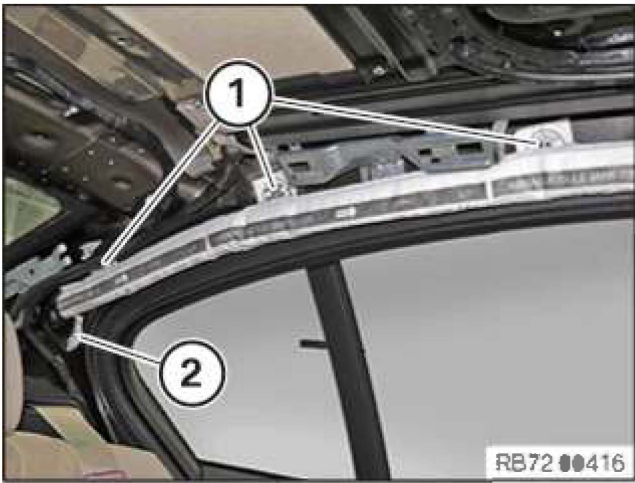
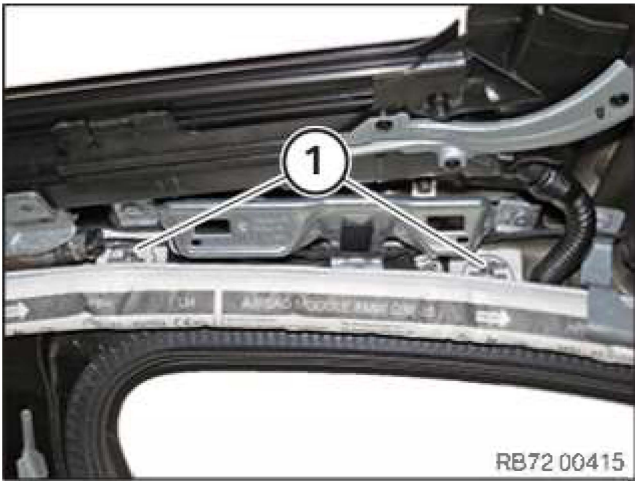
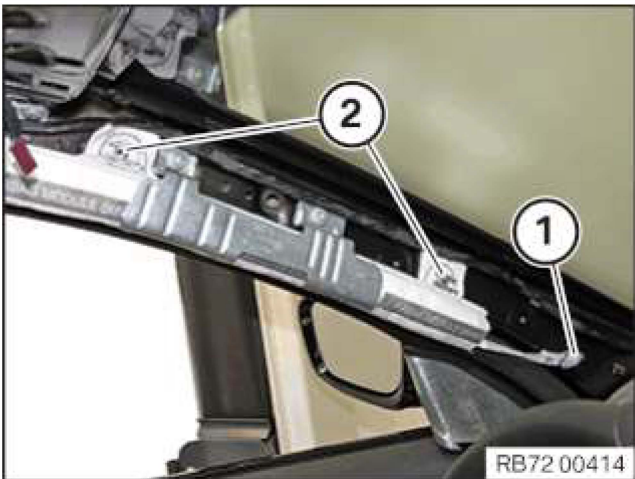
Head airbag

8Nm

- Insert the clamps (1).
- Make sure that the clamps (1) are correctly fitted in the body.

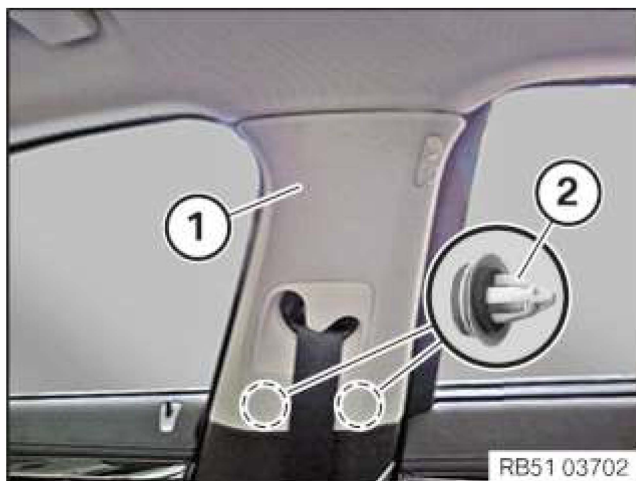
- Attach the B-pillar trim panel (1) and guide in the safety belt.
- Guide in the B-pillar trim panel (1) at the top at the roofliner and clip into the clips (2).
- Check the front and rear of the B-pillar trim panel (1) for the correct fit at the edge protection.

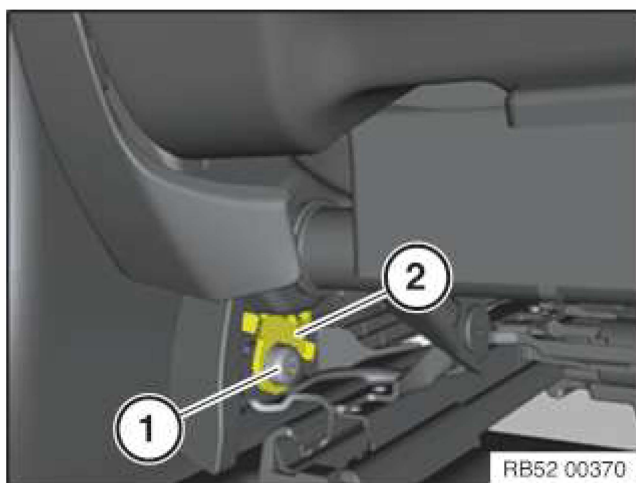
- Adjust the front seat completely to the front and top.
- Insert the end fitting (2).
- Renew the screw (1).

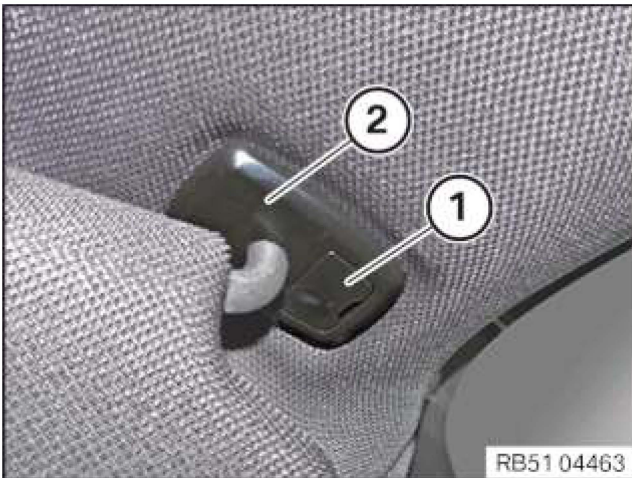
► Install the sun visor

- Connect the sun visor (2) with the corresponding connector.
- Guide the sun visor (2) into the headlining.
- Use cover (1).
- Attach the sun visor (2) on the counter support.

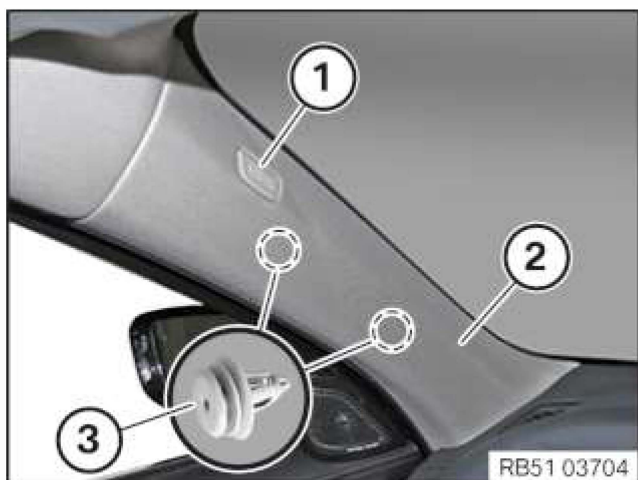
- Insert the A-pillar trim panels (2) and clip into the clips (3).
- Tighten down screw.
