N459NAS1

TECHNICAL BULLETIN

09 JUL 2020

SAFETY RECALL: Door Will Not Close

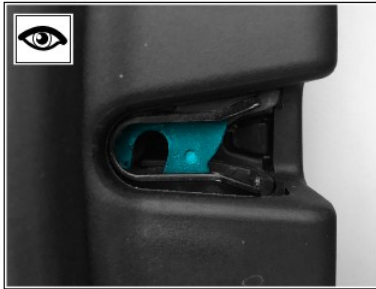
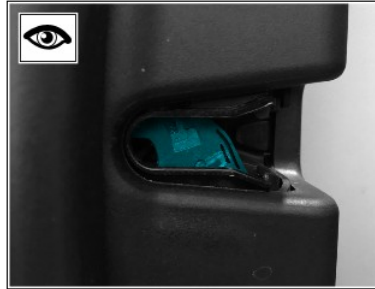
E258158

Use a quick and smooth motion to grasp and pull the exterior door handle, hold the handle in the open/extended position, and observe the position of the door latch lever.

- If the door latch is in the latched position **GREEN (✓)**, continue to step 5.
- If the door latch is **not** in the latched position **RED (X)**, return to step 2.

- When performing step 4, the exterior door handle must be pulled quickly (less than 0.25 seconds from the time a hand is sensed between the door and the exterior door handle and the handle is pulled) as shown in the Service Information video.
- Do not return the exterior door handle to its original position after opening the door.
- If the vehicle unlocks and door mirrors unfold before the exterior door handle is fully open/extended position, the exterior door handle was not pulled fast enough from the point that your hand reached into the exterior door handle opening.

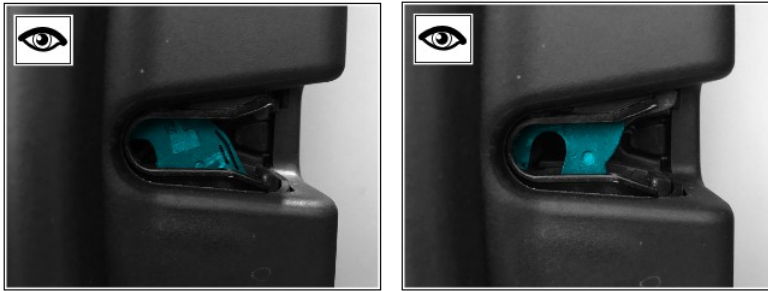
E258160

Observe the position of the door latch lever.

- If the door latch lever is in the unlatched position, as shown by the **GREEN (✓)** in the illustration, the front left door latch has passed the functionality test, **go to Service Instruction 'B'**.
- If the door latch lever is still in the latched position, as shown by the **RED (X)** in the illustration, **go to step 8**.

-
8. Renew the front left door latch (see TOPIx Workshop Manual section 501-14: Handles, Locks, Latches and Entry Systems - Removal and Installation - Front Door Latch).

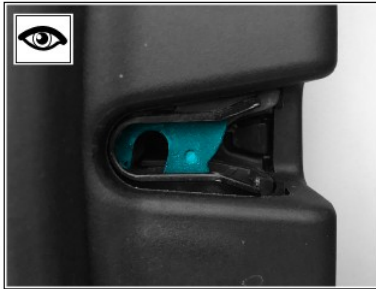
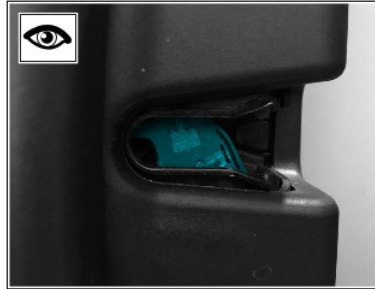
E258158

Use a quick and smooth motion to grasp and pull the exterior door handle, hold the handle in the open/extended position, and observe the position of the door latch lever.

- If the door latch is in the latched position **GREEN (✓)**, go to step 5.
- If the door latch is **not** in the latched position **RED (X)**, return to step 2.

- When performing step 4, the exterior door handle must be pulled quickly (less than 0.25 seconds from the time a hand is sensed between the door and the exterior door handle and the handle is pulled) as shown in the Service Information video.
- Do not return the exterior door handle to its original position after opening the door.
- If the vehicle unlocks and door mirrors unfold before the exterior door handle is fully open/extended position, the exterior door handle was not pulled fast enough from the point that your hand reached into the exterior door handle opening.

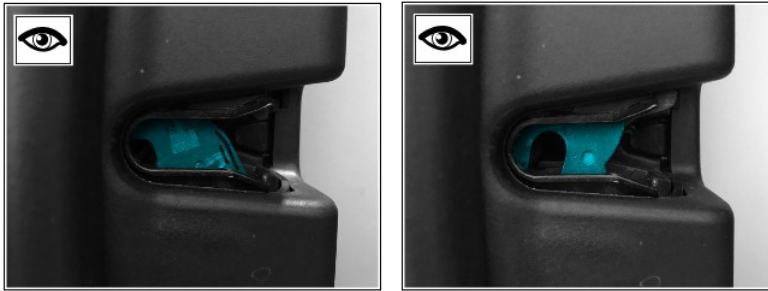
E258160

Observe the position of the door latch lever.

- If the door latch lever is in the unlatched position, as shown by the **GREEN (✓)** in the illustration, the rear left door latch has passed the functionality test, **return the vehicle to the customer.**
- If the door latch lever is still in the latched position, as shown by the **RED (X)** in the illustration, **go to step 8.**

8. ■ Renew the rear left door latch:

- **Range Rover Sport** - (see TOPlx Workshop Manual section 501-14: Handles, Locks, Latches and Entry Systems - Removal and Installation - Rear Door Latch).
- **Range Rover - Standard wheelbase** - (see TOPlx Workshop Manual section 501-14: Handles, Locks, Latches and Entry Systems - Removal and Installation - Rear Door Latch - Standard Wheelbase).
- **Range Rover - Long wheelbase** - (see TOPlx Workshop Manual section 501-14: Handles, Locks, Latches and Entry Systems - Removal and Installation - Rear Door Latch - Long Wheelbase).
- When all tasks are complete, **return the vehicle to the customer.**
