FOREST RIVER RECALL 20V330

BOLT-ON SAFETY CHAIN HARDWARE CORRECTION

Recall Number:	20V330
Product:	Bolt-On Safety Chain Hardware Inspection, Correction

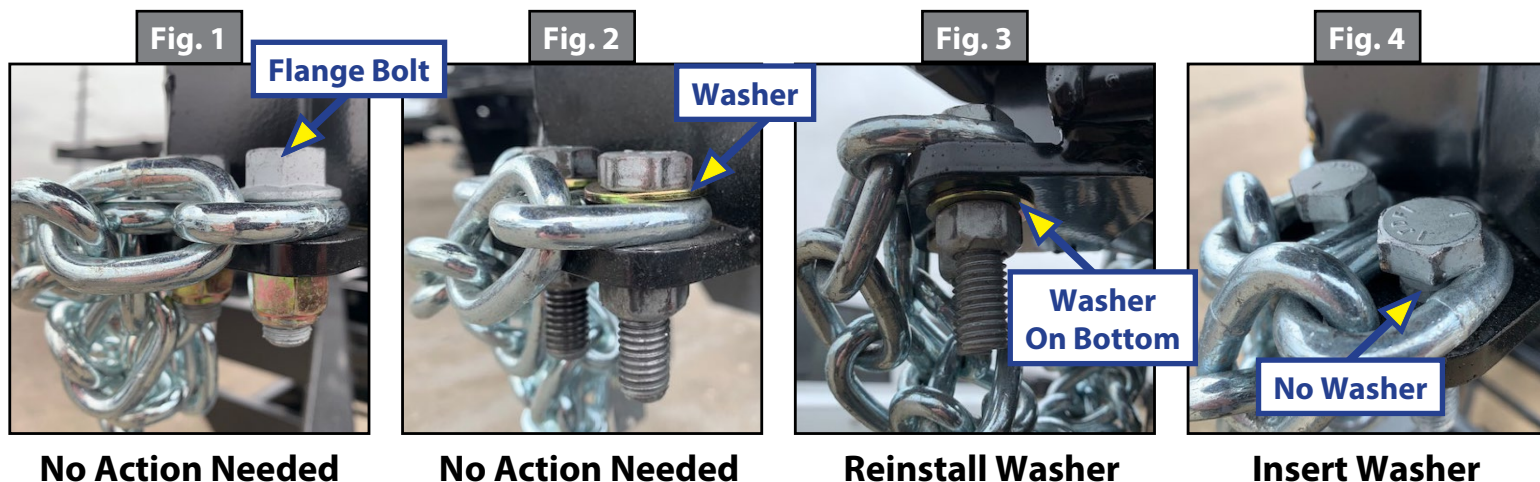
All travel trailers 11,700 pounds and less will be inspected to determine compliance with engineering-approved safety chain hardware. If a flange bolt (Fig. 1) or a washer (Fig. 2) are visible and in use, then no action is needed. If a flange bolt or a washer are not visible or properly installed, then the hardware must be removed and a washer inserted on top of the chain.

1. If the washer is located on the bottom (Fig. 3), remove hardware, reinsert washer on bolt and reinstall bolt with the washer on top of the chain. Secure with nut.
2. If no washer is present (Fig. 4), remove hardware, insert washer on bolt and reinstall bolt with washer on top of the chain. Secure with nut.
