# Safety Recall 20V-362

## Repair Instructions

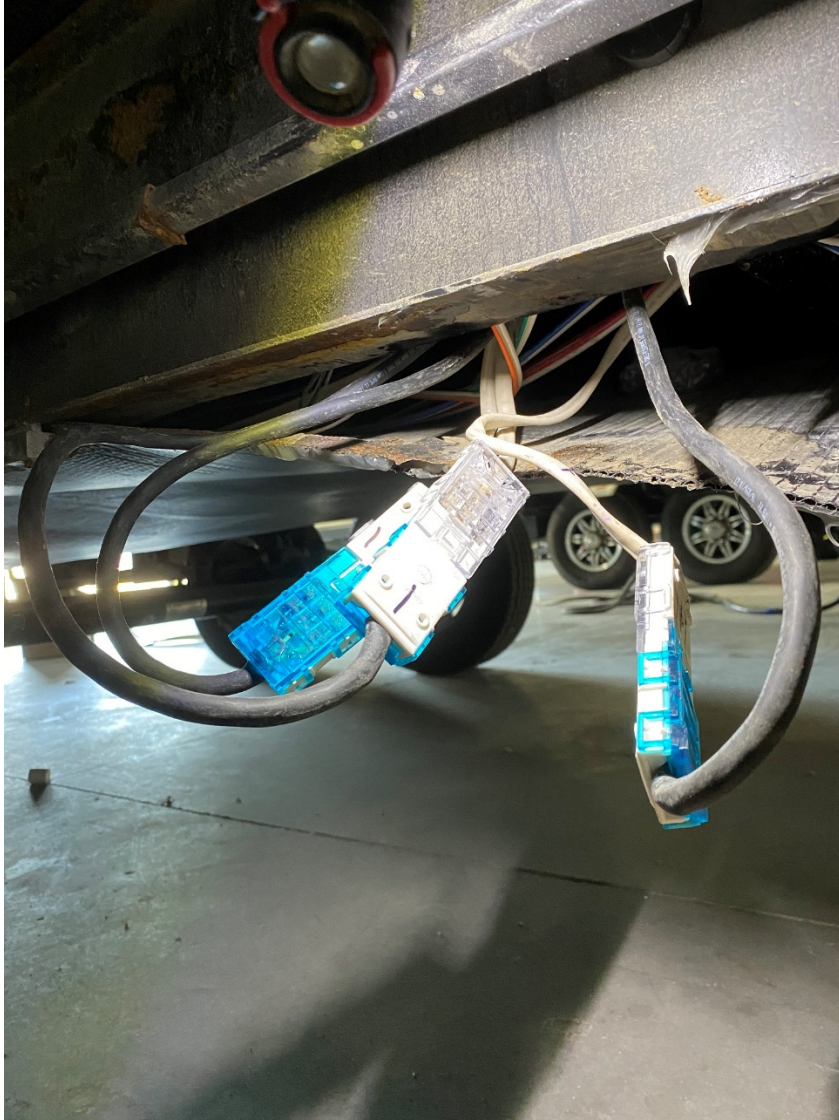
**Step 3:** Pull underbelly from the frame and locate the Molex connectors.

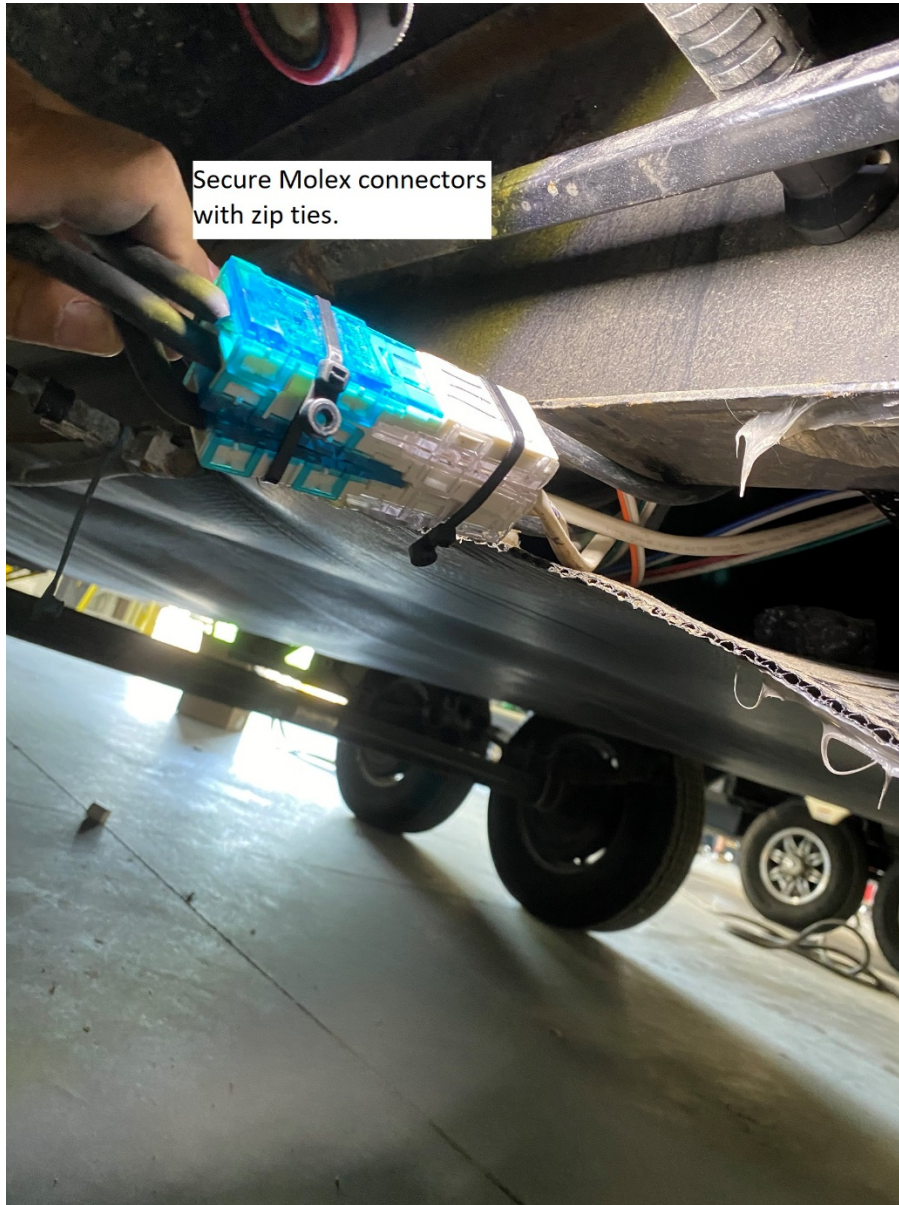
**Step 4:** Remove all Molex connector from underbelly and secure them together with zip ties.
