RECALL 20V375 REMEDY INSTRUCTIONS

Make(s): COLUMBUS
Model(s): CMF389FL, CMF389FLC & CMF389FLW
Model Year(s): 2021

Concern:
The furnace exhaust vent is located under the rear ODS slide and does not meet the installation requirements.

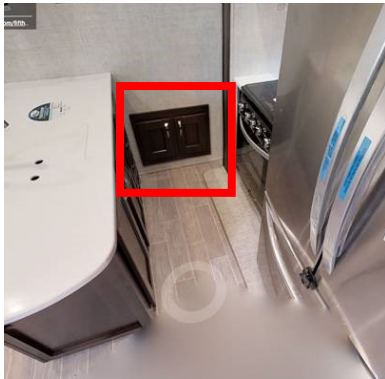
FIGURE 1 – LOWER CABINET

STEP 2: LOCATE THE INTERIOR LOWER CABINET INSERT FROM FIGURE 1, REMOVE FROM VEHICLE;

NOTE:
THE LOWER CABINET INSERT IS 12" IN DEPTH. TO ALLOW FOR THE PROPER RELOCATION AND INSTALLATION OF THE FURNACE, A NEW CABINET NOW 7" IN DEPTH WILL BE INCLUDED IN THE KIT TO RELOCATE THE FURNACE.

STEP 3: REMOVE BOTH CABINET DOORS FROM THE CABINET INSERT, ENSURE TO KEEP ALL HINGE AND HANDLES INSTALLED TO THE DOOR. REMOVE ANY DOOR RETAINER INSTALLED TO THE CABINET. KEEP THESE ASIDE;

STEP 9: INSTALL THE REPLACEMENT CABINET INTO THE OLD LOCATION. INSTALL THE CABINET DOORS USING THE SAME HARDWARE AND ANY DOOR RETAINER REMOVED FROM THE OLD CABINET;
