Quality Bulletin

Recall R10029: Front Seat Belt Fastener, Model Year 2007 - 2018 S60CC, S60L, V60CC, S60, XC60, V60, XC70, V70, S80, S80L

GROUP: 88	CAT/NO: R10029	ISSUING DEPARTMENT: Regulations and Compliance		CAR MARKET: United States and Canada	
REVISIONS: Updates to Section H. and Section I.				ISSUE DATE: 2020-09-23	STATUS DATE: 2020-10-02
Service Personnel: Read and initial		SERVICE MANAGER	SERVICE WRITER	WARRANTY ADMINISTRATOR	Page 1 of 4

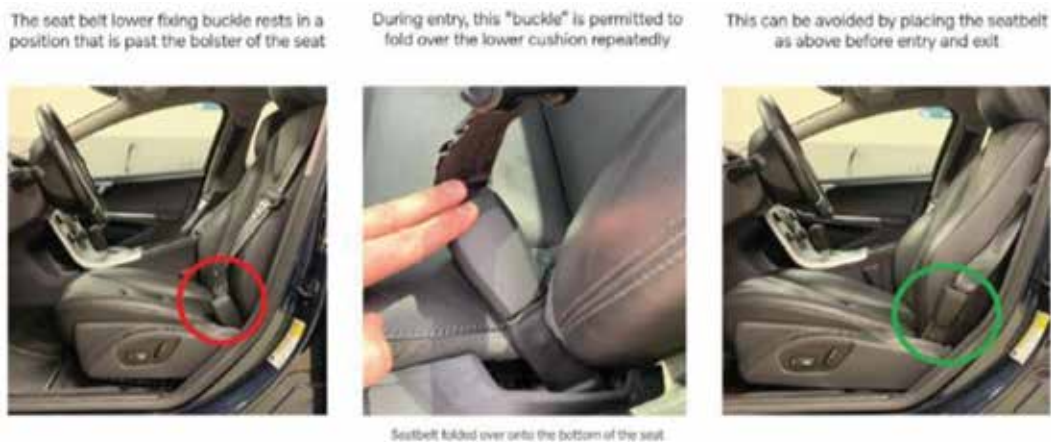
Volvo has identified an issue regarding the front seat belt fastening, mounted on the outboard side of the front seat. The front seat belt fastening cable, may under certain circumstances, suffer from wear and fatigue if repeatedly bent over the seat cushion. This could cause damage to the cable, which could result in reduced or no seat belt restraint function.

Customers can also prevent any damages to the cable from occurring when entering or exiting the vehicle (see image below). We recommend that the driver and front seat passenger secure that the seat belt fastening is in a vertical position, aligned with the backrest, so that it will not be bent over the seat cushion when entering the seat.

The corrective action is to replace the front driver and passenger seat belt fastener.
