**August 1, 2020**

**Noncompliance Recall: Gauge Control Module Software Update**Supersedes 20-047, dated July 29, 2020, to revise the information highlighted in **yellow**.**AFFECTED VEHICLES**

The MOST unit in the gauge control module is unable to process a certain amount of information, which may cause the instrument gauge to go blank or randomly reboot.

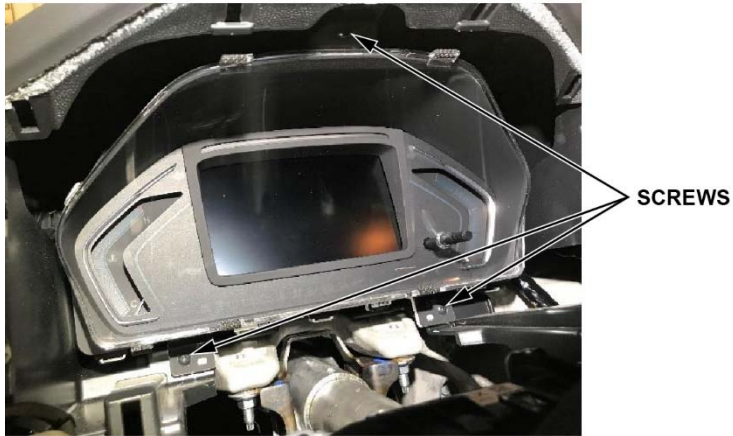
4. Remove the three screws securing the gauge control module.

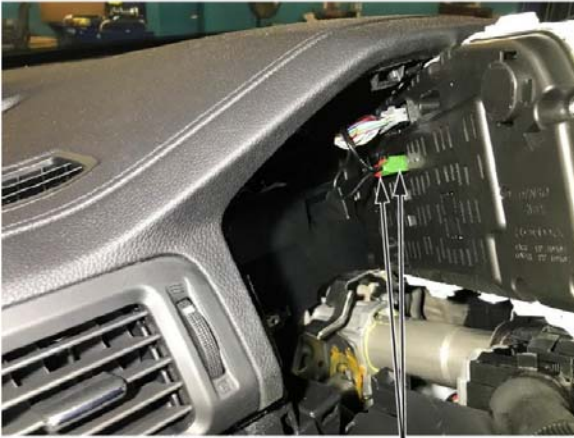
**FAKRA CONNECTORS**

7. Turn the gauge control module to access the rear connectors, being careful not to stretch the wiring harness. Disconnect the red and green FAKRA connectors, then disconnect the remaining connectors, and remove the gauge control module from the vehicle.

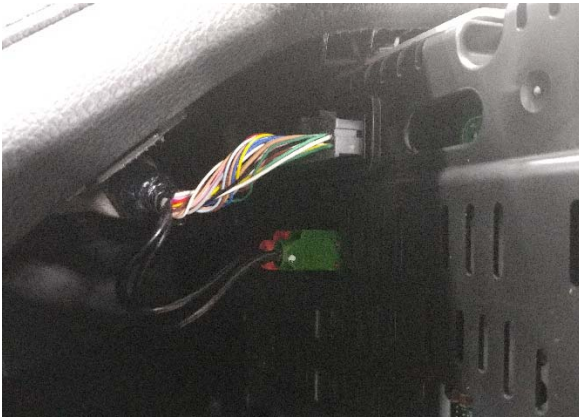
Make sure the harness is straight and not wrapped or tangled with other wires.

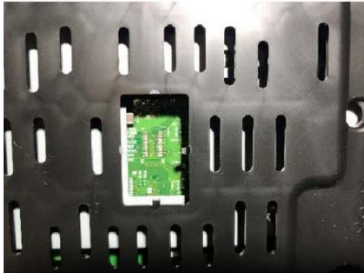
WITHOUT CONNECTOR

Some gauge control modules have a connector on the circuit board and some do not.

- *If there is no connector, go to REPAIR PROCEDURE A.*
- *If there is a connector, go to REPAIR PROCEDURE B.*

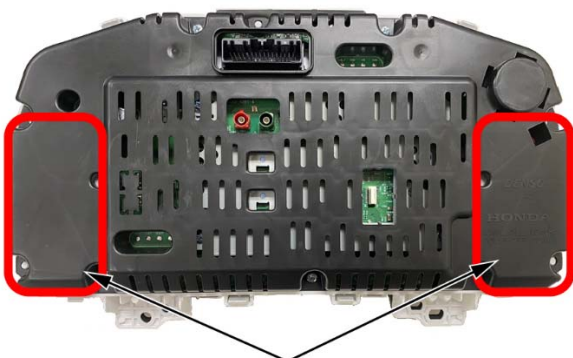
Press only in the designated areas when loading the gauge control module. Pressing on any other areas could damage the module.

Press only in designated areas.

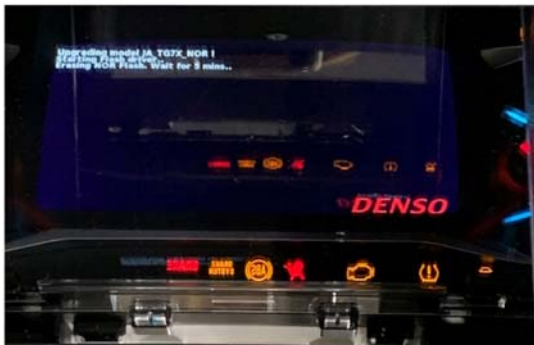
8. Check the reflash status using the inspection mirror under the gauge control module. The update will take about **7 to 10 minutes** to complete. The screen will turn green once the reflash is complete.

*If the reflash fails, set the REFLASH toggle switch to STOP and remove the SMART reflash card. Then, start REPAIR PROCEDURE B again from step 6.*
