## LP Hose/Connector Re-Location

It has been decided that certain 2021 Mallard M26 and 2021 Mallard M33 in this recall population may have been manufactured with the LP hose/connector over the shackle. The Shackle could come in contact with the LP hose/connector damaging them producing an LP leak.

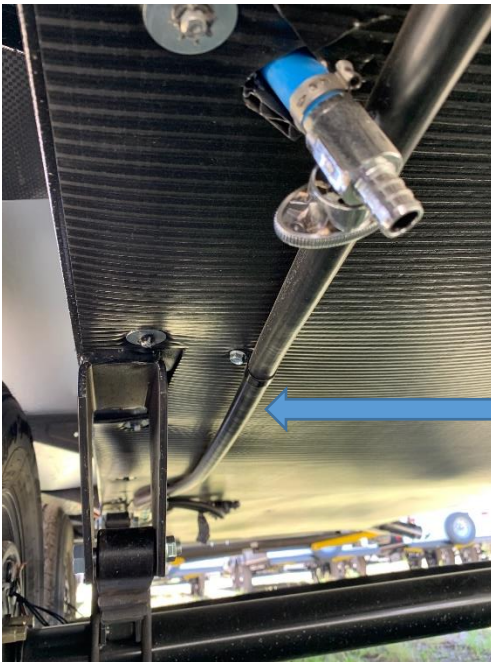
1. Shackle location in proximity to LP hose/connector. – No repair required if the shackle or shackle bolt will not impact the hose or connector. File claim for inspection only.

Notice position of shackle to the LP Hose/Connections. LP components are set back on I-beam out of shackle travel area.

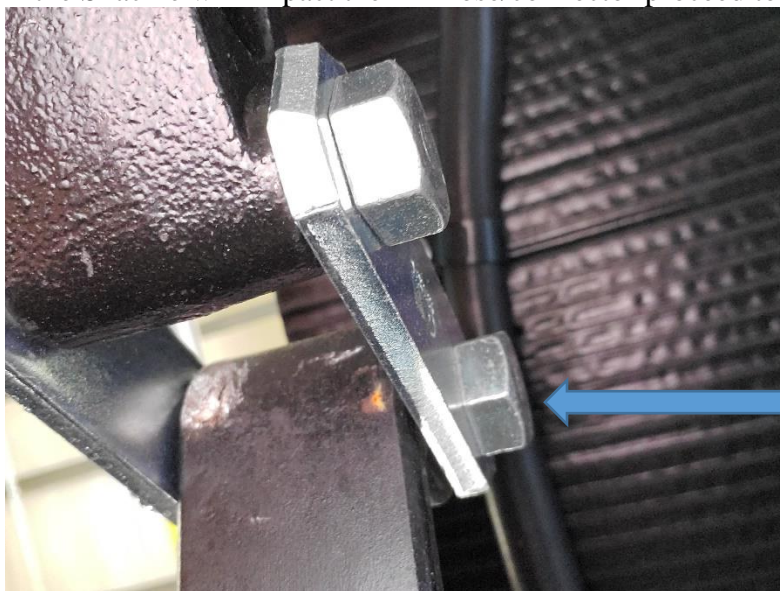
2. If the Shackle will impact the LP Hose/connector proceed to Re-location.

Shackle will  
hit the LP  
connection

3. This will require the relocation of the LP Manifold/ Hoses, Follow the instruction below.
  - 1) Turn off LP tanks and disconnect.
  - 2) Remove LP regulator from stand.

- 3) Remove all hose clamps holding LP line prior to manifold, and post manifold.
  - 4) Remove the three self-tapping screws from LP manifold.
  - 5) It may be necessary to pull additional LP hose from lines that enter unit through flooring to accommodate the relocate.

- 6) Move manifold back approximately to the center of spring where U-bolt mounting plate is located, and most inward side of the I-beam.
  - 7) Be sure that LP hoses coming off the side of the LP manifold face inward. If the hoses face outward toward the Tire be sure to secure hoses to I-beam so as not to contact tires.

- 8) Remount the LP manifold.
  - 9) Seal LP hoses entering unit from underside.
  - 10) Remount LP hose for exterior LP quick connect entering rear of manifold (approximately three hose clamps).

- 11) Start at LP manifold Remount hose clamps holding main line going towards the front of the RV. Hose clamps on each side of spring shackle should be mounted at an angle so that you achieve a loop in LP line around shackle to avoid contact or getting pinched.

- 12) Reinstall all hose clamps holding LP line prior and post of manifold (approximately 12).

- 13) Reinstall LP regulator to stand.
- 14) Reconnect LP tanks.
- 15) Perform Lock out test, and Drop test to insure safety.
