SAFETY RECALL BULLETIN

NHTSA RECALL 20V545

AUTOCAR, LLC SAFETY RECALL ACX-2006

Autocar has determined that a safety defect may exist in the routing of the methane detector sensor harness and/or the methane detector circuit fuse on certain 2019 Xpeditor vehicles which could lead to an over-current condition.

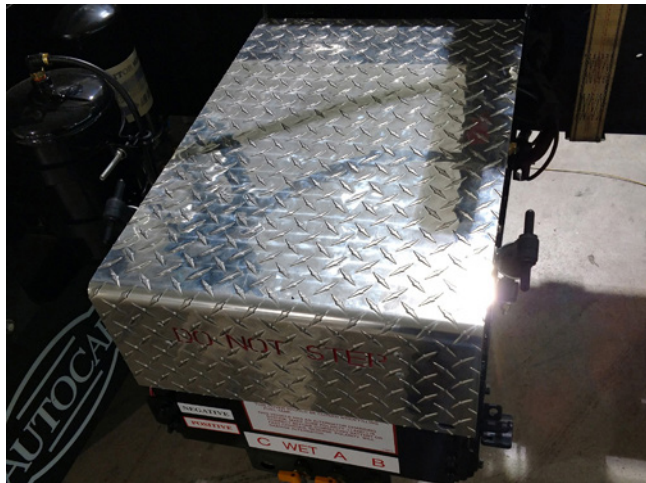
Figure 1, Battery Box

1. Complete the Lockout/Tagout procedure.
2. Locate the battery box, remove the battery box cover and set aside for re-installation (see *Figure 1*).

3. Disconnect all battery terminals beginning with the negative connections, then the positive connections.

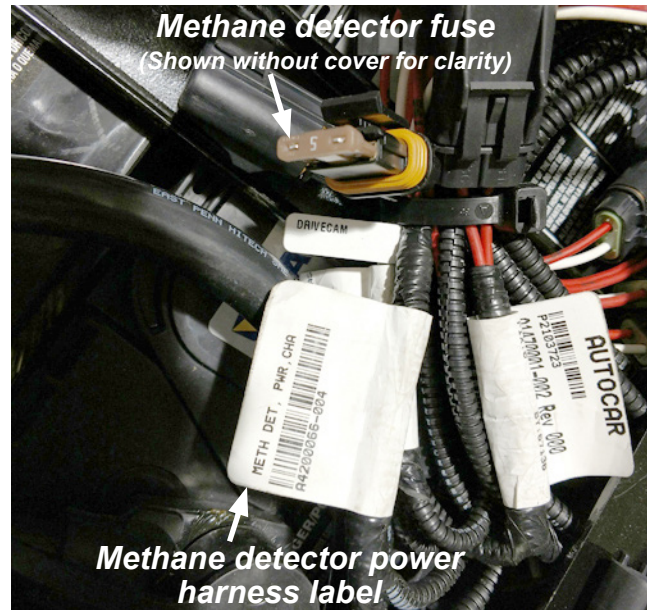
Figure 2, Methane detector fuse

4. Locate the methane detector power harness in-line fuse holder (see *Figure 2*).

5. Remove the in-line fuse holder cover and set aside for re-installation, remove the existing fuse from the methane detector power harness in-line fuse holder and discard.
6. Install a 3 AMP ATC fuse into the methane detector power harness in-line fuse holder and re-install the in-line fuse holder cover that was set aside in step 5.

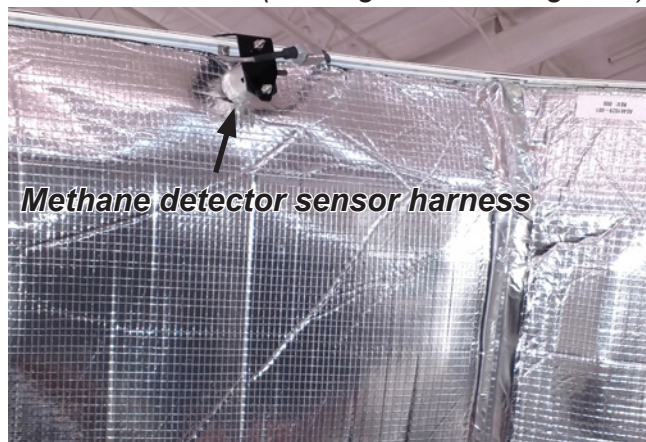
Figure 3, Cab in the raised position

8. Locate the methane detector sensor in the engine tunnel area of the raised cab, inspect the methane detector sensor harness (see *Figure 3 and Figure 4*).
