# IMPORTANT SAFETY RECALL NOTICE

October 15, 2020

Subject: **Can-Am® Ryker - Possible Front Wheel Loss**

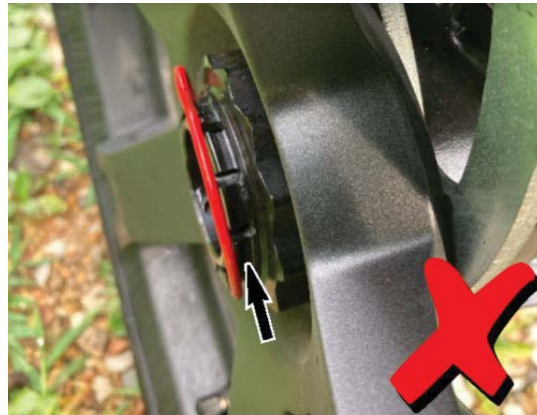
The front wheels assembly may not have been performed properly (torque application and installation of the red locking clip). In some situations, this could result in a wheel loss, increasing the risk of a crash.

**RED LOCKING CLIP OUT OF THE GROOVE**

- Follow all instructions provided in the attached Safety Campaign Bulletin including the requirements of the Mandatory Certification Form.
