SUBJECT: **Safety Recall 20S62 – Supplement #2**
 Certain 2013 through 2017 Model Year Explorer and Police Interceptor Utility Vehicles that are Registered or Sold in High Corrosion States/Provinces
 Rear Toe Link Ball Joint Inspection

Safety Recall 20S62 - *Supplement #2*

CERTAIN 2013-2017 MODEL YEAR EXPLORER VEHICLES — REAR SUSPENSION TOE LINK TO WHEEL KNUCKLE BALL JOINT

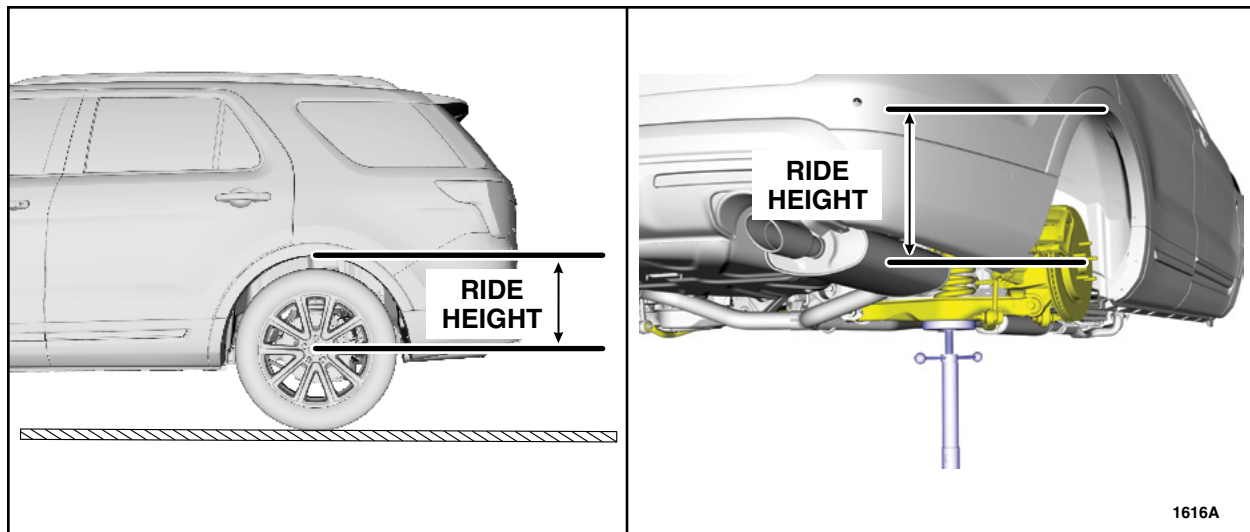
FIGURE 1

1. Measure the distance from the center of the wheel hub to the lip of the fender with the vehicle in a level, static ground position (ride height) before disassembly. See Figure 1.

NOTE: The toe links must be secured at ride height during replacement. See Figure 1.

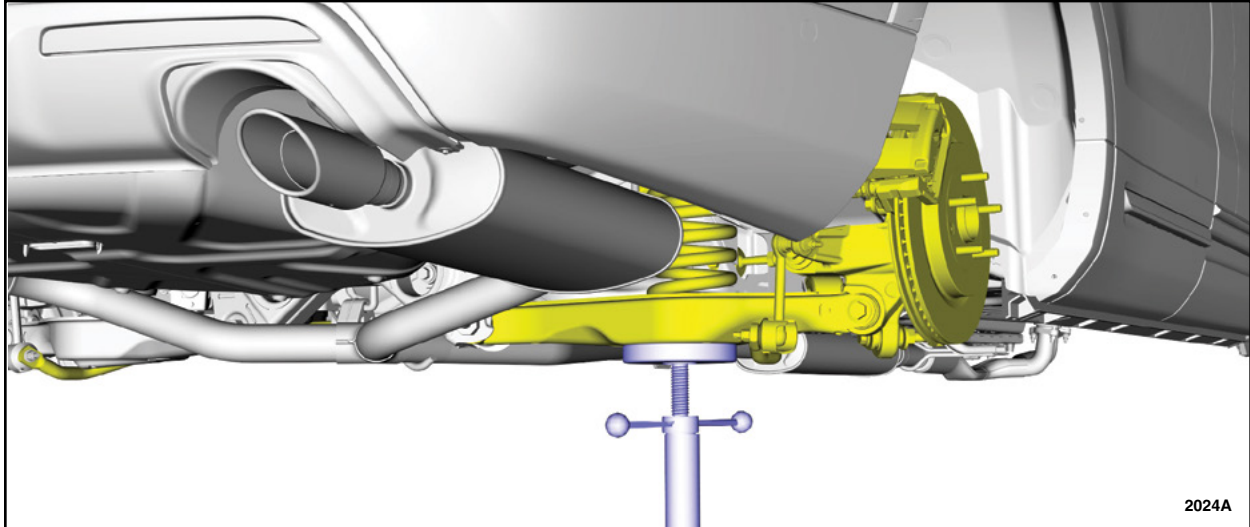
FIGURE 2

2. Position the vehicle on a hoist. Please follow the WSM procedures in Section 100-02.
3. Remove both rear tires. Please follow the WSM procedures in Section 204-04A.
4. Using a jack stand, support the rear suspension to ride height. See Figure 2.

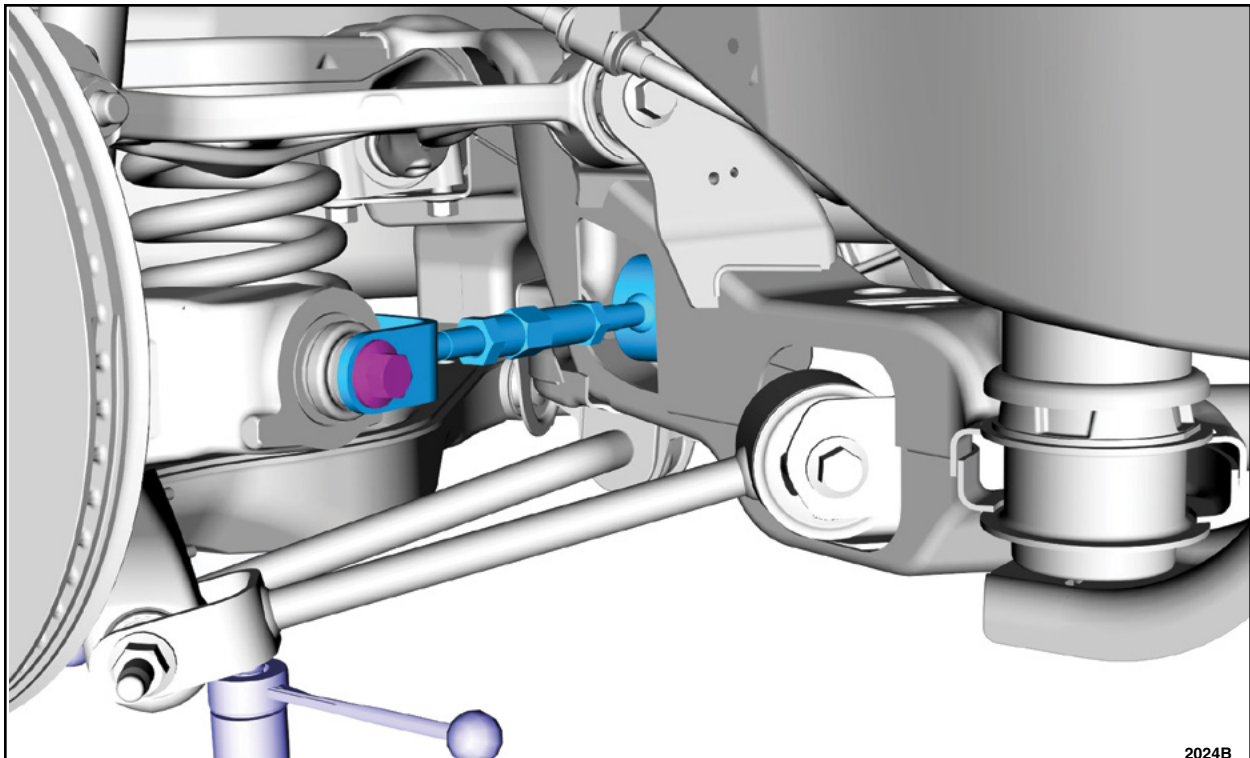
FIGURE 3

5. Remove the toe link-to-wheel knuckle bolt and nut. See Figure 3.

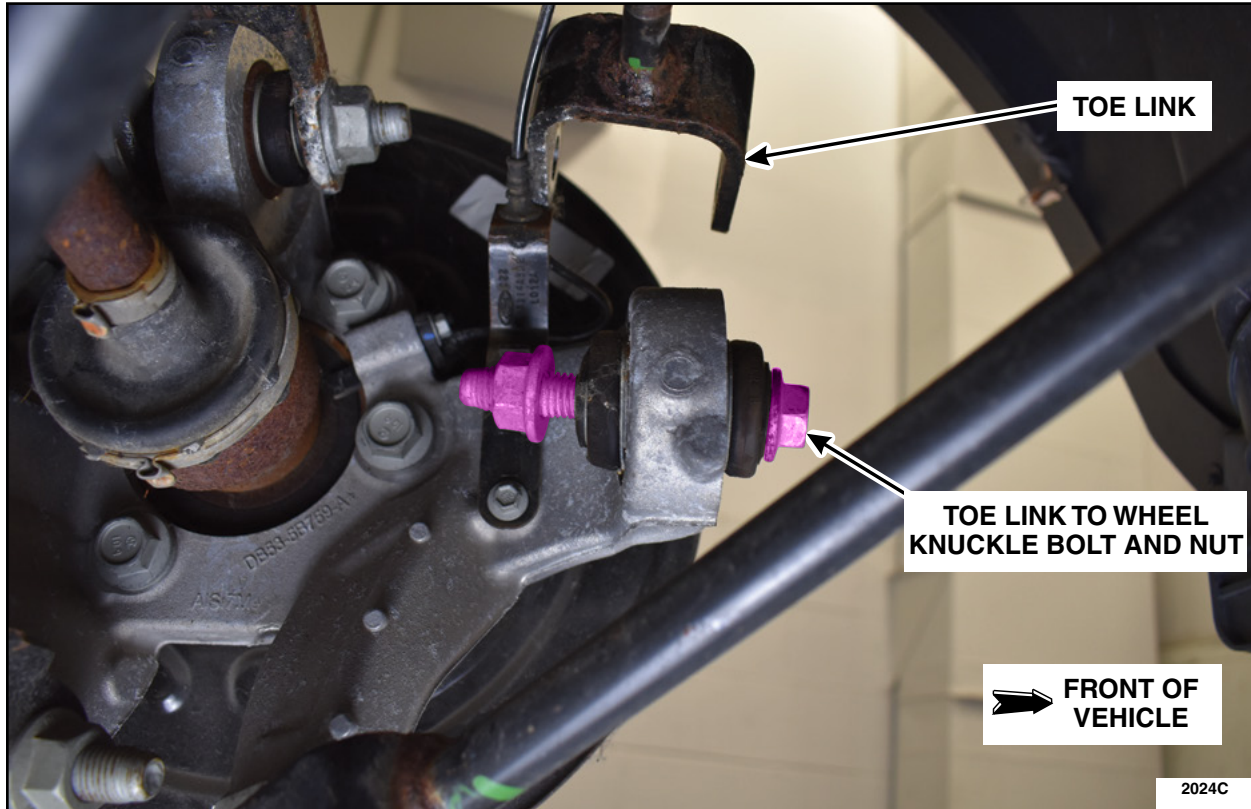
FIGURE 4

6. Install the toe link to knuckle bolt and nut. Tighten the nut while holding the bolt still with a wrench.
See Figure 4.

- Torque: 111 lb.ft (150 Nm).

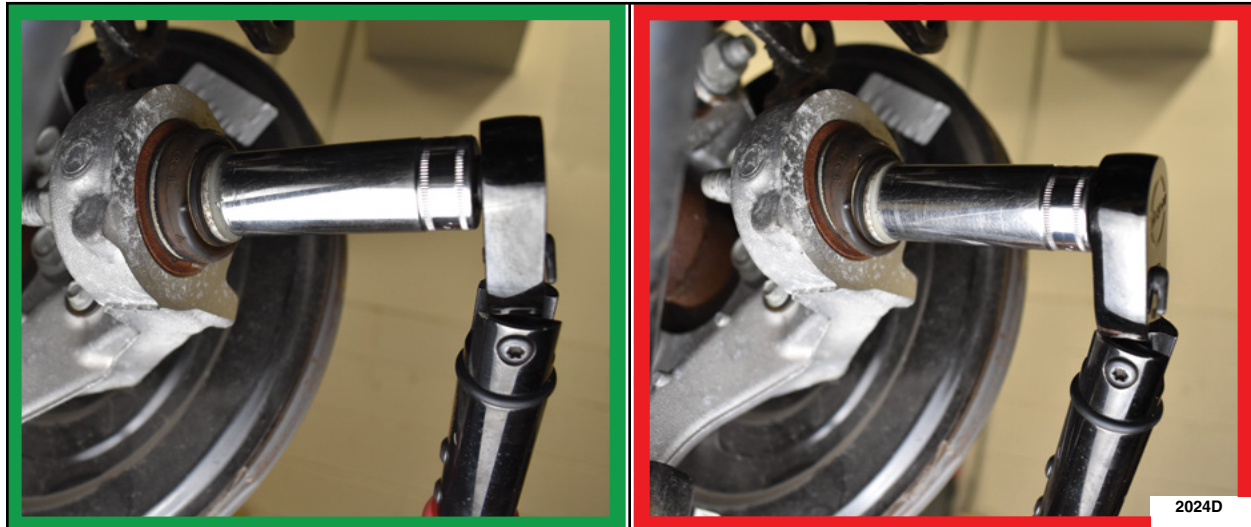
FIGURE 5

NOTE: When functioning properly the toe link ball joints should rotate freely. This inspection step will determine if the ability for the ball joint to rotate freely has been affected, requiring replacement.

7. Using a digital or dial type torque wrench, rotate the toe link to wheel knuckle bolt while keeping the ball joint straight. Do not allow the ball joint to twist as shown in the red picture below. Note the reading off of the torque wrench when the ball joint begins to rotate. See Figure 5.

9. Are the readings over 11 lb. ft (15 Nm)?

- If YES - The RH ball joint has FAILED. Proceed to step 13 for replacement instructions on this side*
- If NO - Proceed to Step 10 for the RH side of the vehicle.*

- If YES - The LH ball joint has FAILED. Proceed to step 13 for replacement instructions on this side.*
- If NO - Proceed to Step 10 for the LH side of the vehicle.*

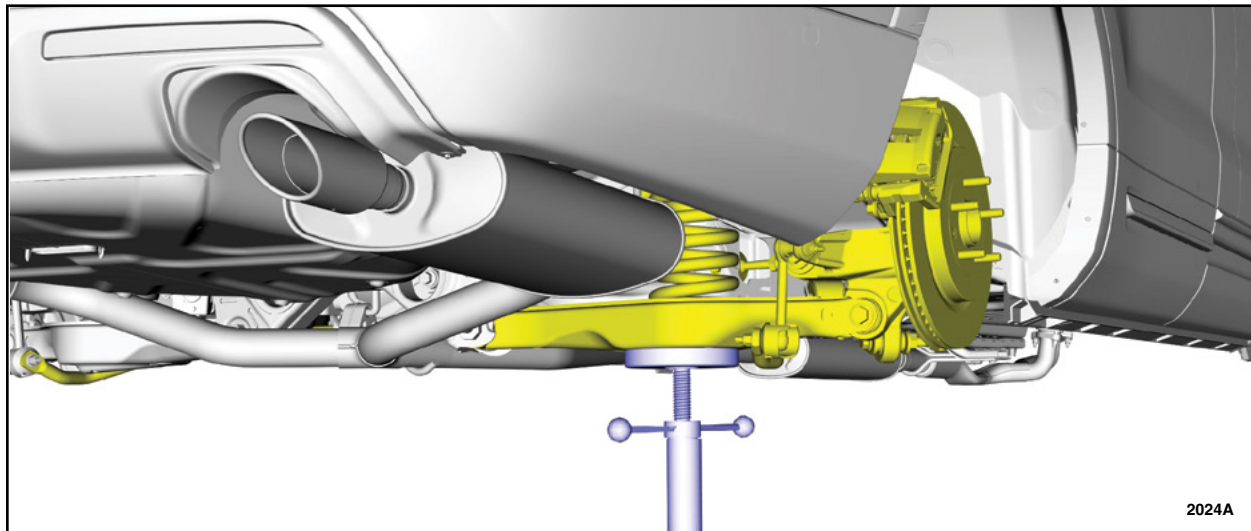
FIGURE 7

11. Remove the jack stand. See Figure 7.
