Mercedes-Benz

Campaign No. 2021020019, March 2021

SUBJECT: **Model A-Class vehicles (177 platform)**  
**Model Year 2019**  
**Check identification plate and various information labels**

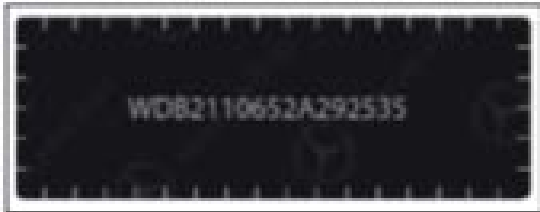
Figure 1

1. Check on the cross-member below the windshield on the left-hand side (**Figure 2**)(8.1) for the VIN identification plate (**Figure 1**) If type plate is missing apply new type plate in the location shown in (**Figure 2**)(8.1).

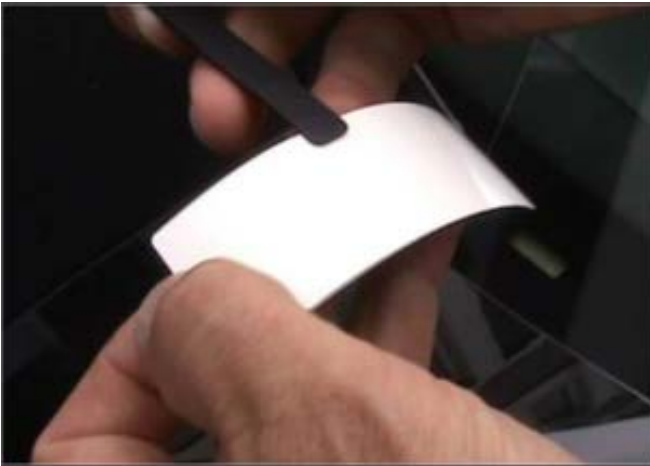
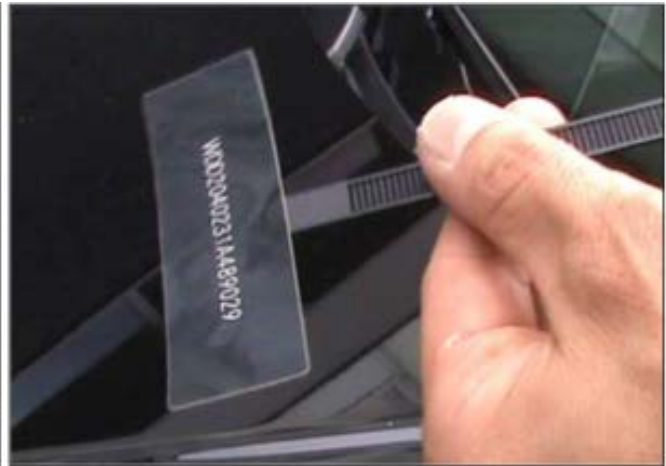
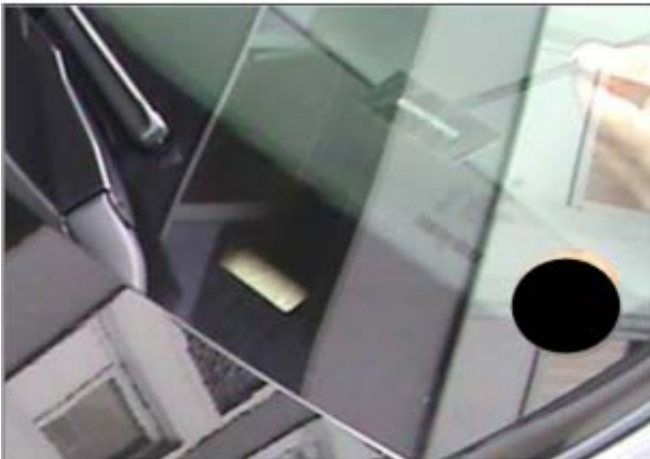
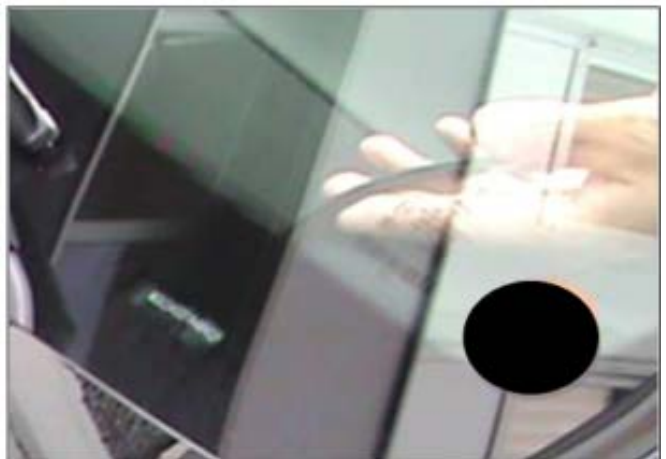
- i** To attach identification plate. Insert identification label using a cable tie between the windshield and instrument panel and attach using aid on the cross-member (**figures 3–6**).

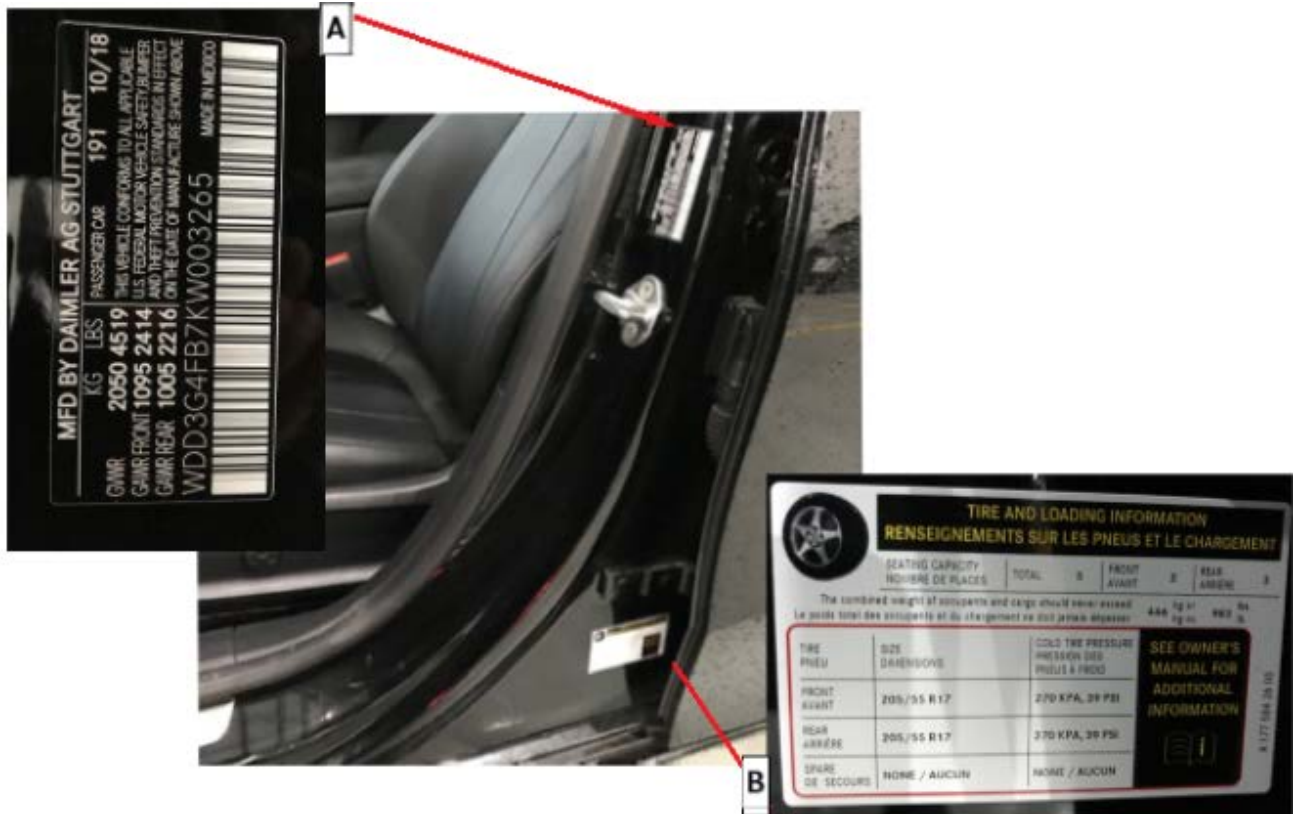
Figure 7

2. Check on the driver side B-pillar (**Figure 7**) for the VIN identification information label (**Figure 7**)(A) and the tire and load information label (**Figure 7**)(B) If a label is missing apply new label in the location shown in (**Figure 7**).

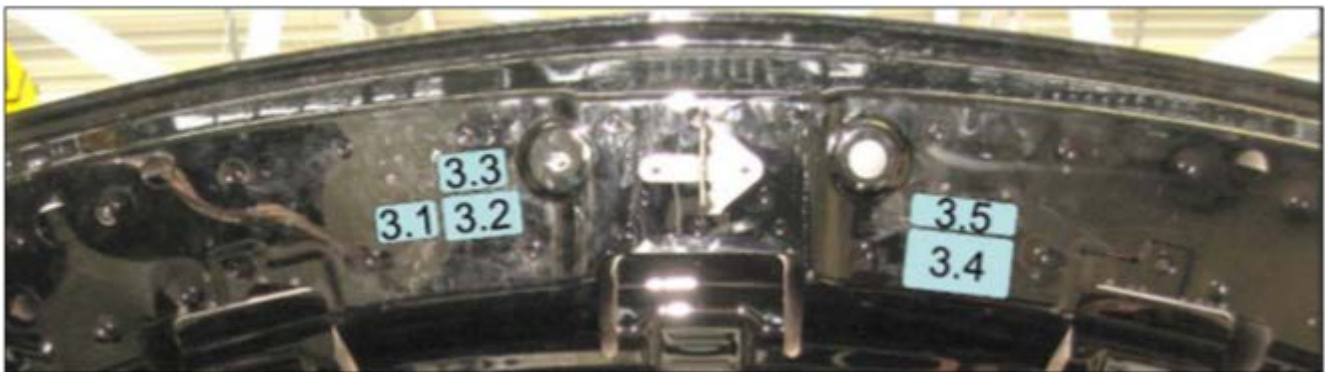
Figure 8

3. Check on the front underside of the hood (**Figure 8**)(3.1) for the equipment information label in the engine compartment (**Figure 9**) If the label is missing apply new label in the location shown in (**Figure 8**)(3.1).
4. Check on the front underside of the hood (**Figure 8**)(3.2) for the air conditioning system label (R-134a) (**Figure 10**) If the label is missing apply new label in the location shown in (**Figure 8**)(3.2).
5. Check on the front underside of the hood (**Figure 8**)(3.4) for the USA emission control information label (**Figure 11**) If the label is missing apply new label in the location shown in (**Figure 8**)(3.4).
6. Check on the front underside of the hood (**Figure 8**)(3.5) for the 4MATIC information label (**Figure 12**) If the label is missing apply new label in the location shown in (**Figure 8**)(3.5).

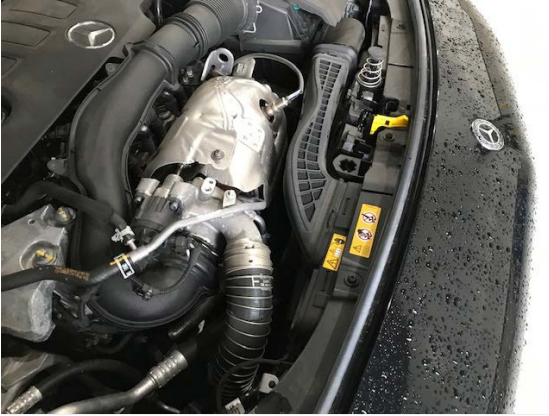
Figure 13

7. Check under the hood in the front of the engine compartment (**Figure 13**) for the radiator fan run-on information labels (**Figure 14**). If a label is missing apply new label in the location shown in (**Figure 13**).

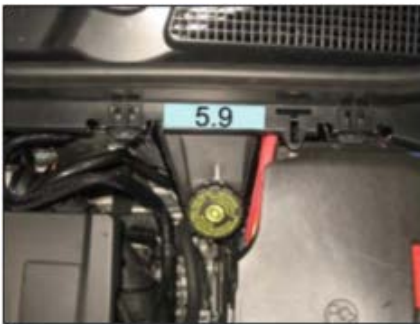
Figure 15

8. Check the rear of engine compartment near the brake reservoir fill (**Figure 15**)(5.9) for the brake fluid reservoir label (**Figure 16**). If the label is missing apply new labels in the location shown in (**Figure 15**)(5.9).

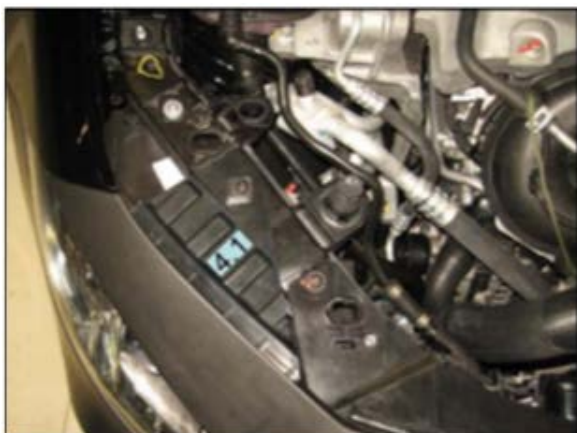
Figure 17

9. Check the front of the engine compartment (**Figure 17**)(4.1) for the LED headlamp information label (**Figure 18**). If the label is missing apply new labels in the location shown in (**Figure 17**)(4.1).

**i** Only on vehicles with option, code 640 LED headlamps.

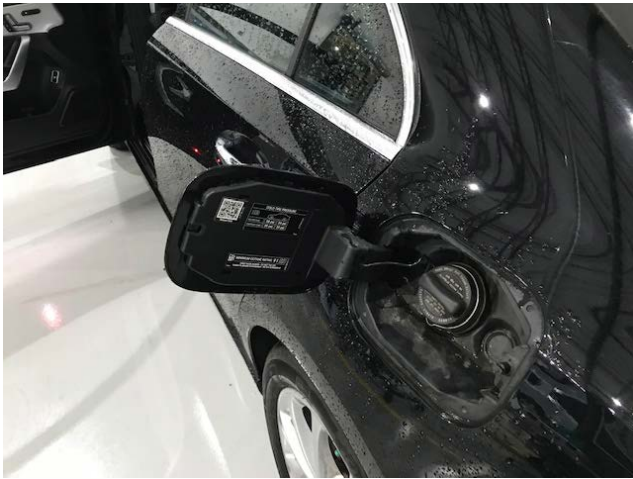
Figure 19

10. Check on the inside of the fuel filler flap (**Figure 19**) for the rescue data QR code label 1 (**Figure 20**) (A), tire pressure label (**Figure 20**) (B), and fueling label (**Figure 20**) (C). If a label is missing apply new labels in the location shown in (**Figure 19 and 20**).

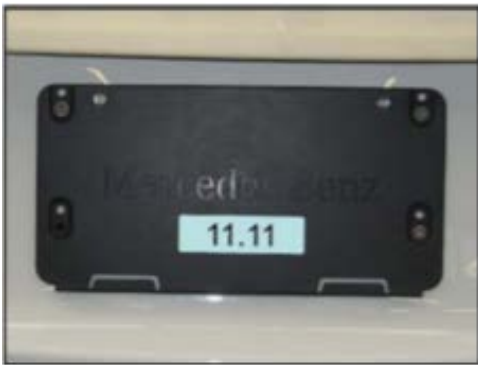
Figure 21

11. Check on the rear license plate mount (**Figure 21**)(11.11) for the VIN label (**Figure 22**). If the label is missing apply new label in the location shown in (**Figure 21**)(11.11).

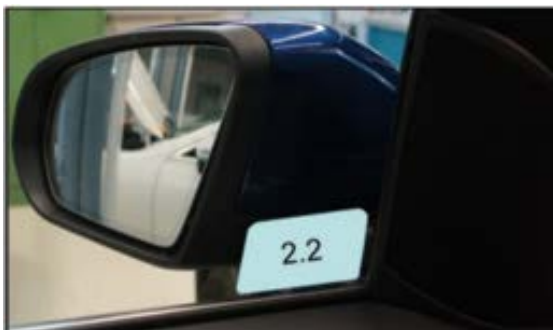
Figure 23

12. Check on the inside of the driver's side front window (**Figure 23**)(2.2) for the chemicals information label (**Figure 24**) If the label is missing apply new label in the location shown in (**Figure 23**)(2.2).

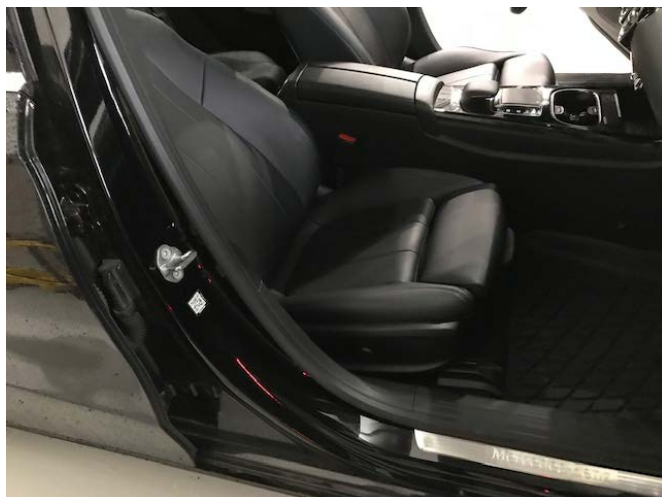
Figure 25

13. A Check on the passenger's side B-pillar (**Figure 25**) for the rescue data QR code label 2 (**Figure 26**) If the label is missing apply new label in the location shown in (**Figure 25**).
