Safety Recall: 2013-15 Accord Driveshaft Inspection

AFFECTED VEHICLES

Year	Model	Trim Level	VIN Range
2013-15	Accord	CVT models only	Check the iN VIN status for eligibility.

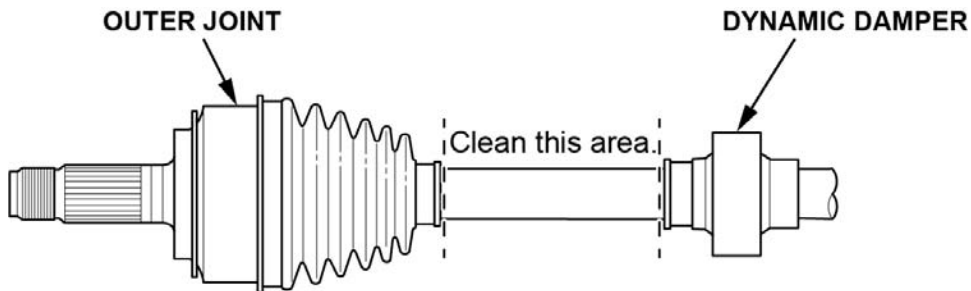
1. Raise and support the vehicle.
2. Use a clean shop towel to wipe any excess dirt and debris from the driveshafts between the outer joint and the dynamic damper.

Paint chips may be sharp and could cut bare hands. Use gloves when wiping the driveshaft.

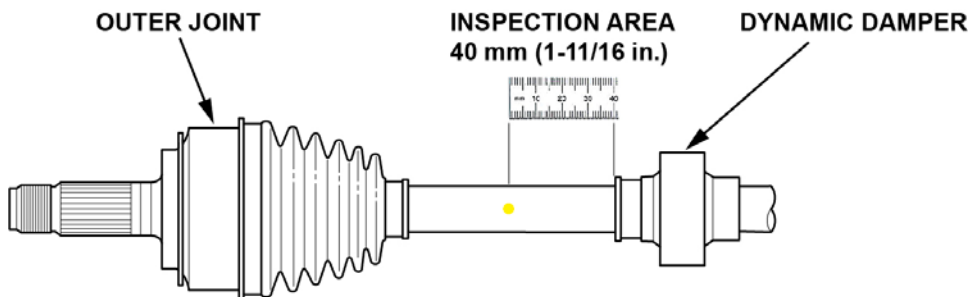
3. Using a ruler and yellow paint marker, measure **40 mm (1-11/16 in)** away from the dynamic damper, and mark the driveshaft with a dot. Click [HERE](#) to view the video on how to do the inspection procedure.

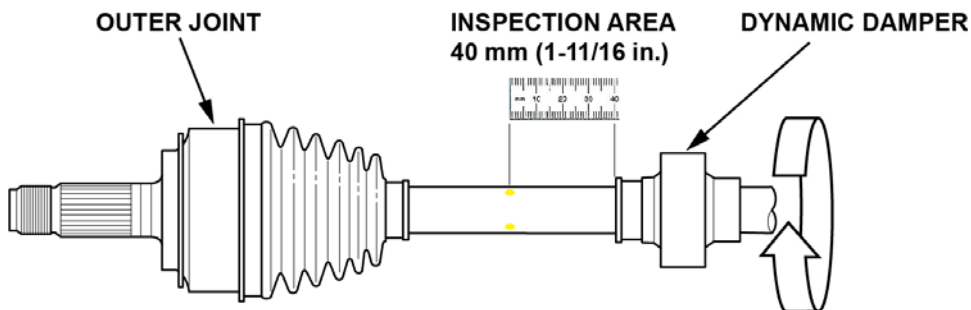
4. Rotate the axle 1/4 turn and repeat the above step **3 times** until there are 4 paint dots on the axle.

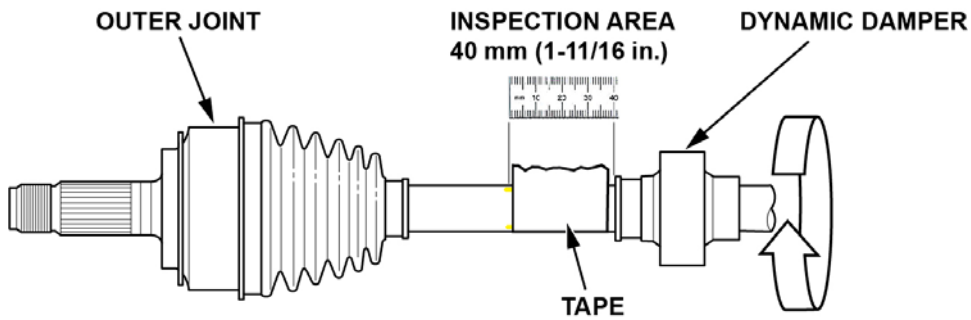
5. Connect the 4 painted dots around the axle using masking tape.

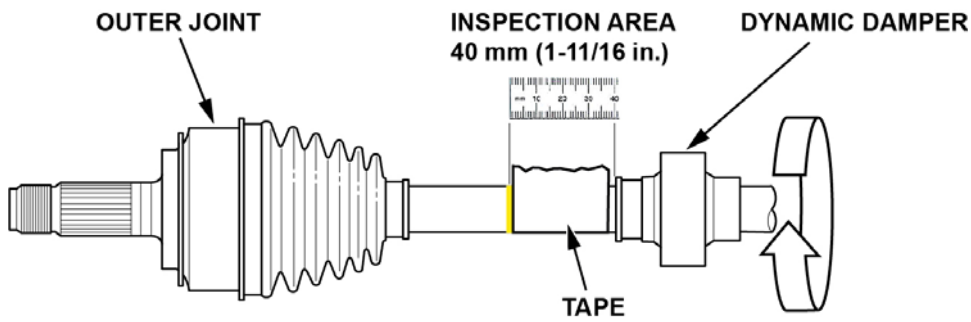
6. Using the masking tape as a guide, trace a line all around the axle using the yellow paint marker.

Marking the line accurately is important, especially if there is damage close to or inside the 40 mm line.

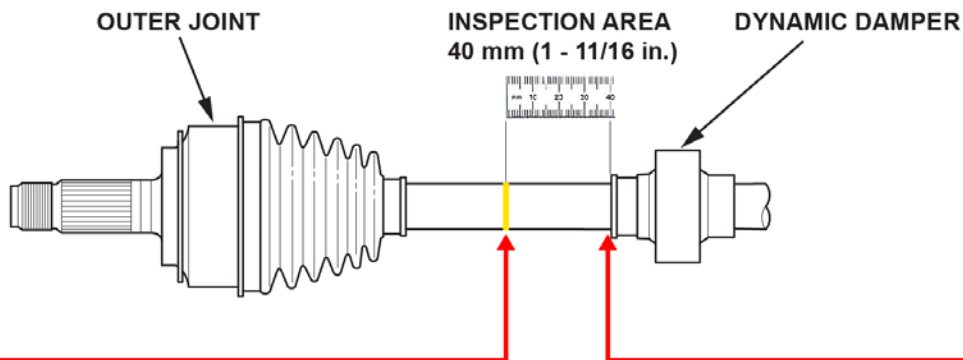
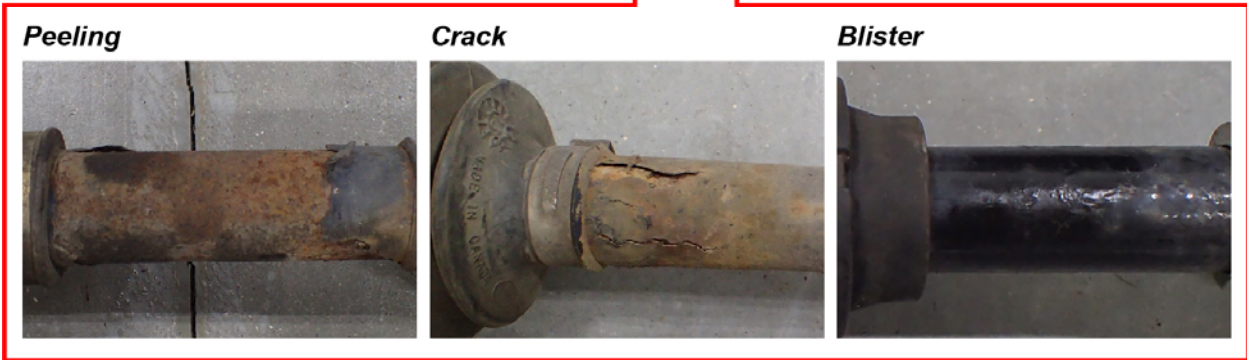
8. Inspect the driveshaft surface between the dynamic damper and the line for peeling paint, cracks, or blisters.

Corrosion or paint defects between the outer joint and the yellow line are OK.

Is there peeling paint, cracks, or blisters on either driveshaft within **40 mm (1-11/16 in)** of the dynamic damper?

- Yes. Go to the REPAIR PROCEDURE.
- No. The driveshafts are OK. Return the vehicle to the customer.

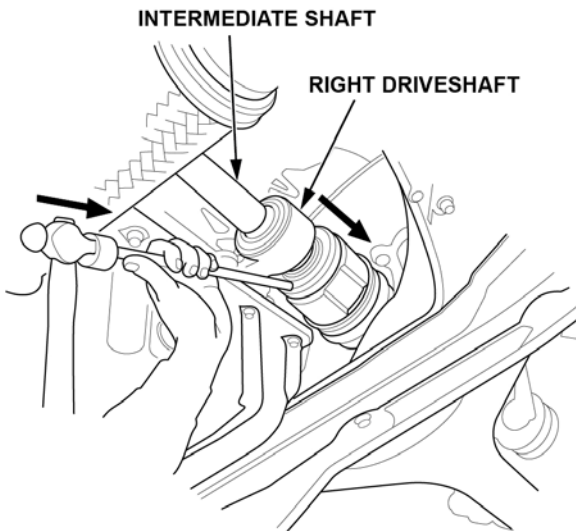
7. Use a drift punch and a hammer to remove the right driveshaft from the intermediate shaft.

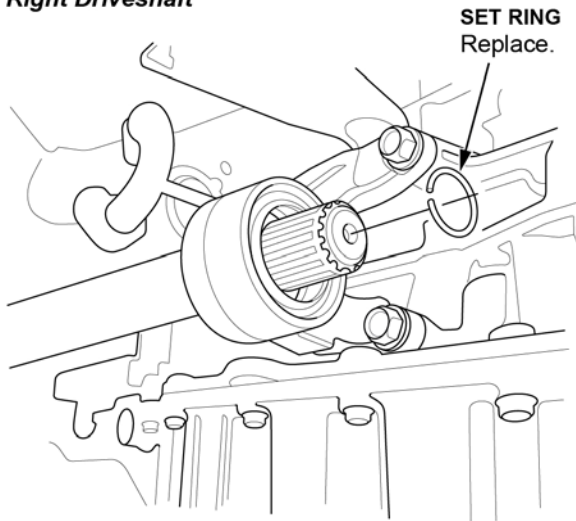
Right Driveshaft

9. Replace the set ring on the intermediate shaft with the one provided in the hardware kit.

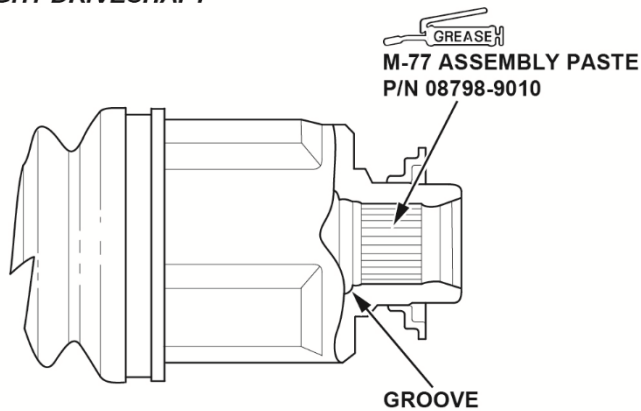
RIGHT DRIVESHAFT

10. Apply **0.5-1.0 g (0.018-0.035 oz)** of M-77 Assembly Paste (P/N 08798-9010) to the splined surface of the right driveshaft.

Remove grease from the splined grooves every 2-3 splines and the set ring groove so that air can bleed from the intermediate shaft.

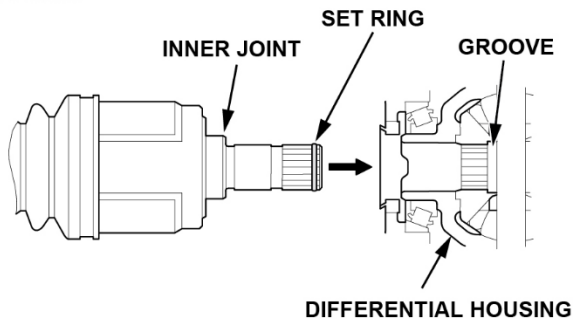
Left Driveshaft

11. Install the new driveshafts. Insert them until the set rings lock in the grooves.

Insert the left driveshaft straight in to avoid damaging the transmission oil seal.

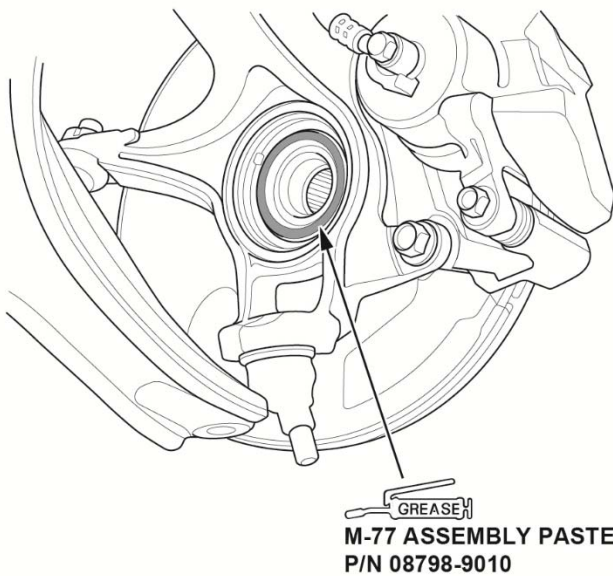
12. Apply about **3 g (0.11 oz)** of M-77 Assembly Paste (P/N 08798-9010) to the contact area of the outboard joint and the front wheel bearings.

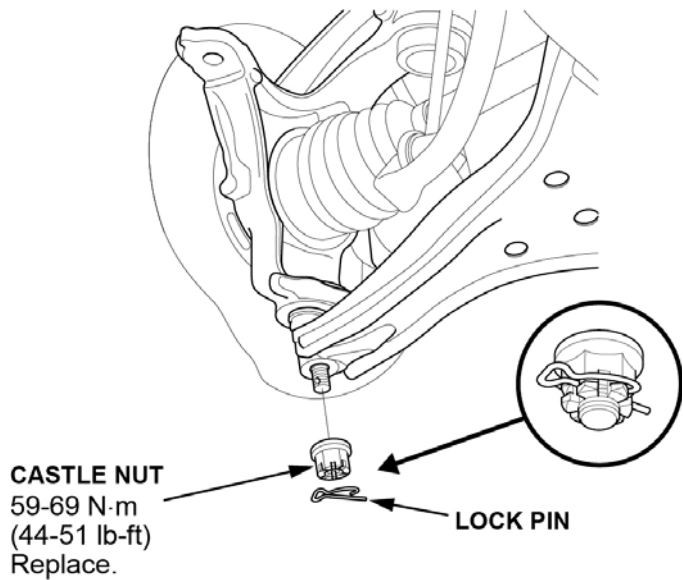
14. Connect the lower ball joints to the lower control arm. Use new castle nuts provided in the hardware kit.

Torque the castle nuts to the lower torque specification, then tighten them only far enough to align the slot with the ball joint pin hole. Do not align the castle nuts by loosening them. When aligned, install the lock pin through the hole.

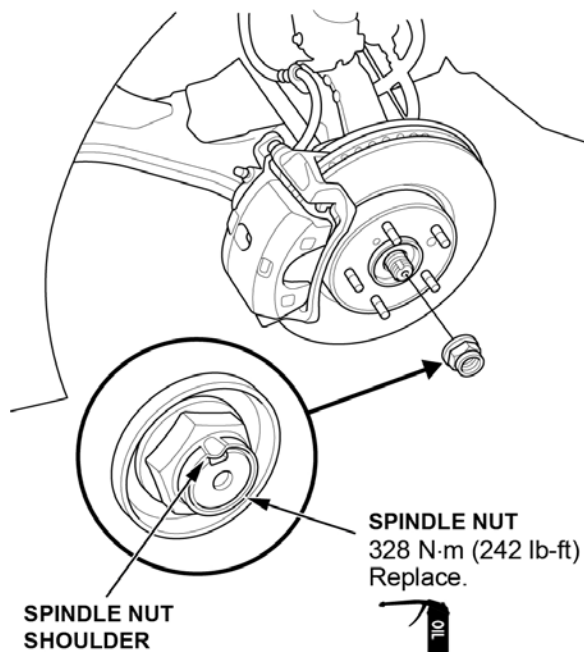
15. Install the new spindle nuts provided in the hardware kit.

Apply a small amount of engine oil to the seating surface of each new spindle nut.

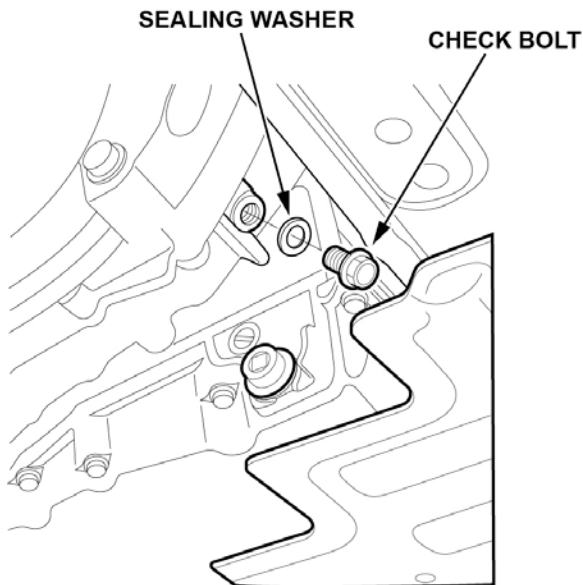
21. Remove the check bolt and sealing washer.

- When checking the transmission fluid level at the check bolt, it is not uncommon to find the fluid at the upper or lower level.
- Do the transmission fluid level check immediately after the shift lever operation.
- The check bolt and the transmission fluid may be hot.

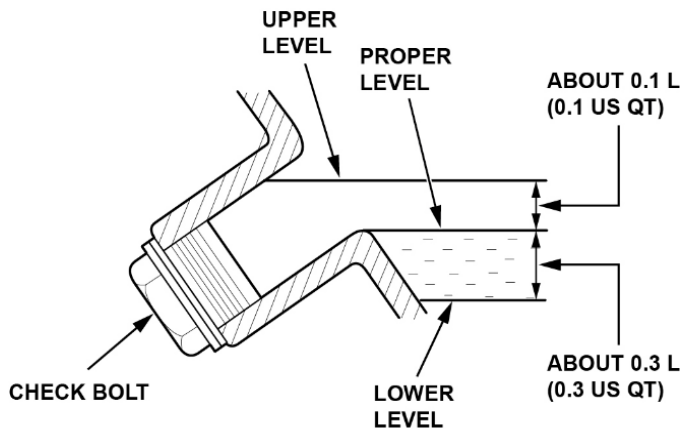
The transmission is at the proper level if the fluid is dripping from the hole gradually.

- If the transmission fluid is flowing out of the check hole, wait for until it is dripping from the hole gradually. Then, go to step 25.
- If the transmission fluid is dripleless from the check hole, loosely install the check bolt and go to the next step.

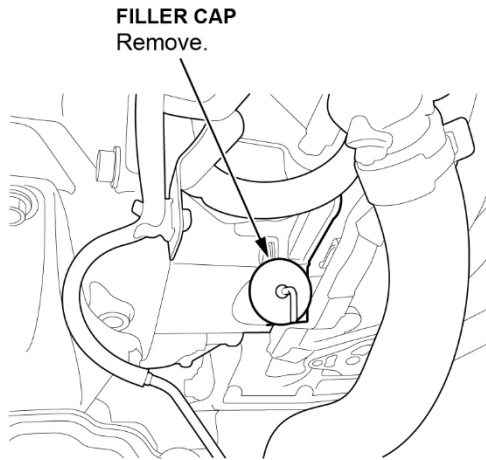
22. Remove the filler cap.

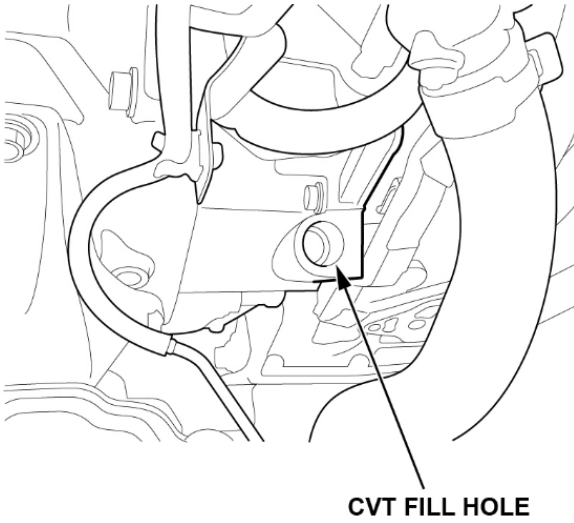
23. Fill the transmission with a suitable amount of HCF-2 CVT Fluid.

Using the wrong type of fluid will damage the transmission.

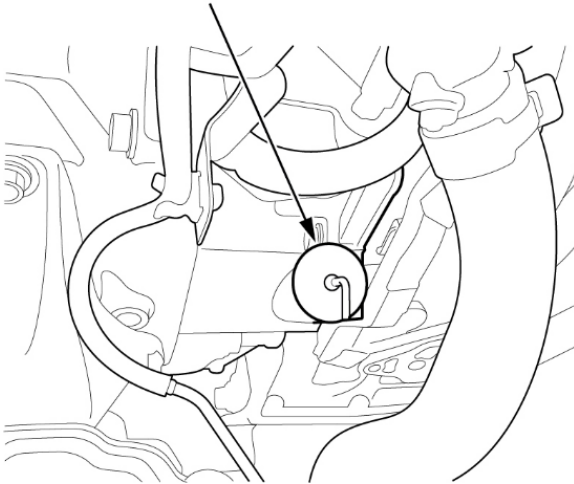
FILLER CAP
Install.

24. Install the filler cap in the direction shown and restart the procedure at step 18.

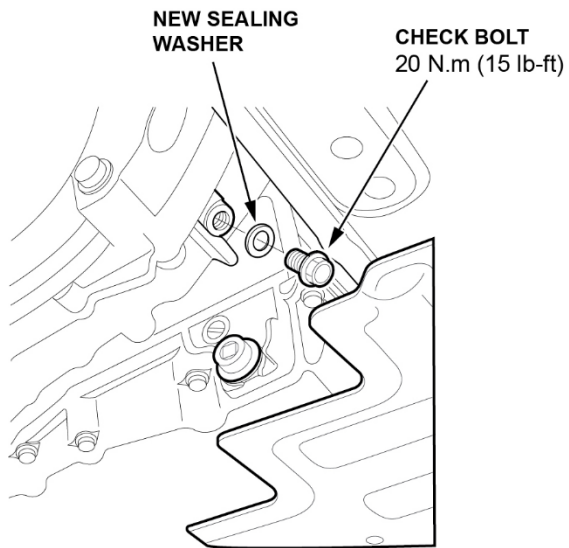
25. Install the original check bolt with a new sealing washer.
