Safety Recall

Code: 69BC

Subject	Driver Frontal Airbag																									
Release Date	December 10, 2021																									
Revision Summary	<u>USA ONLY</u> <ul style="list-style-type: none">• Added Rental Car/Loaner program claiming instructions• Added Appendix for Rental Car/Loaner program FAQs																									
Affected Vehicles

Subject: Safety Recall 69BC –Driver Frontal Airbag

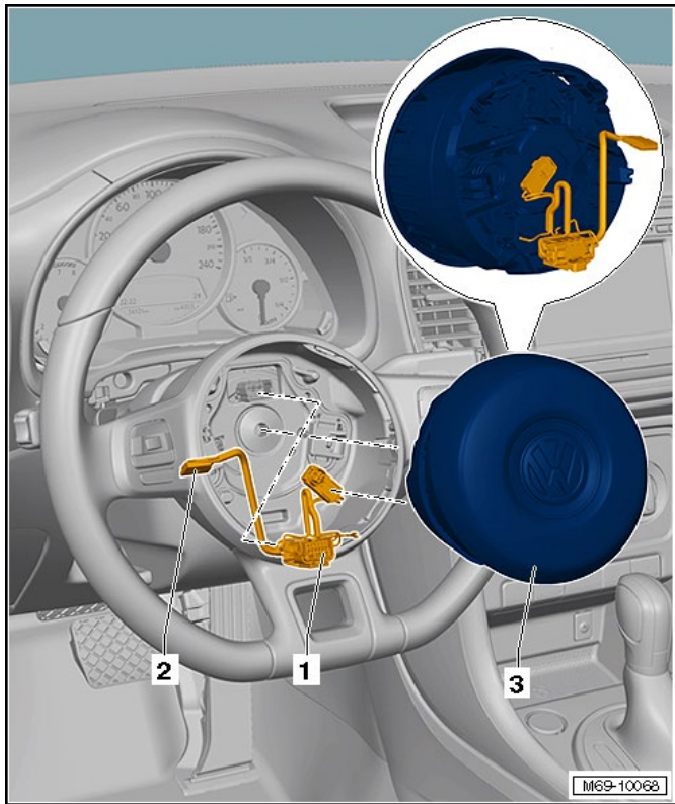
- Release the connector lock and disconnect the airbag connector <1>.
- Vehicles with multifunction steering wheel: Release the connector lock and disconnect the connector <2>.
- Install new airbag in the reverse order of removal.

- Connect the airbag connector <1> with the wiring harness to the back of the airbag unit <3>.
- The airbag connector must click into place.
- Insert the connector <2> in the connector lock. This is required only on the multifunction steering wheel.
- Press the airbag unit <3> into the steering wheel until it audibly engages.
- Gently pull on the airbag unit to make sure it is locked securely inside steering wheel on the left and right sides.
