Thor Motor Coach Recall Repair Instructions

Recall #	20V-804 2020-644		
Description/Title:	Overhead Cabinets		
Affected Product Line(s):	Certain model year 2018-2019 Hurricane and Windsport motorhomes		
Service Campaign # :	RC000208	Released Date:	1/22/2021
Codes:	Inspect Only: TMCRC80498Y Inspect with Repair: TMCRC80498V	Document Date:	1/22/2021
Time Allowed:	Inspect Only: 0.2 Inspect with Repair: 0.3	Document Revision:	A

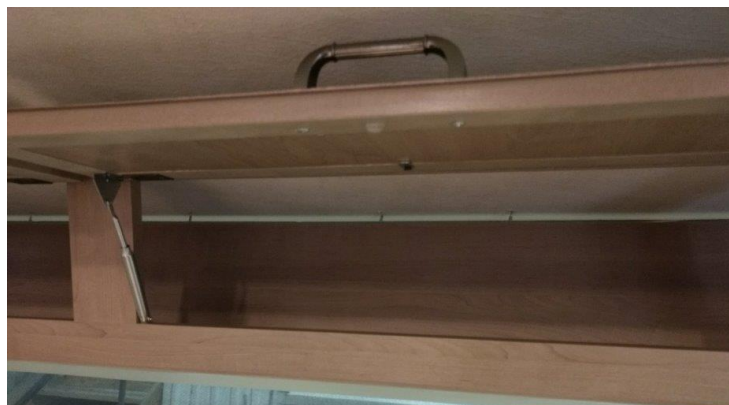
It has been discovered that on certain model year 2018-2019 Hurricane and Windsport motorhomes, the overhead cabinets located above the driver and front passenger seats may have been improperly installed during production. If the cabinet comes detached while the vehicle is in motion, the cabinet may impact the vehicle operator causing a loss of vehicle control which can result in crash. A crash can result in personal injury or death.
