Product Safety Recall

N202322230 Seat Belt May Not Be Properly Attached

Release Date: December 2020

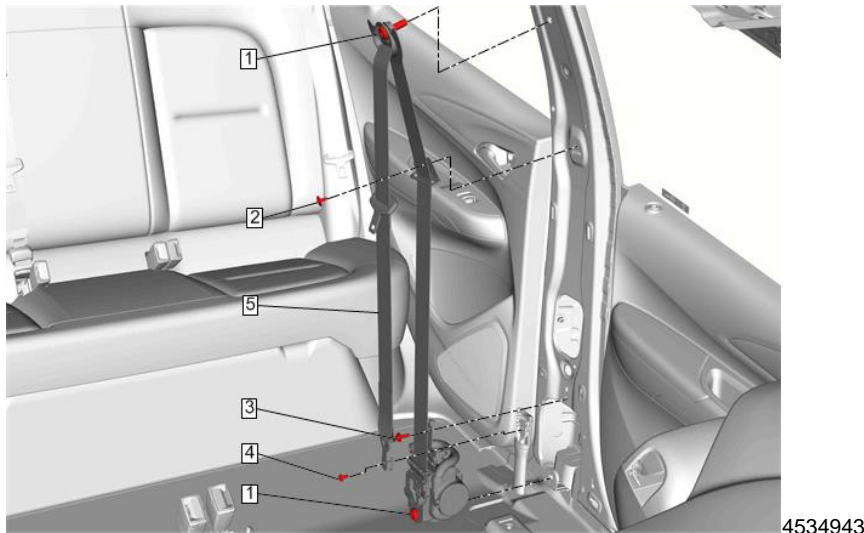
Note: The LH side is shown for reference purposes only.

2. Remove and discard the lower retractor bolt (1).
3. Install the new retractor mounting bolt. Refer to the note above for installation details. Tighten the new service bolt to 45 N.m (33 lb. ft).
4. Reinstall the center pillar lower trim panel. Refer to *Center Pillar Lower Trim Panel Replacement* in SI.

NOTE: The bolt being removed from the vehicle may not have cut the proper threads in the nut when the vehicle was manufactured. If this occurred, expect to feel resistance for the complete bolt length when removing the bolt. When the new bolt is being installed in an unthreaded nut, there will be resistance as the self-threading bolt threads the nut. There will be an initial resistance while the thread is being cut, followed by a reduction in resistance. This is an expected condition. Continue tightening the bolt until the retractor or belt bracket is secured. To complete the installation, tighten the bolt to the proper torque specification.
